Conservation Works on Wall Paintings of Aghtamar Church in Van

Fatma Sedes

Faculty of Architecture and Design, Istanbul Aydin University, Istanbul, Türkiye
Email: fatmasedes@aydin.edu.tr

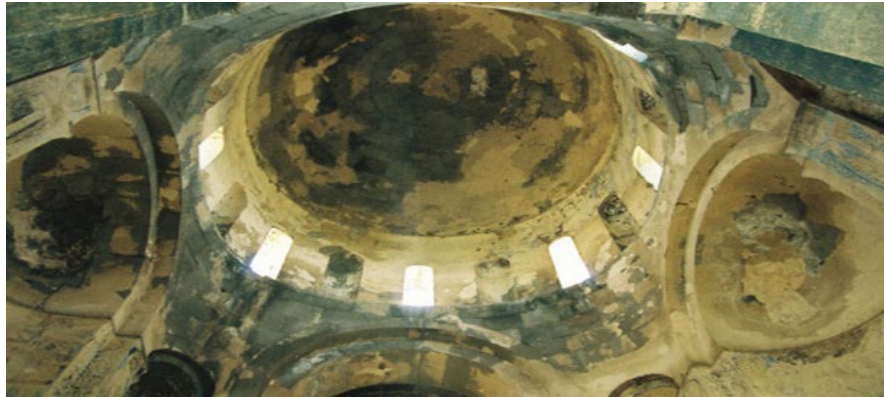
These decays in the stone cause exfoliation in the stone, and in more advanced stages, the stone turns into dust. After the building was abandoned, especially due to the lack of glasses at windows to prevent the rain, the rain water flowed inside, destroyed the paints in the places where it flowed, and also created traces of streams with the dirt it carried (Figures 2-4).

Figure 3. Dirty traces of streams in the dome (Bengül, 2005).

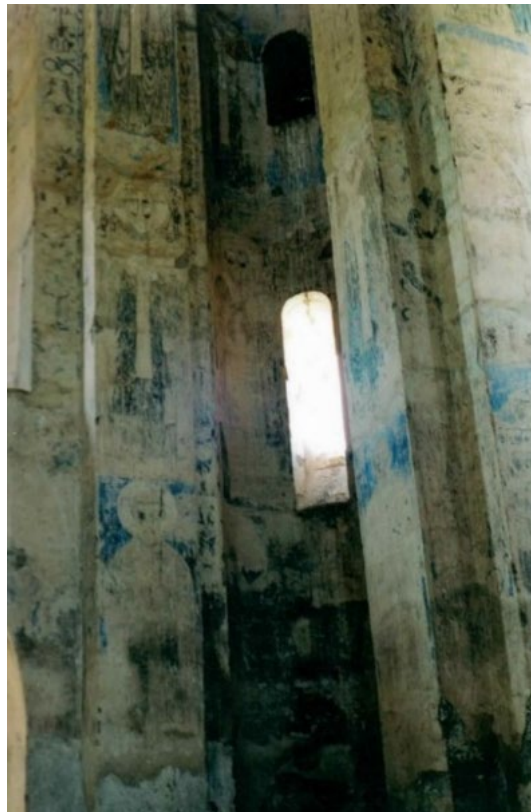
Figure 4. The church walls before repairing (Bengül, 2005).

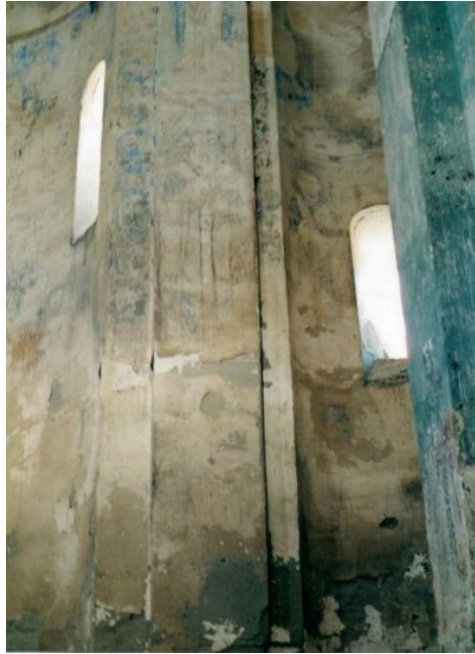
Figure 5. Deteriorations of plasters (Bengül, 2005).

The three layers of plaster were separated from the stone (Figure 5 and Figure 6) and separated from each other due to earth tremors and gravity during the 1000-year life of the building, and a large part of it was poured, especially in the domes. Most of the spills were in the painting floor plaster and intonacoda. Just below the pulley, the plasters were completely poured and stones remained. We understand from the plaster made in 3 - 4 layers that the building has been repaired before (Figure 7 and Figure 8).

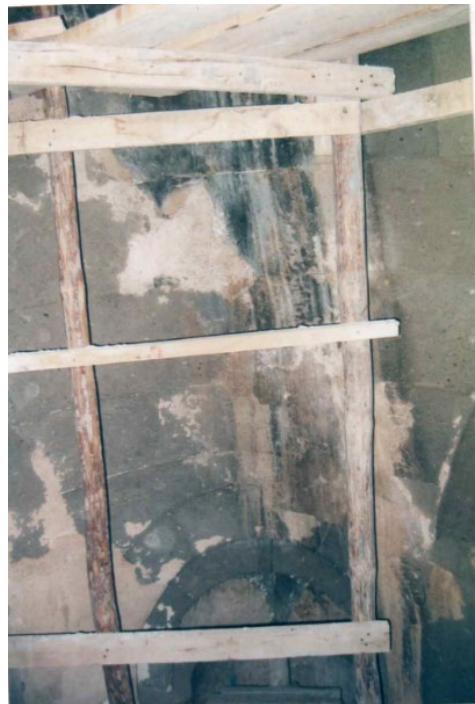
Figure 6. Pollution from rain runoff (Bengül, 2005).

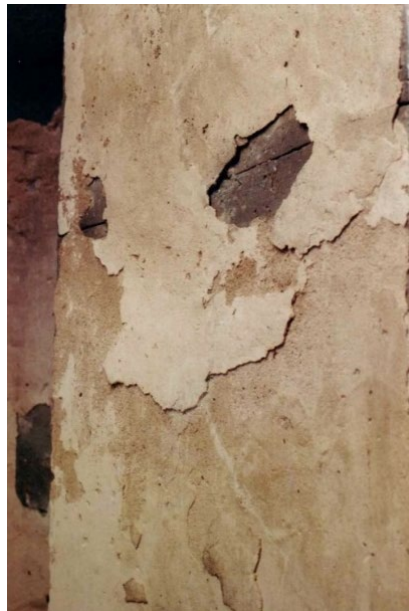
Figure 7. Swelling and flaking plasters (Bengül, 2005).

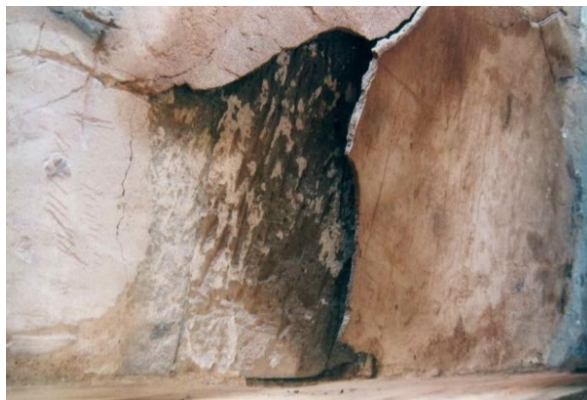
Figure 8. Plaster that splits and cracks from the wall (Bengül, 2005).

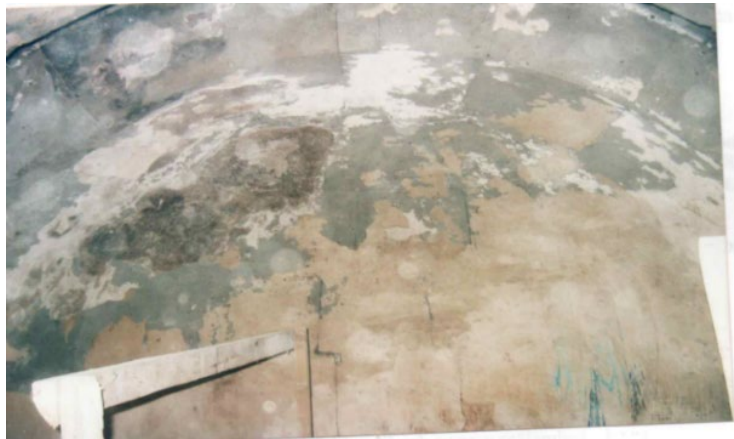
Figure 9. Plaster losses in the dome and rotting of the plaster due to moisture (Bengül, 2005).

The painting floor plaster is separated in the form of foil, and when it is too thin, (Figure 9) its consolidation is done first. While doing this, the dust between the puar and the two plasters was cleaned first, then Primal SF 016 prepared at a rate of 2% - 4% was injected into the back with the help of an injector and adhered by pressing with a pompom (nylon filled with cotton). Then, the place made with wet cotton was cleaned so that Primal SF 016, which overflowed, did not dry and shine.

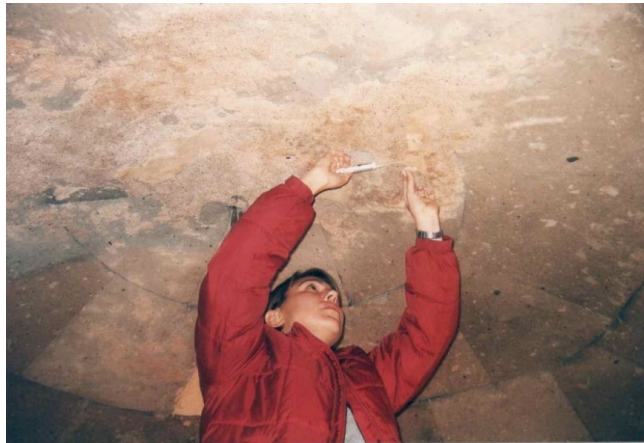
Figure 10. Consolidation of the plaster by injecting primal SF 016 with the help of an injector (Bengül, 2005).

On the lower floors, it was understood that some parts were separated from the wall according to the sound of the plaster and the back was empty. A hole was drilled where needed with auger, and it was cleaned with a puar. Water with 2.5% alcohol was given by syringe. Then, hydraulic lime + 2% Primal SF 016 + pumice powder + water mixed slurry was injected. Control was carried out by constantly hitting it by hand. The process ended when the voice gave a full sound. Checked again a day later. Decay was detected in the stone in places that continued to give a sound. In order to strengthen this decay, a low percentage (2% - 3%) SF 016 was injected into the back of the plaster. After waiting for one day, the injection process was performed (Figures 10-13).

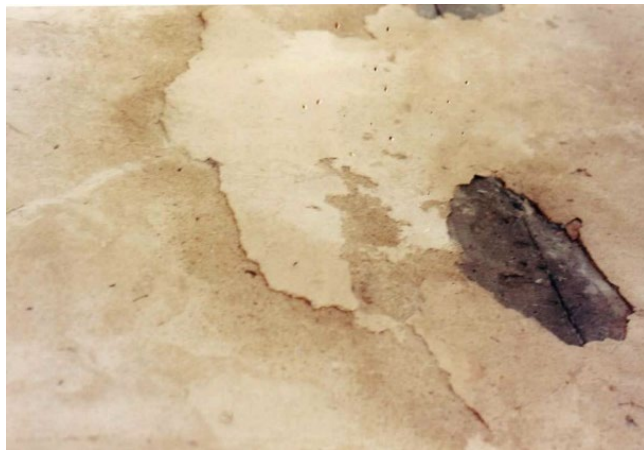
Figure 11. Consolidation of the plaster that has reached the deterioration stage (Bengül, 2005).

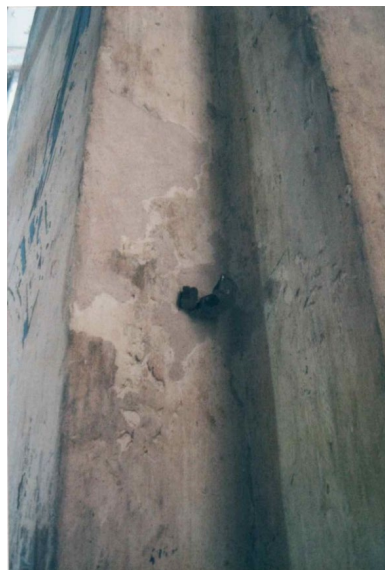
Figure 12. Example of reinforced plaster (Bengül, 2005).

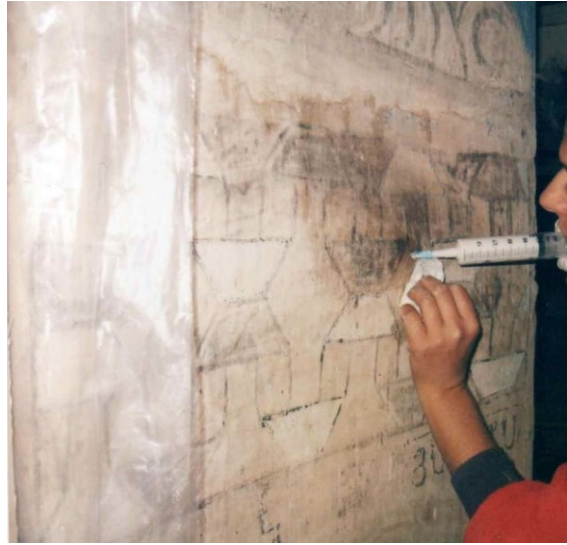
Figure 13. Injection process (Bengül, 2005).

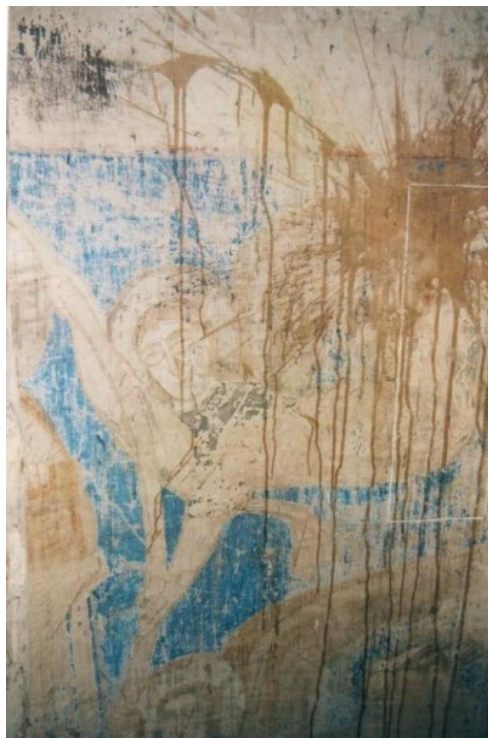
Egg wastes were seen in the North and West façades, the North half dome, the South half dome, and the window niche on the lower floor in the apse where the paintings were. These egg wastes penetrated the plaster thoroughly and dried. In addition, the egg corresponding to the dyes penetrated the dyes well and darkened the color of the place where it was found.

In some places, it has polluted a large area that will cover an area of 50×70 cm (Figures 13-15).

Figure 14. Egg waste on the inner walls of the west side (Bengül, 2005).

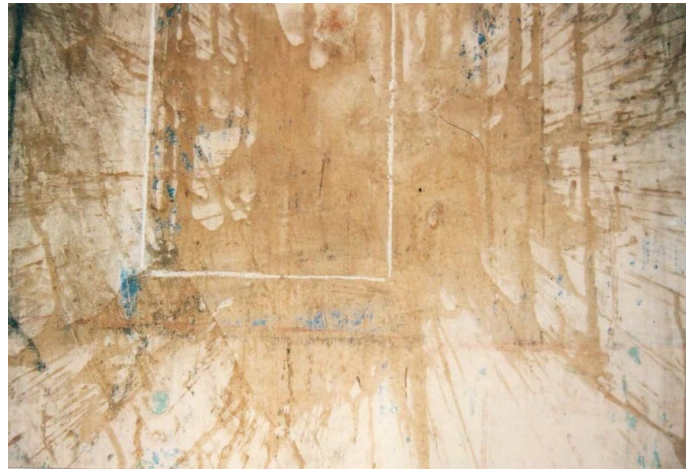
Figure 15. Egg waste on the inner walls of the north side (Bengül, 2005).

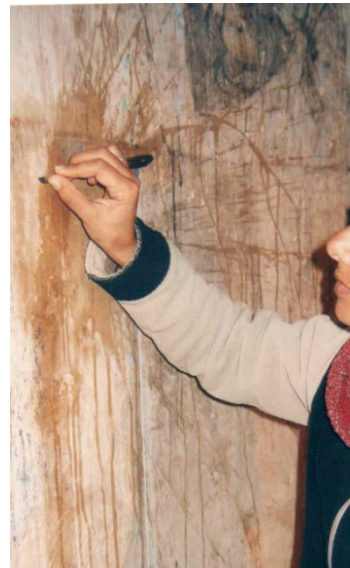
Figure 16. Mechanical cleaning of egg waste (Bengül, 2005).

Mechanical application was made to clean bird droppings and aged dirt (**Figure 16**). Bird droppings were first brushed with a soft brush, and the remaining dirt was cleaned with a scalpel. Aged dirt was erased with a non-marking eraser. In places where there was no paint, especially in the king's lodge, cleaning was done with the help of water and a soft sponge (Öney, 1990).

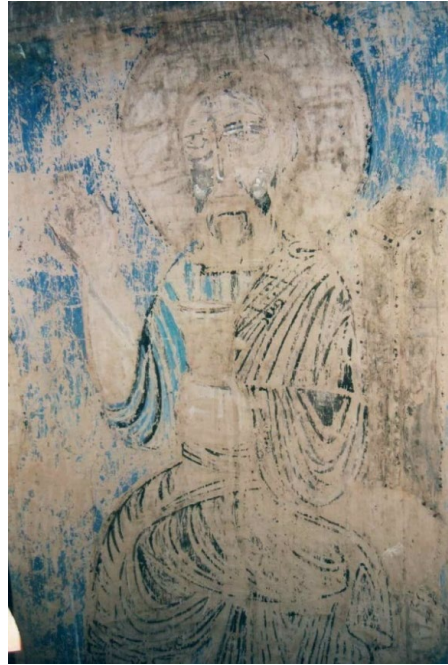
The effect of lake water and therefore soda on dyes was tested with litmus paper (pH value was 10). It has been determined that the soda in the lake water has a very negative effect on the dyes (**Figure 17** and **Figure 18**).

Figure 17. Blue paint on the wall paintings (Bengül, 2005).

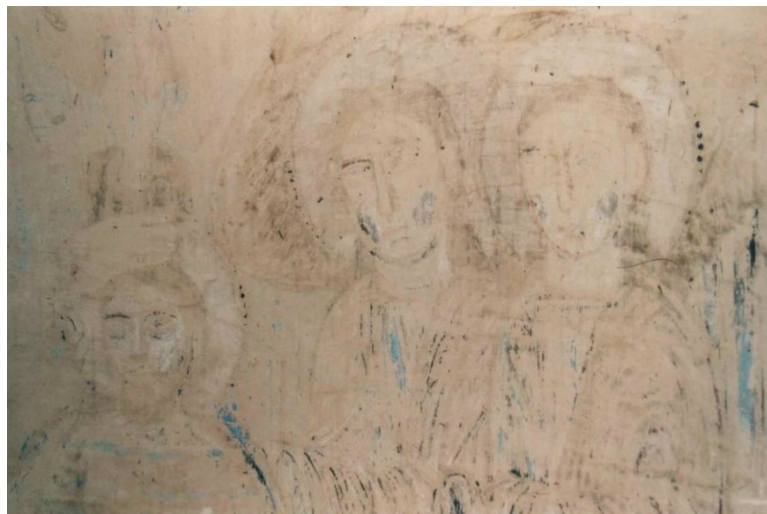
Figure 18. Deterioration of the wall paintings (Bengül, 2005).

These swelled paints were fixed again with the help of an injector with 2% thinned SF 016. SF 016 remaining on the surface was cleaned with wet cotton. After this process, paraloid B 72, which was thinned by 2%, was applied to the pollinated paints by spraying with a brush to the non-pollinating paints.

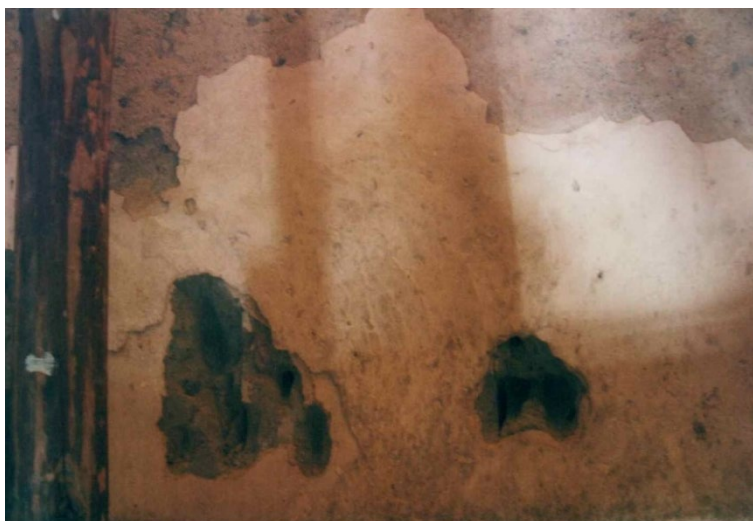
Especially in the dome, just above the drum, there are large bullet holes throughout the diameter of the dome. These bullets also punctured the stone, causing holes up to 30 - 35 cm in size and up to 10 centimeters deep.

In the scene of the massacre of the king's children on the western front, there are intensely ridiculous traces on the king. These pellets made 2 - 3 cm holes in the plaster (**Figure 19**).

Figure 19. Holes made by bullet holes in plaster and walls (Bengül, 2005).

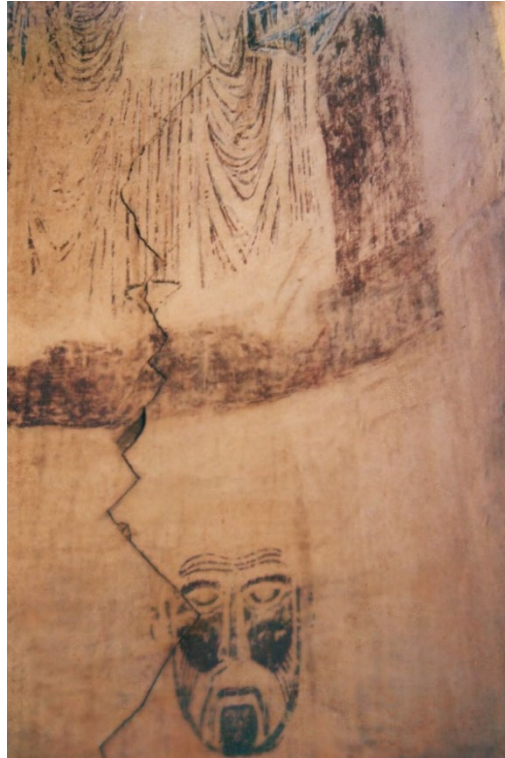
As the building moved due to ground tremors, the stones were moved, separated from each other and deep cracks were formed. These separations in the stones caused cracks in the plasters. These cracks formed in both directions, horizontally and vertically, and formed zigzags in most places.

Cracks are visible on every facade of the whole building from top to bottom. Some cracks 3 mm. While most of them were opened up to 1 cm (**Figure 20**).

Figure 20. Vertically descending zigzag crack (Bengül, 2005).

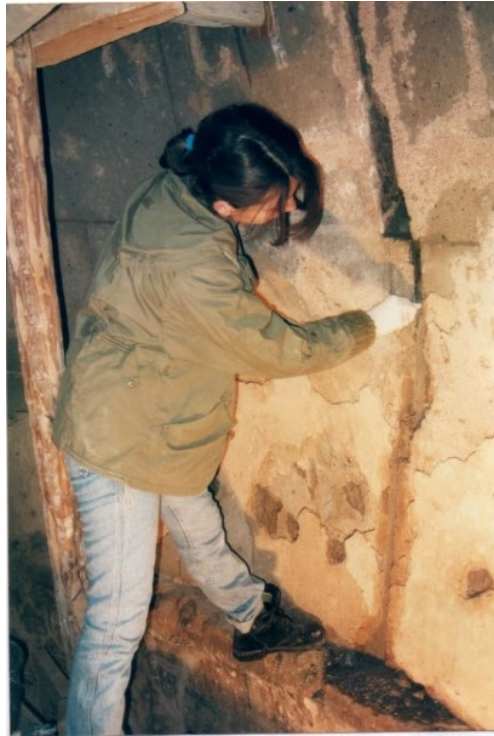
Figure 21. Filling process of the deep cracks (Bengül, 2005).

In this application, first of all, used material was determined. The most suitable mortar was found in various trials. In the rough plaster, coarse crumb brick + sand + brick dust + hydraulic lime was used. As the first process, the surface was cleaned of dust and dirt with a long-bristled brush and puar. The surface was thoroughly wetted with water, the mortar was applied to the application area sufficiently. After the mortar set, the surface was scraped and made rough with the help of a flat trowel. Although it is the same in thinner plaster, thin towed material was used. In the same way, after the surface was cleaned with puar, it was thoroughly wetted and mortar was applied to the surface with the help of a spatula (Figure 21).

In very deep decays, especially on the bottom floor, the stone was completely removed and replaced with a solid stone. Depth or black spots on the lower floor

were covered with 1 hydraulic lime + 3 sand scale mortar (Figure 21).

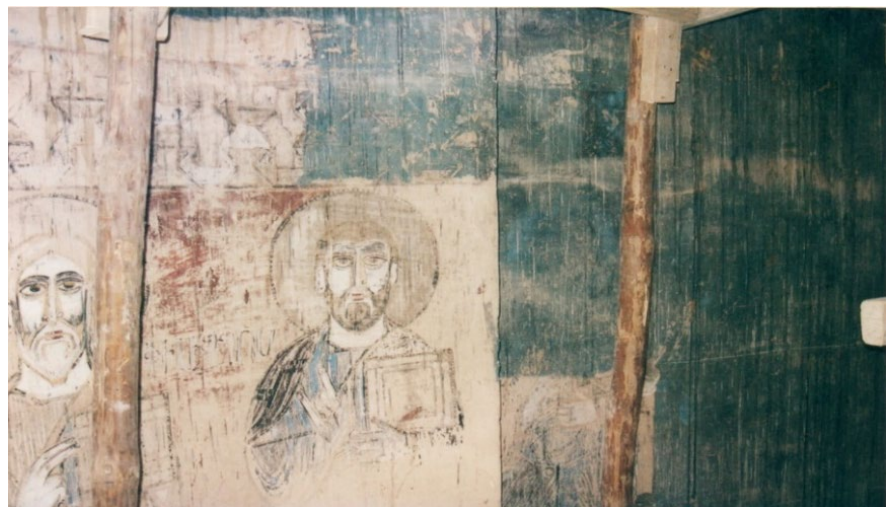
Figure 22. The blue paint applied in the form of whitewash on the apse (Bengül, 2005).

The swollen areas were strengthened with 2% SF 016 with the help of an injector. Paraloid B 72 thinned by 2.5% was applied in order to reduce the absorbency of the surface and to keep the plum on the surface a little longer. Thus, more melt remaining on the surface can enter the reaction more.

A solution of 10% - 20% Ammoniumb carbonate + EDTA mixture was applied

over the clinex with a soft brush. The same process was applied until there were 5 klinex in a row. Gelatin was placed on it in order to cut off its contact with the air and to provide a better reaction. Waiting time was different everywhere. The melt applied areas were checked every 10 - 15 minutes. When the colors started to become clear, the molten clinex was removed. Further waiting will result in damage to the original paint (**Figure 22**).

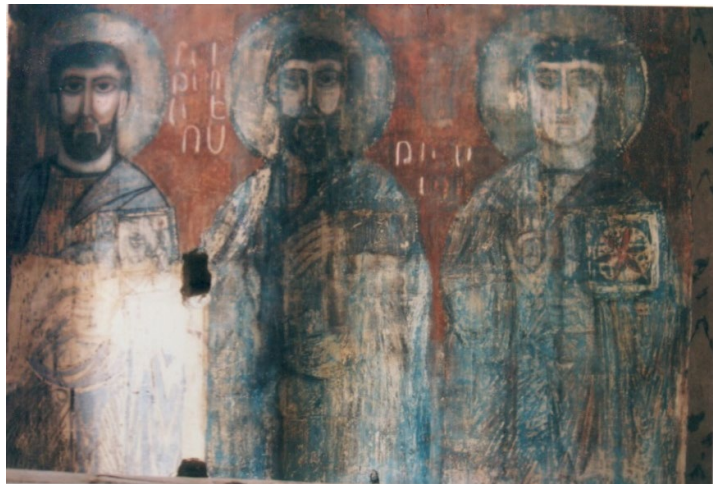
Figure 23. Images of saints coming out from under the blue paint (Bengül, 2005).

After all possible cleaning work was done, 2% thinned paraloid B 72 was applied. The aim here is to throw back the blue paint that remains on the surface like a curtain and to make the original colors more pronounced. Paraloid B72 was applied 6 - 8 times before the surface reached the shine stage (**Figure 23**).

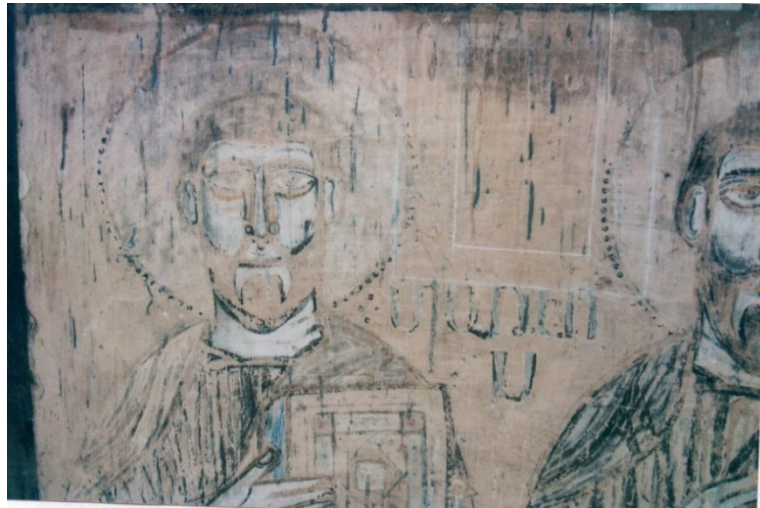
There were copious amounts of paint bleeds on the six saints who weren't painted over. These streams of paint were mechanically cleaned with the help of a scalpel (**Figure 24**).

Figure 24. Intense paint runs (Bengül, 2005).

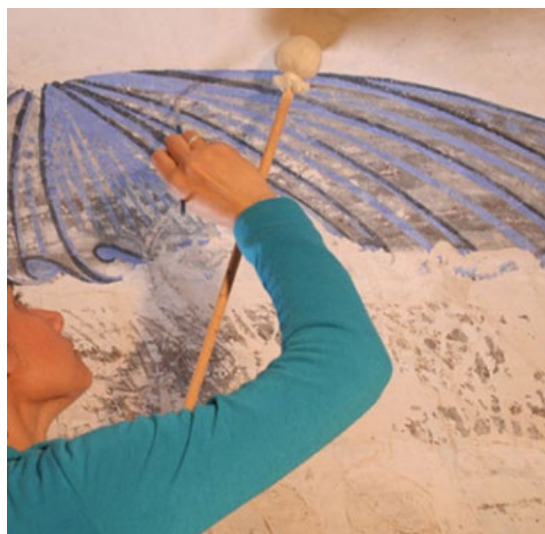
Figure 25. The retouching work (Bengül, 2005).

In the retouching work, the work was done with quality watercolors. Where the original paint remained and spills occurred in the paint, a study was carried out in a way that would match the color but be lighter. The aim here is to notice the retouched area when viewed closely, but not to be noticed when viewed from afar. The places where the paint was completely spilled, only the traces remained, were not intervened. Again, while retouching, the areas with large spills were not touched up (Figure 25 and Figure 26).

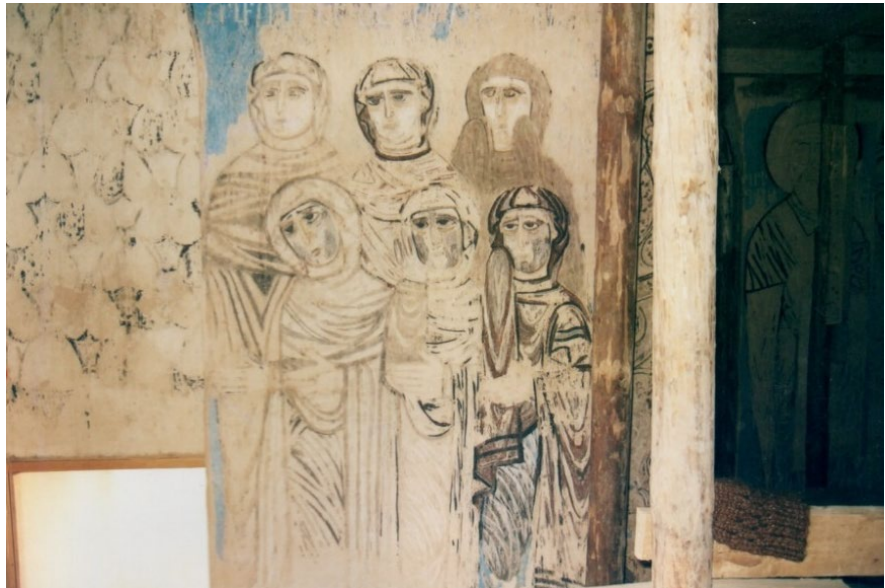
Figure 26. Crying women scene after retouch (Bengül, 2005).

After the retouching process was completed, in order to protect the original work and the original, paraloid B 72 thinned to 3%, it was applied with a soft brush with long bristles to protect the wall paintings against external factors (Figure 26 and Figure 27) (Mora et al., 1984).

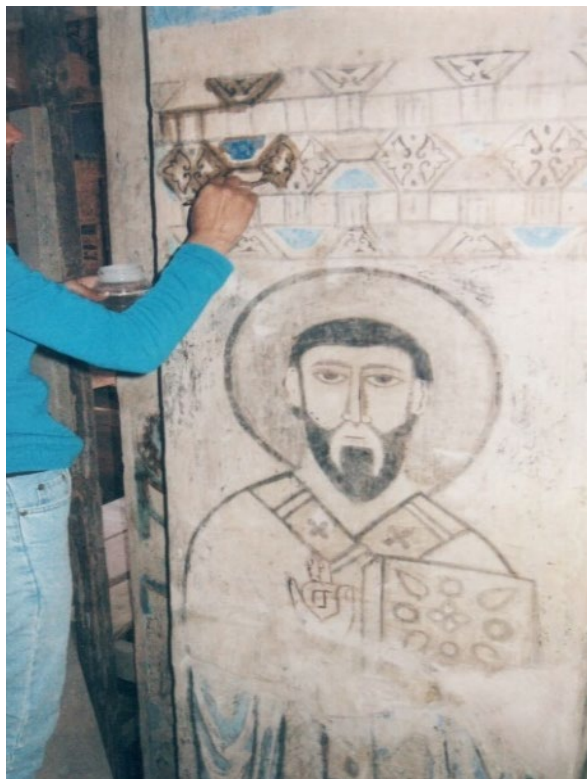
Figure 27. Process of protective application (Bengül, 2005).

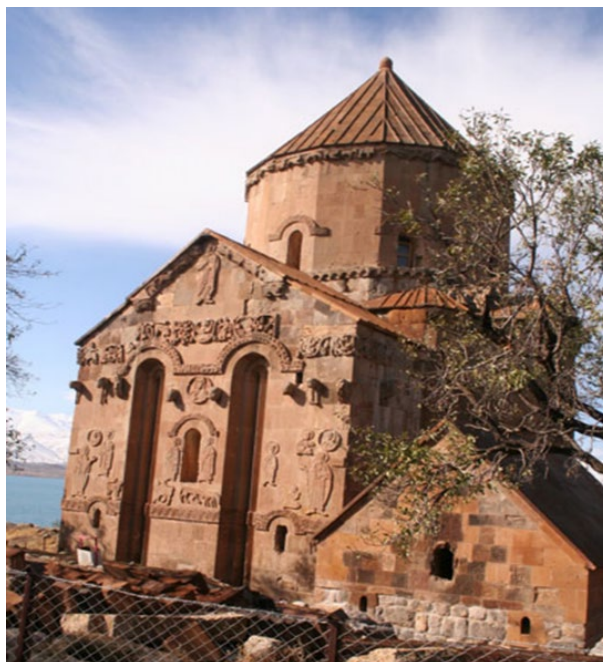
Figure 28. After restoration (outer walls) (Sedes, 2005).
