Decoding RoPax Ship Capsizes and Development of an ISO Ship Safety Standard

Soonhung Han¹, Robert Latorre²

How to cite this paper: Han, S. and Latorre, R. (2024) Decoding RoPax Ship Capsizes and Development of an ISO Ship Safety Standard. *Engineering*, 16, 225-236.
<https://doi.org/10.4236/eng.2024.169017>

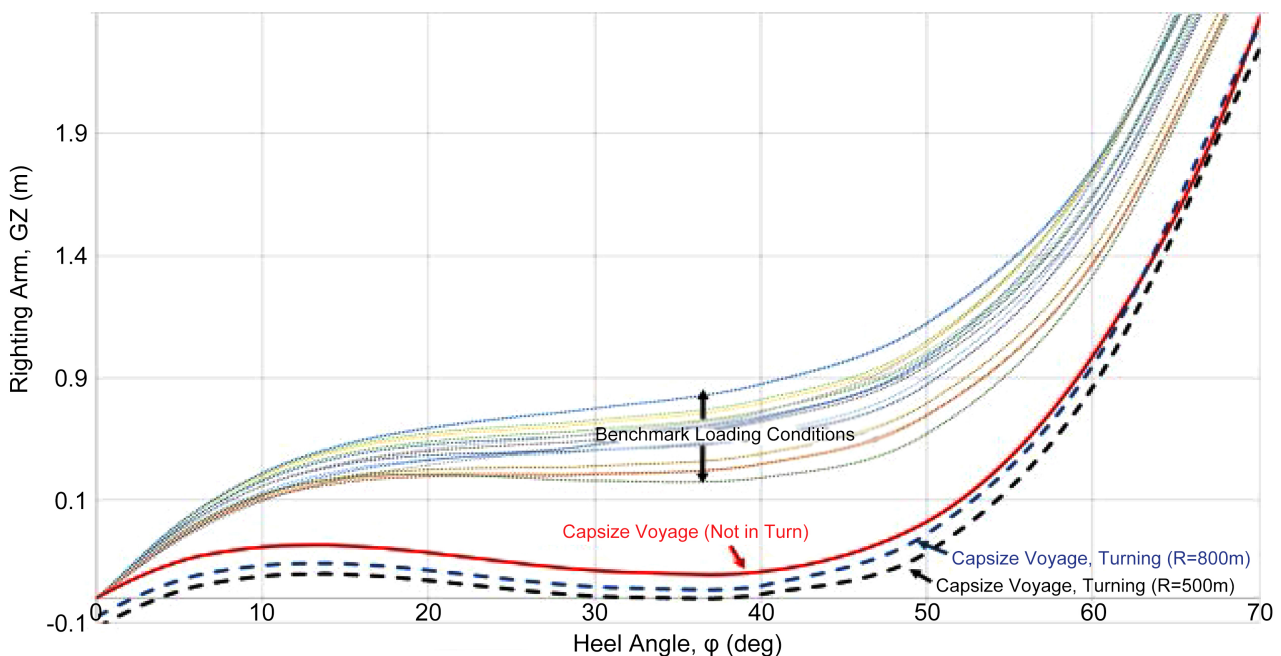
Figure 5. GZ versus heel angle for MV Golden Ray [12].

Typically, ship safety is assessed by calculating the ship's transverse metacenter, denoted by GM. This calculation allows for estimating the ship's transverse righting arm GZ at different heel angles, as shown in **Figure 5** for the MV Golden Ray. These calculations were performed in a post-accident analysis [12]. For small heel angles, the GZ is large, which may lead the crew to believe the ship is safe during loading, as the heel angle remains relatively small. However, observing safety regulations regarding the total area under the GZ curve, the resulting GZ curve often displays a concave region, as shown in **Figure 5**.

This concave region, in **Figure 5**, defined by an inflection point around a heel angle of 10 degrees and extending to around 50 degrees, creates a dangerous operating condition during turns. This situation can cause the vessel to list and settle at a large angle of heel (60 degrees for MV Golden Ray and 40 degrees for MV Hoegh Osaka). As a result, recently built PCCs and PCTCs are at risk of experiencing similar capsizing accidents in the future.

When a vessel makes a sharp turn, a heeling moment caused by centrifugal force is generated. The centrifugal force increases as turning radius (R) decreases, resulting in the righting arm GZ curves. This GZ reduction is shown in **Figure 5** for $R = 800$ m and $R = 500$ m.

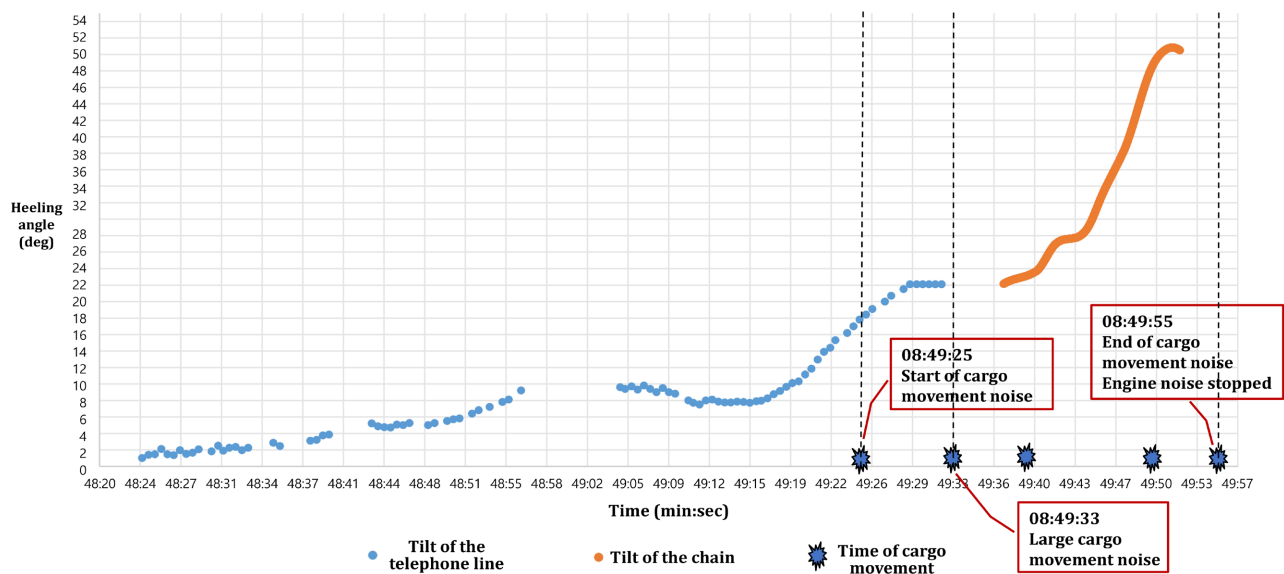
Figure 6. Change of heeling angle and time stamps of cargo movement noise during the MV Sewol ferry accident [16].

The heeled deck also generates tangential force and an overturning moment acting on the lashed cargoes or tied-down vehicles. These forces and moments can break the tied-down cables, leading to a shift in the cargo. **Figure 6** shows a post-accident analysis of the MV Sewol's heel angle versus time, marking the onset of the cargo shift around 18-degree heel ($t = 8:49:25$). It should be noted that RoPax ships like the MV Sewol typically carry a wide range of cars, trucks, and busses. The trucks can be overloaded and unstable when the ship heels.

The rationale for limiting the heel angle to 15 degrees is based on the fact that at a heeling angle of 18 degrees (Figure 6), cargo loaded without safety devices begin to slide. The authors recommend that the SOLAS limit for the “steady” heel angle be extended to also limit the maximum heel angle θ_{max} (refer Figure 7) during the “transient” period of a ship’s turn.

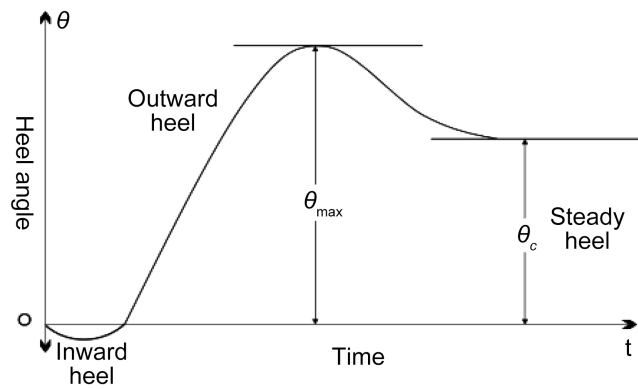
Figure 7. Heel angle versus time during ship turning.

Figure 7 shows the changes in ship heel angle during turning. After the rudder is turned, the ship experiences an initial inward heel caused by rudder force, followed by a larger outward heel due to centrifugal force. As previously noted, the ships in **Table 1** have a low stability margin (GZ in **Figure 5**), creating a dangerous situation when they experience a large heel angle θ_{max} occurring at the beginning of a turn.

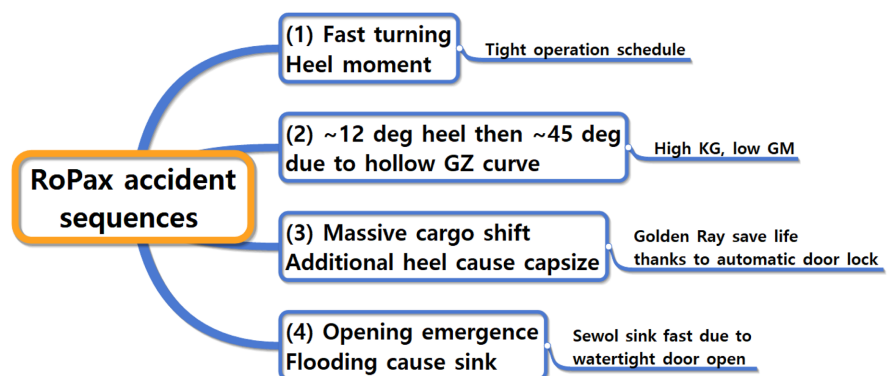
Figure 8. RoPax accident sequences when turning.

The capsize of a RoPax ship involves several interconnected design and operational factors. However, these factors are not fully addressed by current IMO rules. It is crucial for the naval architects to prioritize the goal of designing a safe RoPax ship, rather than relying solely on IMO and national marine safety organizations to impose loading and operational restrictions on current and future RoPax ships. Achieving an adequate stability margin is essential for the safe operation of RoPax

- 1) Precisely determine the ship's center of gravity KG when fully loaded.
- 2) Adopt navigation systems that limit the ship's angle of heel by controlling the centrifugal force during turns.
- 3) Calculate stability assuming a 100% filling level for liquid cargo.

A number of possible methods to improve RoPax safety during turns are summarized in **Table 2**. These methods form the basis for the author's developing an ISO standard aimed at reducing RoPax ship capsizing during turns. The proposed methods are listed alongside the sequence numbers shown in **Figure 8**.
