# Diagnosis of a Small Dam Using Electric and Electromagnetic Methods

## —Case of Gonsé Dam (Central Region, Burkina Faso)

Maxime Wubda, Youssouf Koussoubé, Julien Nikiema, Soumaila Paré

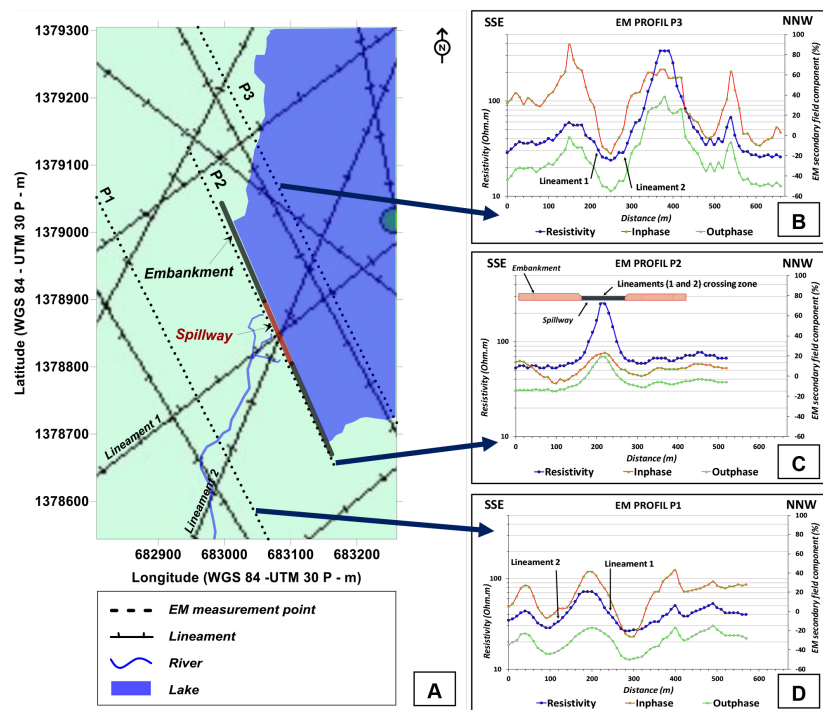
**Figure 3.** Map of site lineaments and electromagnetism prospecting results by profile. (Source: Alos Palsar images (2016))

Among the lineaments identified on the site (nine), only two of them cross the dam installation area. On the map in **Figure 3(A)**, it can be observed that they intersect in the center of the spillway. On the site, however, we did not observe any particular indications of the presence of a geological accident that could correspond to the identified lineaments. Observations are also made difficult by the fact that the site was greatly disturbed by the construction works of the dam: building of the embankment, spillway and ancillary works such as the development of the lake basin.

This is the reconnaissance profile for the embankment installation area (**Figure 3(C)**). In this part of the site, the resistivity values read along the two sections of the embankment vary very little, and are close to 50 Ohm.m. These values contrast with those observed at the spillway, where a series of high values can be observed. Concerning secondary magnetic field components values, the shape of the curves at the spillway confirms the presence of an anomaly, but probably not a vertical

The results on this third profile (Cf; **Figure 3(B)**) were intended to compensate for the lack of geophysical response of the lineaments in the spillway area. However, the recorded data is more difficult to interpret on the profile scale. Indeed, the major resistant anomaly that appears through the resistivity curve does not correspond to any structure visible on the site. One of the explanations we came up with, was the response of the granitic basement, which would be closer to the surface at this point. The position of the two lineaments, as presented in the figure, is neither revealed by geophysical data nor by on-site observations.

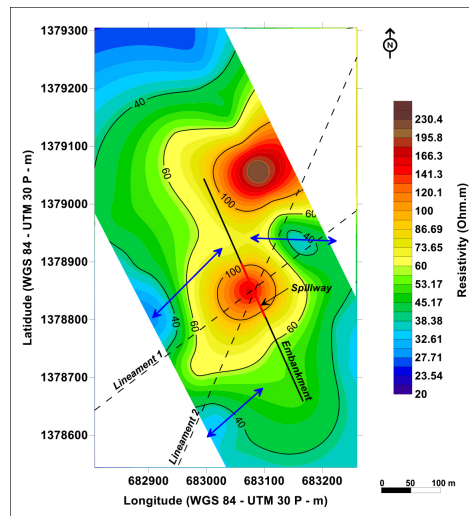
Figure 4. Apparent resistivity map of the site.

- The spatial analysis of exploration data, reveals conductive anomalies which originate from the embankment. The embankment is an artificial object in the landscape, and these conductive anomalies associated with it can therefore be considered as resulting from its installation. The basic explanation for this observation is the existence of water leakage through the embankment. The fact that the anomalies extend over several tens of meters, implies that the water leaks are significant and, above all, date back several years.

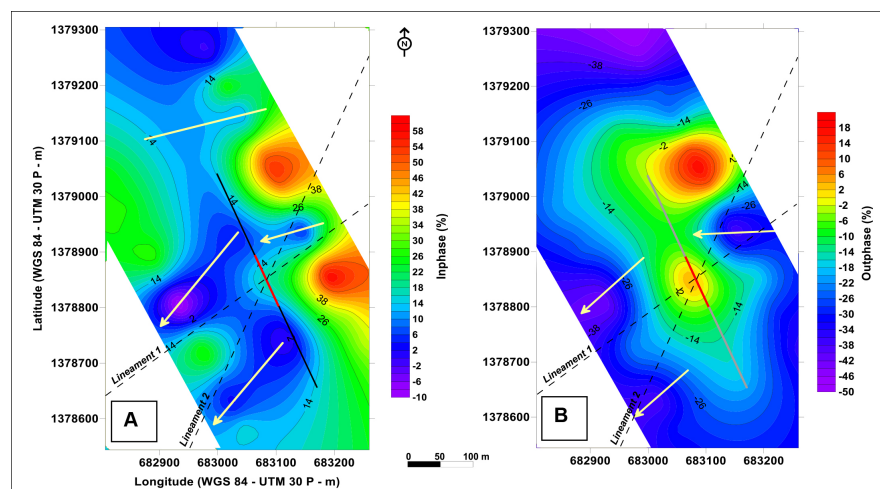
Figure 5. Maps of secondary electromagnetic field components. (A) In-phase; (B) Out-of-phase.

The phase map is more interesting because it better presents the variations of the secondary field, linked to the strong drops in resistivity. Indeed, through the negative variations of this component of the field, we can distinguish four anomalies, three of them corresponding to those already observed on the resistivity map. The fourth anomaly to the north of the site passes beyond the dam embankment and will not be taken into account in this study. Another striking aspect of this map is the role of the embankment. It seems to constitute the barrier from which the conductive anomalies start, particularly both downstream of the embankment (Cf; **Figure 5(A)**).

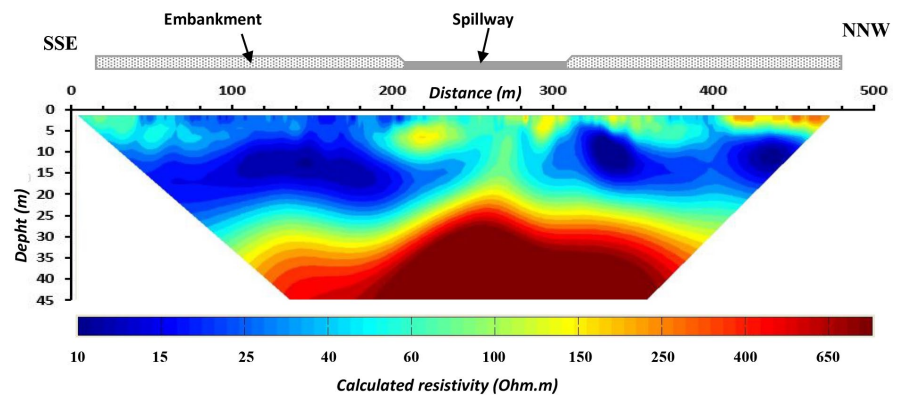
**Figure 6.** Calculated resistivity cross-section along the embankment of the dam.

The displayed calculated resistivity section shows resistivity values ranging from 10 to 6500 Ohm.m, organized globally in tabular ranges. From surface to depth, we distinguish:

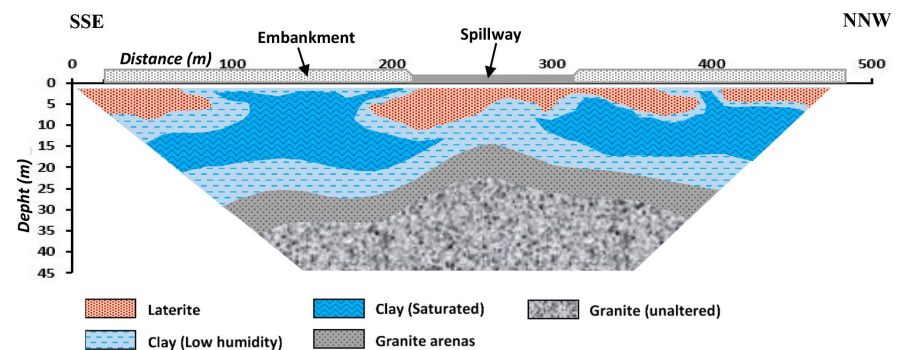
**Figure 7.** Interpretation of the calculated resistivity cross-section.

In the proposed interpretation, four types of terrain are distinguished. However, their boundaries may not correspond to changes in nature, but rather to changes influenced by the water content and/or electrical conductivity of the imbibing water, as it is known, resistivity largely depends on these factors.

- At the surface, the resistant layers correspond to outcropping lateritic horizons, which are in some places, covered by thin silty-clay layers (20 to 50 cm). Their thicknesses as observed in the wells or the over-digging of the watercourse downstream of the dam, are around a meter, while the resistivity cross-section shows greater thicknesses (up to 5 m or more, at the level of the spillway). This suggests that the lateritic layer, in the vicinity of the dike, is not natural but probably created or reinforced by addition of materials used for the installation of the embankment. This also explains the particularly thick layer of the lateritic layer at the level of the spillway. At this location on the site, it can be seen that, in addition to the laterite, rubble and boulders were added to stabilize the dissipation basin downstream of the spillway. Finally, field observations show that the lateritic layer is continuous. Therefore, the discontinuities that appear on the resistivity section seem to result from differences in the state (especially water content) of the layer.

- Based on the displayed resistivity values and field observations, particularly materials extracted from artisanal wells and those constituting termite mounds, we concluded that the layer below the lateritic one is clayey. It is an ocher to whitish clay (as observed in artisanal wells) reaching 20 to 25 m thick, within which, the very low resistivities (marked in darker blue) would result from a higher water content. This can be verified at some points such as the southern part of the embankment, where wetter parts of the layer reach the surface. These areas correspond to marshy places in the rainy season;

Furthermore, it seems illogical that this backfill has such varying thicknesses and be so fragmented along the embankment, as shown by the interpretation in **Figure 7**. Explanation which can be given here, is that the appearance of the backfill layer, as reflected by the resistivity, does not correspond to the actual structure of the soil. Indeed, knowing that resistivity is influenced by the water content of the materials, it is highly plausible that the conductive parts observed in the backfill, correspond to zones of high water content. The connection observed between the conductive zones on the surface and those at depth, would therefore be linked to a similar water content in these areas. This suggests that the backfill layer is quite continuous, as presented in **Figure 8**. Its thickness would be fairly uniform in both parts of the dike, and greater at the spillway, where we believe the backfill is reinforced.

- The southern part of the embankment, from a distance of 90 meters to the contact zone with the spillway at 200 meters. At this point, moisture affects a large part of the base of the embankment;
- The area below the spillway. The measurements taken here do not show a rise in humidity up to the level of the concrete part of the spillway. However, field observations show the existence of the Renard phenomenon at the base of the spillway. Patching work even seems to have been carried out, but apparently, without much result (the scours are still clearly visible);
- The small area is within a 400-meter distance. It is a small subvertical rise which extends over a few meters at the base of the embankment.

Below the backfill layer, we can also observe that, the zone considered to have a high water content, constitutes a continuous layer that stretches along the interpreted section. It could be an aquifer seasonally recharged largely by water from the dam. Knowing that the tomography measurements were carried out in May, the level of this water table, as seen in the section, would correspond to its lowest level. It is therefore very likely that at the end of the rainy season (in October), the level of this water table rises sufficiently to invade the entire embankment, helped by the water level in the dam, which at this period is at its maximum.

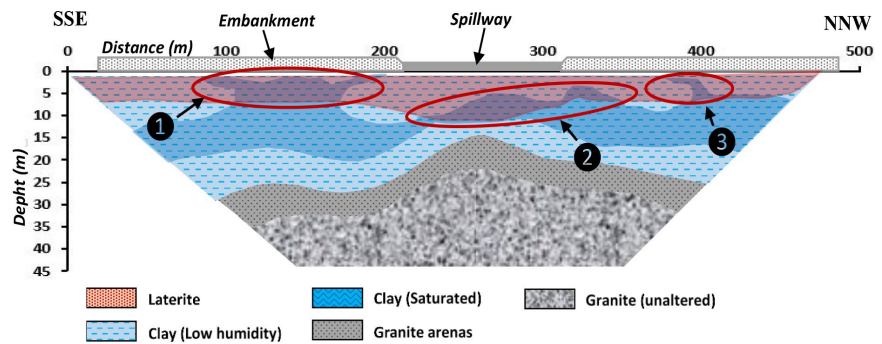
**Figure 8.** Reinterpretation of the resistivity cross-section by assuming the continuity of the surface layer and taking into account variations in water content in the layer.

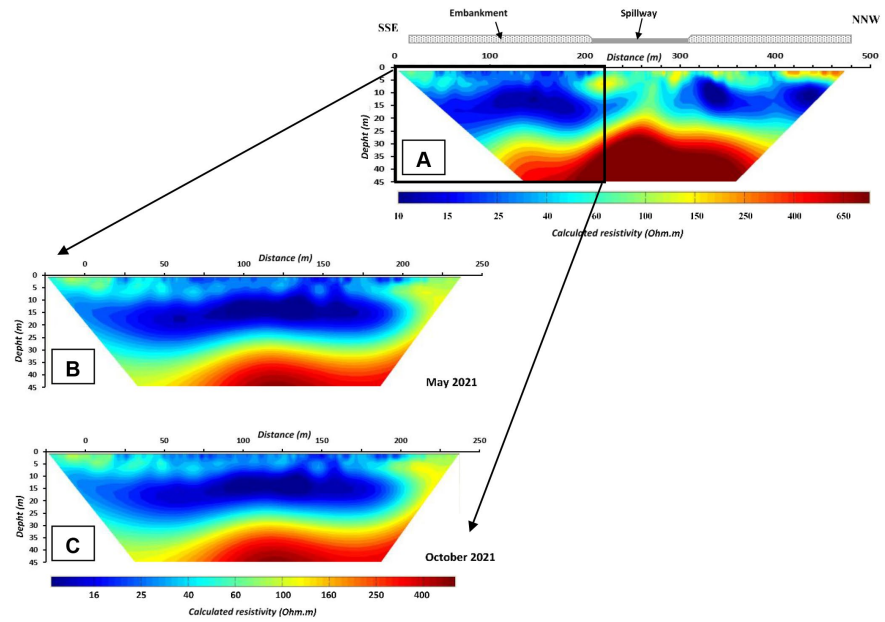
Measurements in October (25th of the month) were carried out in very wet soil conditions. Apart from the first 20 meters of the profile, the rest was muddy.

The calculated resistivity cross-section (**Figure 9(C)**) shows a generalized increase of resistivities over the first 5 meters, which is clearly visible at the beginning and end of the section. The large conductive zone in the center of the image, also shows a reduction in its size.

**Figure 9.** Time-lapse monitoring results for May and October. (A) Monitored part of the embankment; (B) Calculated resistivity section for May; (C) Calculated resistivity section for October.

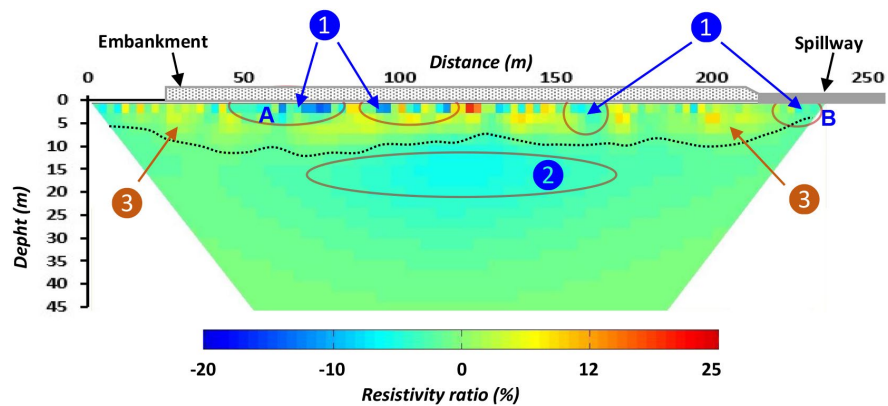
**Figure 10.** Resistivity ratio cross-section (October/May).

This resistivity effect can be observed at the surface of the time-lapse ratio cross-section (zone 3). It results in an increase of resistivity caused by the quality of the infiltrated water which is resistant: water, taken from an artisanal well near the site, had a resistivity of 170 Ohm.m in October. Assuming that the embankment is watertight, impregnation water in the layers downstream the embankment would therefore, be from the recently-completed rainy season. The reason why the effect of water resistivity is so visible at this level of the ground would come from the fact that, surface layers are transit zones and therefore are not saturated (less saturation effect).

Assuming that the increases of resistivity in the upper layers are induced by resistivity effect of rainwater, the existence of superficial zones of resistivity decreases (zone 1), raises questions about these differences. The explanation we found is based on the difference in soil water content. We think that, what is observed at this location corresponds to the saturation effect. This is possible in places where soil moisture levels remain particularly high throughout the year (also the case in zone 2, deeper). Knowing that there is no zone of water stagnation along the embankment, we can therefore conclude that these zones of reduced resistivity, simply correspond to places constantly moistened by water leaks through the embankment. For the area between 50 and 75 meters on the monitoring cross-section, the leak is actually visible on the site.

It is now known that, this part of the embankment has enough fragile zones that deserve to be taken into account for rehabilitation work or a check of the condition of the structure.

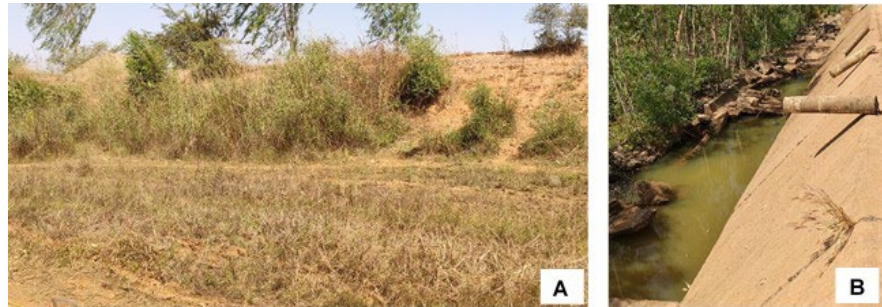
The leak on the embankment side is clearly visible because it creates a wetland (downstream of the dike) with grasses that are sometimes still green at the end of the dry season (Cf; **Figure 11(A)**).

At the spillway, the monitoring results show that the leakage does not occur in the contact zone between the embankment and the spillway (dam failures often occur at these points), but rather under the spillway. Consequently, the leakage observed at this level does not immediately threaten the safety of the embankment. On the other hand, the damage to the spillway is already considerable, with the concrete zone collapsing, downstream (Cf; **Figure 11(B)**).

**Figure 11.** View of areas affected by water leakage. (A) Downstream of the southern section of the embankment. This area remains wet all year round, benefiting the grass and shrubs that persist on the soil and embankment throughout the year. (B) Downstream of the spillway. The persistence of water at this location during the dry season (February) indicates the presence of water leaks below the spillway. The damage we also observe there, is doubtless partly caused by these leaks.
