# Recovery of an Unoccupied Aircraft System and Recommendations for Avoiding Communication Loss in a Forested Environment

Michael G. Wing\*, Matthew I. Barker, Katharine H. Nicolato

Department of Forest Engineering, Resources, and Management, Oregon State University, Corvallis, OR, USA  
Email: \*michael.wing@oregonstate.edu

**How to cite this paper:** Wing, M.G., Barker, M.I. and Nicolato, K.H. (2024) Recovery of an Unoccupied Aircraft System and Recommendations for Avoiding Communication Loss in a Forested Environment. *Journal of Geographic Information System*, 16, 431-442.

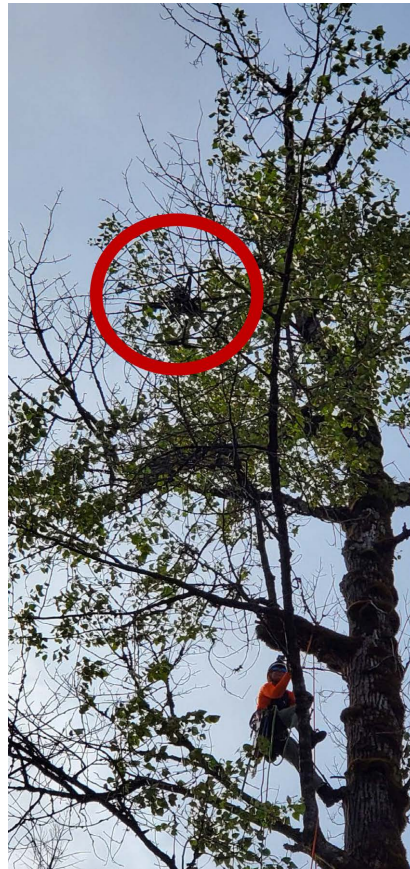
Instead, what occurred after communication loss was that the platform began a steady descent downwards into a tree crown, behaving as if it was losing power. This descent was clearly visible on the controller display screen as were the decreasing altitude readings. While the platform was partially obscured from the remote pilot in command during this descent, a nearby observer was in full view of the platform and advised the remote pilot to increase platform altitude. The remote pilot found that flight controls were unresponsive and resultingly, the platform continued its descent until it became lodged in a deciduous cottonwood tree canopy approximately 15 m above the surface of a stream. The descent appeared to increase in speed as the platform approached the canopy.

Although lodged in the tree canopy, the platform continued to transmit location data and a live camera feed which allowed the flight crew to determine an approximate platform location. The crew was able to navigate to the location of the platform using the map in the flight planning software. Additionally, the software provided a settings option to enable the platform to produce a continuous beeping sound that allowed the crew to identify the platform's precise location. The flight crew was able to view the area below the platform from across the stream channel and determined that rope and tarps would be helpful in a possible platform recovery effort. These items were purchased at a nearby store and once procured, the recovery team proceeded across two stream channels until reaching a small island adjacent to the stem of the cottonwood. Navigating the second stream channel was extremely rigorous and required caution. It became evident that the platform could only be recovered by a certified or otherwise professional tree climber given the 15 m distance from the ground. A tarp was tied so that it lay flat approximately one meter above the island and surrounding stream surface. The tarp was intended to cushion the platform should it fall and hopefully, prevent it from entering the stream.

**Figure 1.** Tree climber and lodged UAS platform with circle indicating platform position.

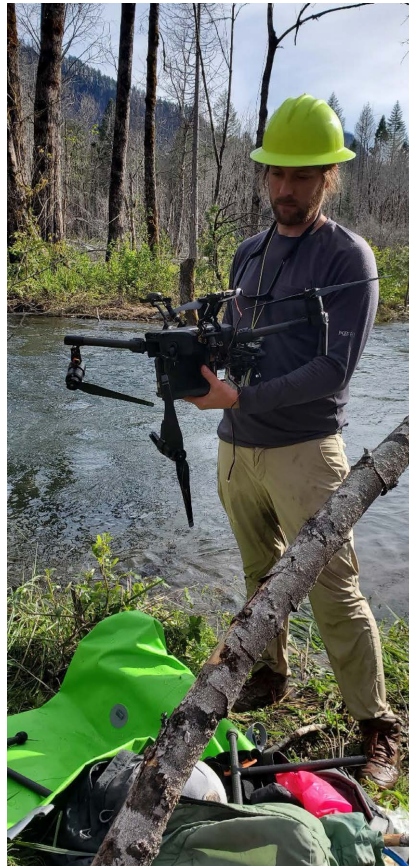
The tree climber limb walked outwards on the branch until in reach of the aircraft with an extendable grabber. The grabber end was clamped to one of the landing gear supports and the climber attempted to secure the aircraft to their harness. The landing gear support loosened, and the aircraft fell downwards onto the tarp and bounced into the stream becoming fully immersed. A recovery crew member was able to extract the aircraft within 30 seconds of becoming submerged. Visually apparent damage to the aircraft included the rear two engine speed controllers (ESCs) and the frame extensions that support the ESCs (**Figure 2**). Other damage to the aircraft frame was minimal and the sensor appeared to escape physical damage.

**Figure 2.** Recovery team member with UAS platform after retrieval from the river.

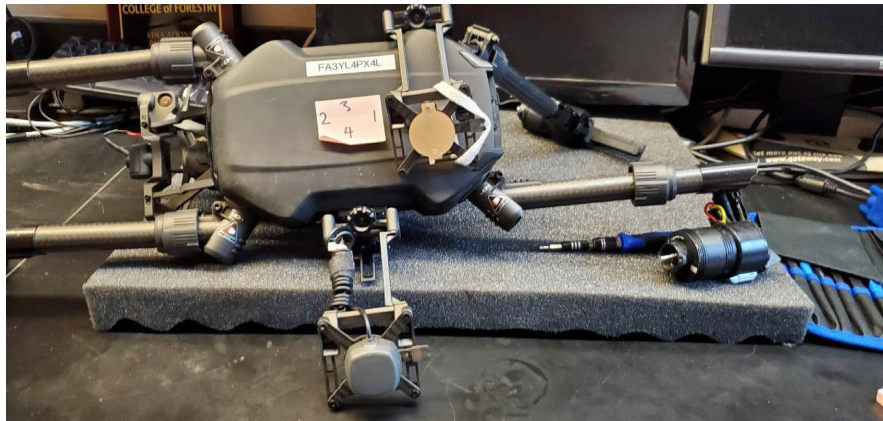
We verified field-based perceptions of platform damage to the ESCs and supporting extensions (**Figure 3**). Other minor damage was also observed but did not appear to be noteworthy. We established contact with potential repair organizations. One offered a diagnostic exam to determine what repairs would be needed and their approximate cost. The price for the diagnostic exam would be approximately USD 200 and shipping costs would be an additional expense. Another potential service provider suggested that we consider contacting a DJI affiliated repair center but cautioned that they would not be likely to consider repair if the platform chassis had evidence of water penetration. We were advised that DJI places adhesive labels inside the M200 chassis, and these labels would become red in color when exposed to moisture. We disassembled the chassis and discovered a red label.

**Figure 3.** Matric 200 platform during laboratory damage inspection.

We decided not to proceed with platform repair given the risk of moisture potentially impacting both external and internal electrical components, and the nearly three years of flight operations we experienced with the M200. In addition, the M200 was no longer being manufactured and was replaced by the updated M210 version.
