# Detection and Evaluation of a Migrated Timber Structure House

Inspection and Certification Co., Ltd., MCC, Beijing, China

This article takes the inspection and appraisal of a certain migratory wooden structure as the backdrop, presents the inspection process of the wooden structure. Upon on-site examination, it was discovered that the connection (or node) construction mode of the building was correct. Only local surface flaws were present, and the operation was normal. The stress wave velocity of the randomly inspected wooden columns with surface cracking was close to the critical velocity, suggesting that no obvious cavities or decay defects existed within the measured wooden components. Based on the inspection outcomes, finite element computations were carried out for the wooden structure, arriving at the conclusion that the maximum stress value of the wooden members was smaller than the designed value of wood strength, and the vertical bearing capacity conformed to the requirements of the specifications. And rationally offered relevant treatment suggestions, providing a reference for the inspection and identification of such projects.

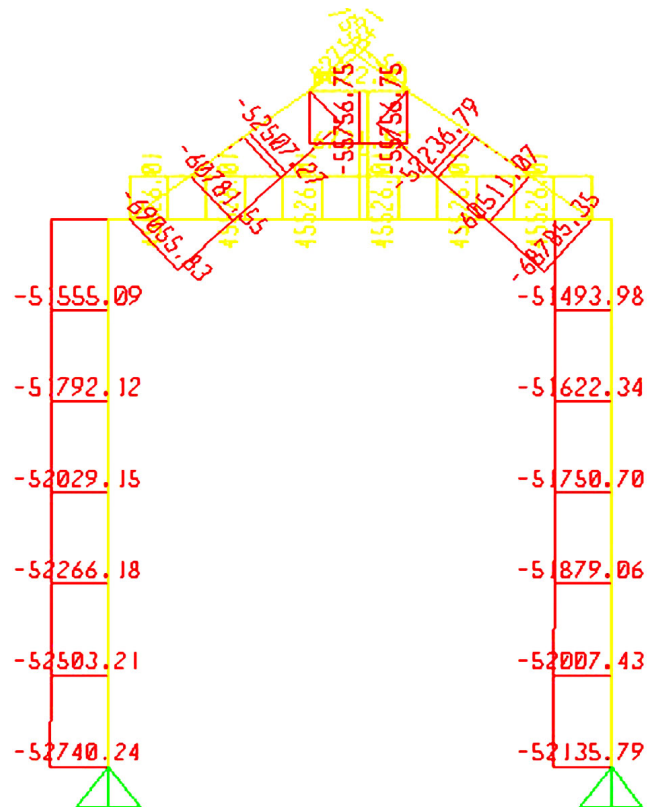
In accordance with the relevant regulations of GB50009 Building Structure Load Code, the axial force combination calculation results of the wood structural members of this project are presented as shown in **Figure 4**. In line with the stipulations of GB50005 Wood Structure Design Code regarding the design value of the strength of wood materials, the verification results demonstrate that the maximum stress value of the wood members in this project is smaller than the design value of the wood strength. The vertical bearing capacity complies with the requirements of the code, namely  $R/(\gamma_0 S) > 1.0$  [11].

**Figure 4.** Calculation results of combined axial forces of wooden components.

4) The verification results indicate that the maximum stress value of the wood components in this project is smaller than the design value of the wood strength, and the vertical bearing capacity meets the requirements of the code.
