# Analysis and Research on Common Failure Modes of Internal Combustion Engine Springs

<sup>1</sup>Weichai Power Co., Ltd., Weifang, China

## Abstract

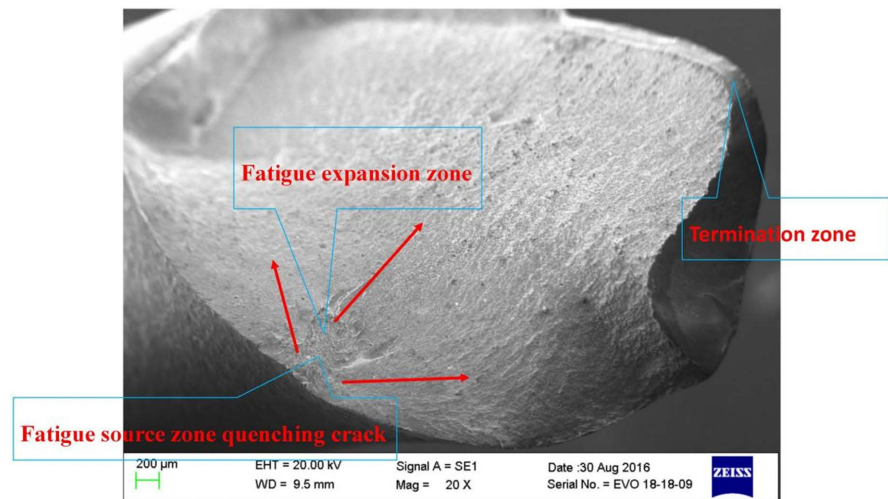
from the source area to the surrounding area under the low fold and microscopic morphology, the fatigue source area is mainly fractured along the crystal, the fatigue expansion area is obvious, and the final fault area is mostly U-shaped, generally ductile fracture, serious oxidation, and the lead attachment is often accompanied by lead adhesion in the spring quenching crack area of the lead bath heating. The morphology of the fracture caused by spring quenching cracks is shown in **Figure 2**. The micromorphology of the fatigue fracture along the fracture and the fatigue propagation zone in the fracture fatigue source area are shown in **Figure 3** and **Figure 4**, and the lead adhesion in the electron microscopy spectroscopy analysis of the spring quenching crack area is shown in **Figure 5**.

**Figure 2.** Fracture morphology caused by spring quenching cracks.

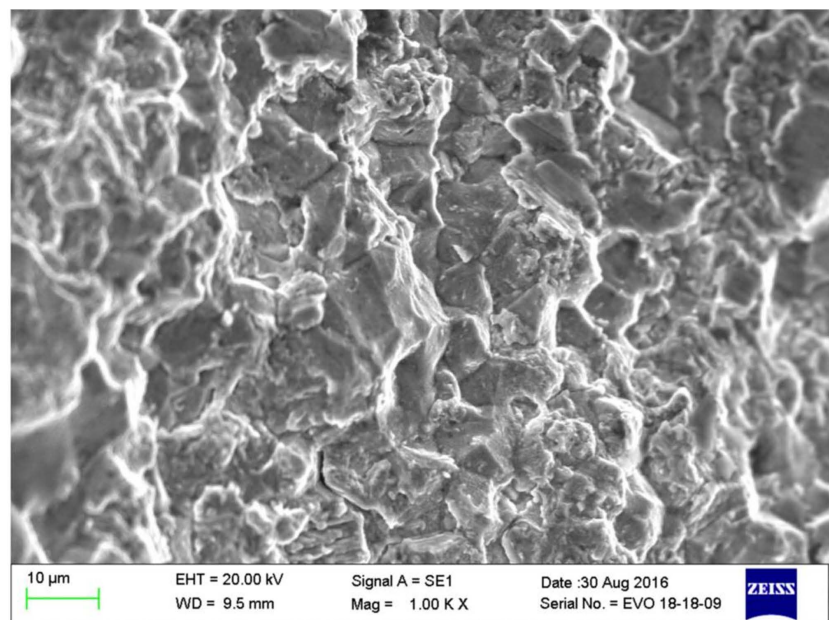
**Figure 3.** Microscopic morphology of fatigue source area caused by spring quenching cracks.

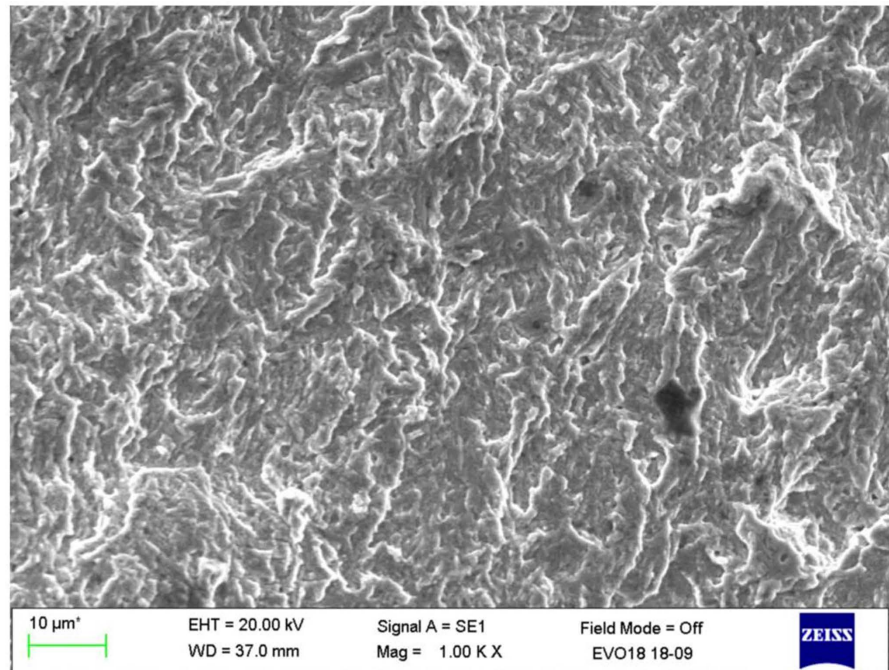
**Figure 4.** Microscopic morphology of fatigue fracture propagation zone caused by spring quenching cracks.

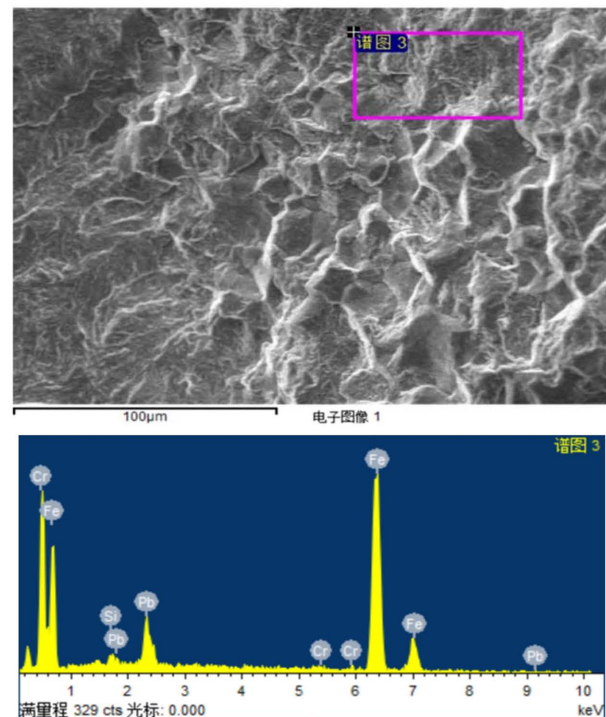
Element	Weight	Atom
	Percentage	Percentage
Si K	1.29	2.91
Cr K	0.48	0.58
Fe K	80.10	90.95
Pb M	18.14	5.55
Total	100.00

**Figure 5.** Electron microscopy analysis results of the spring quenching crack zone.

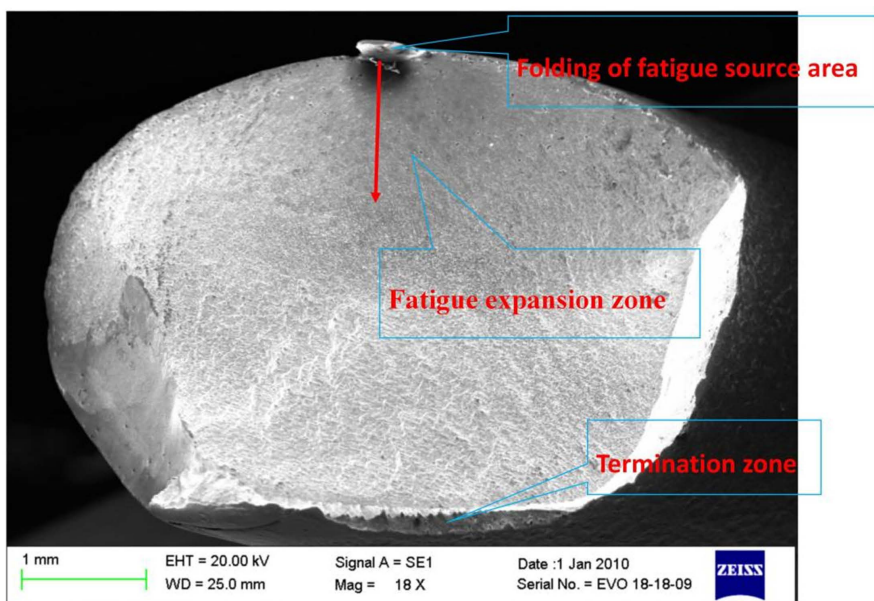
cess to form a kind of “false skin”, which is improperly cold-processed and usually presents continuous or intermittent straight lines, furrows, or fish scale cracks. The fracture in the fatigue source area is severely oxidized, and the two sides are concave and protruding, and the fatigue extension area is obvious. The morphology of the fatigue fracture caused by spring folding is shown in **Figure 6**, and the microscopic morphology of the fatigue source area, fatigue propagation zone, and final fault area caused by spring folding are shown in **Figures 7-9**.

**Figure 6.** Morphology of fatigue fracture caused by spring folding.

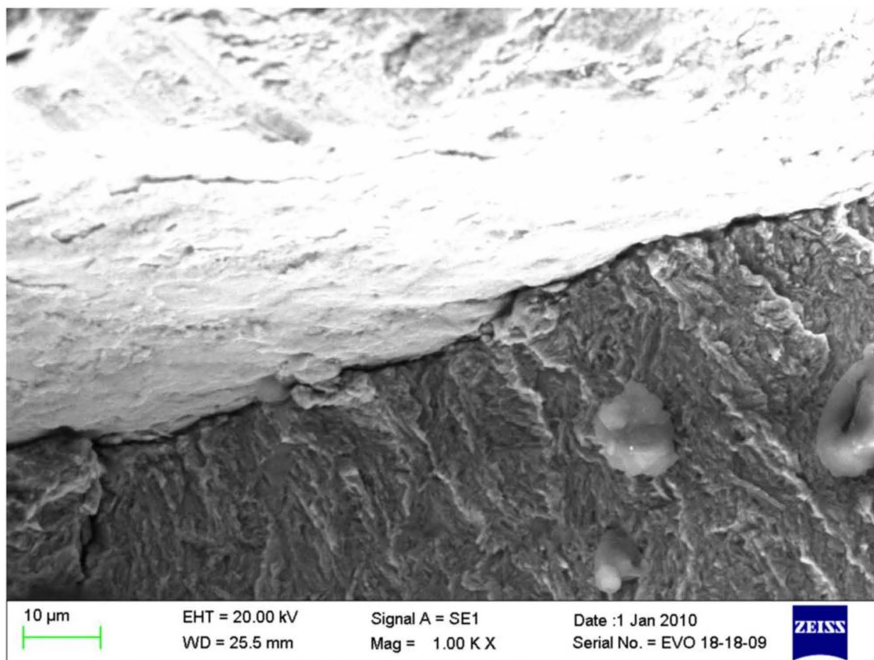
**Figure 7.** Microscopic morphology of the fatigue source area caused by spring folding.

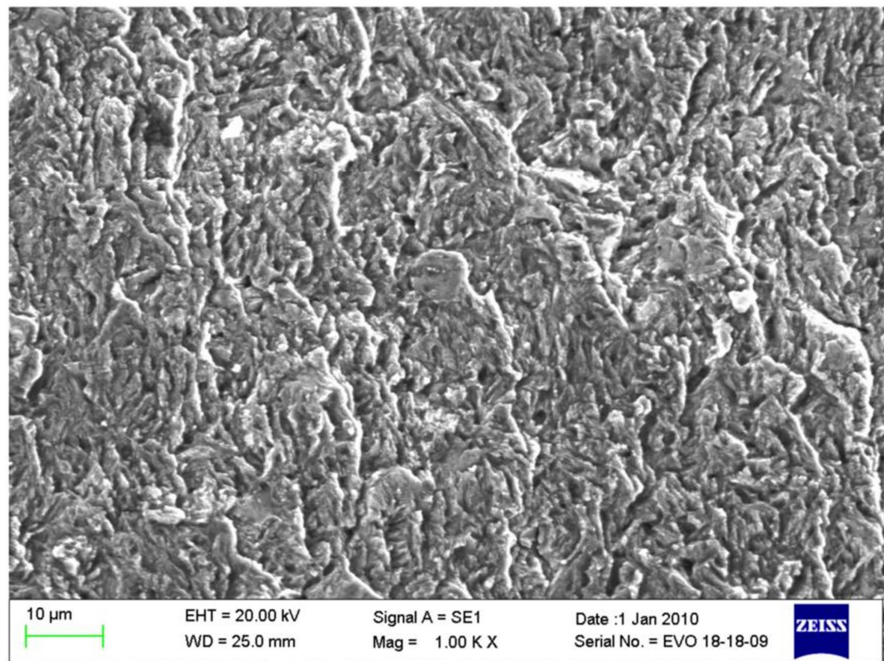
**Figure 8.** Microscopic morphology of fatigue propagation zone caused by spring folding.

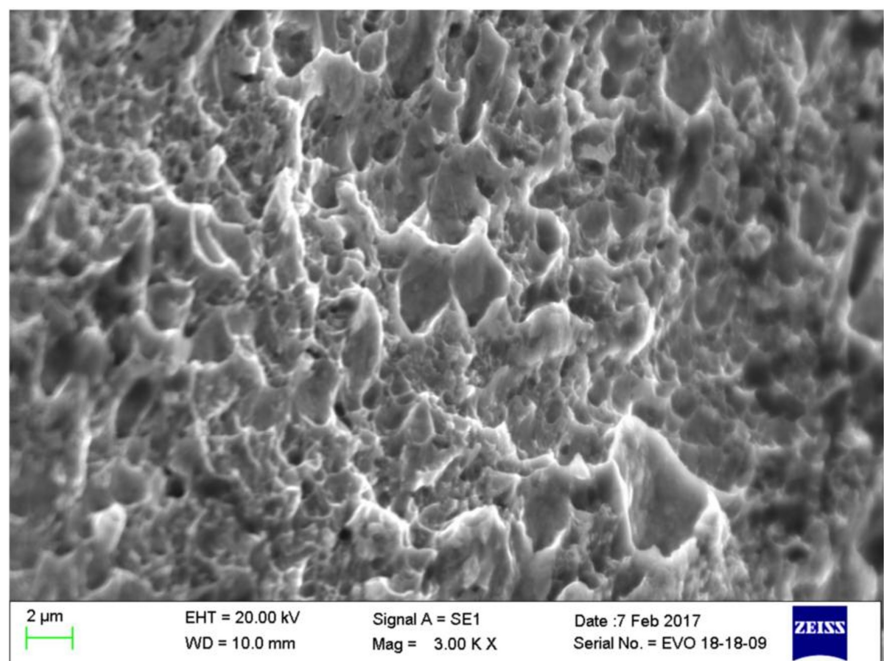
**Figure 9.** Microscopic morphology of the fatigue fracture final fault zone caused by spring folding.

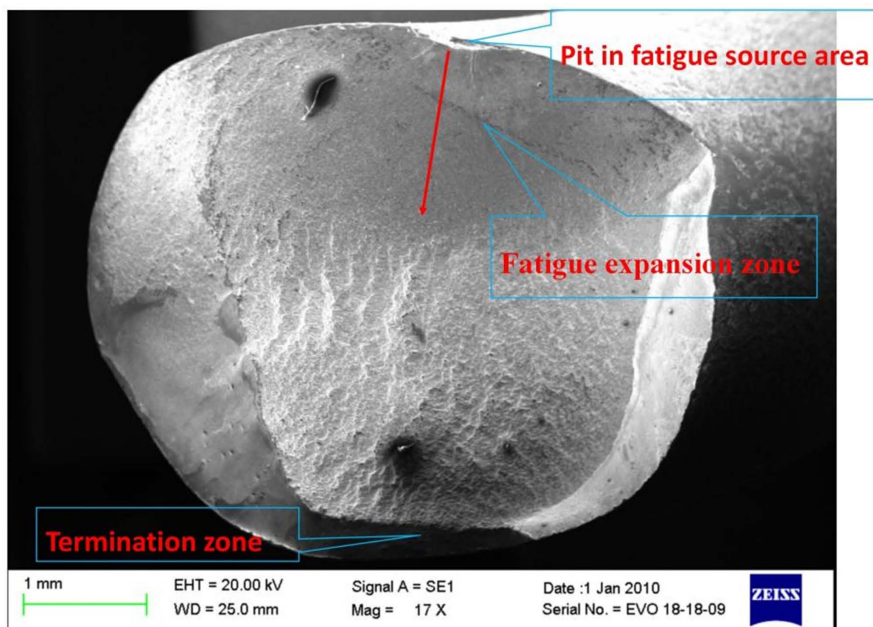
Pits are mechanical impacts that form small depressions locally. The fracture of the fatigue source area has obvious depressions and severe oxidation, independent or small amounts, mostly caused by mechanical damage, obvious fatigue flaring

in the fatigue expansion area, and most of the final fault area is U-shaped, generally ductile fracture. The morphology of the fracture caused by the spring pit is shown in **Figure 10**, and the micromorphology of the fatigue glow in the fatigue source area and fatigue expansion area caused by the spring pit is shown in **Figure 11** and **Figure 12**.

**Figure 10.** Morphology of fatigue fracture caused by spring pits.

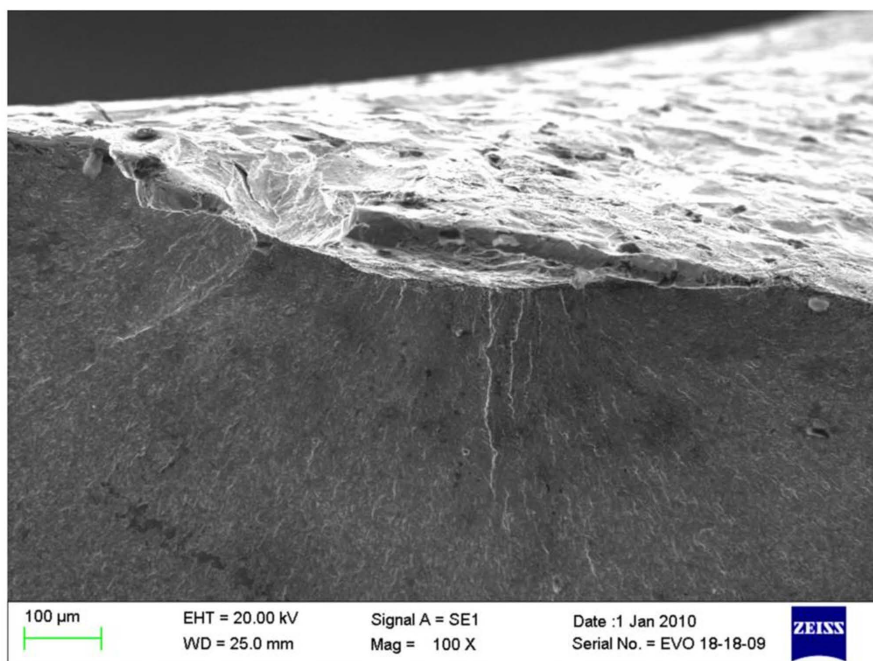
**Figure 11.** Microscopic morphology of the fatigue source area caused by fatigue fracture due to spring pits.

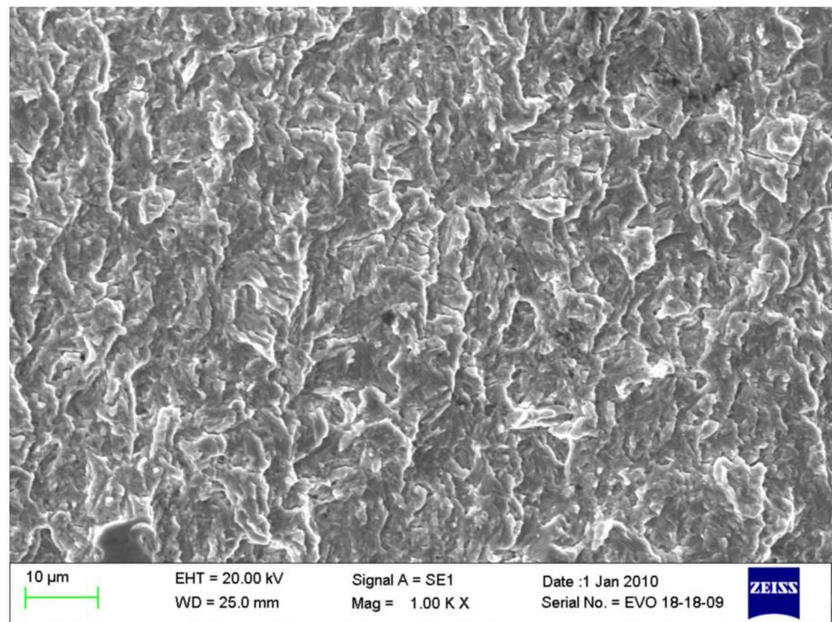
**Figure 12.** Microscopic morphology of the fatigue propagation zone caused by fatigue fracture due to spring pits.

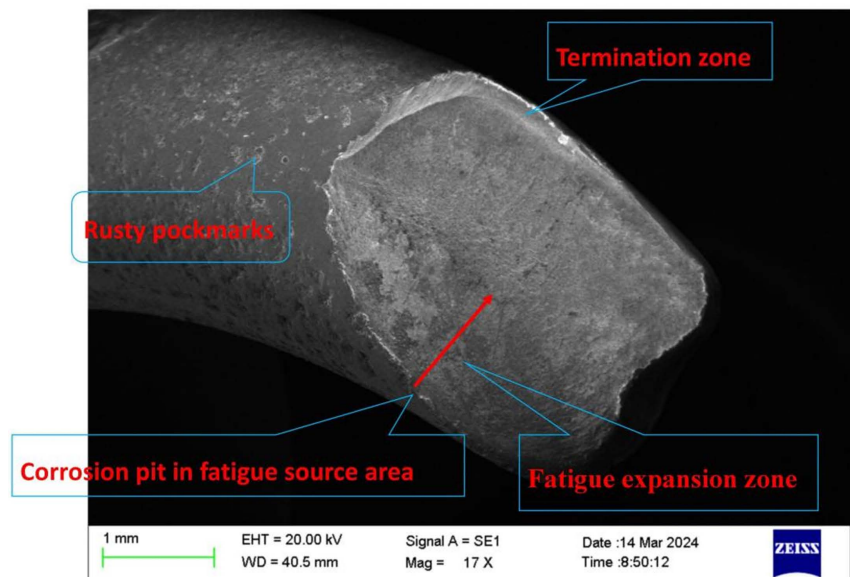
There are obvious corrosion pits and serious oxidation at the fracture in the fatigue source area, and the surrounding or the entire spring surface is densely corroded with pits, which are mostly caused by rust on the surface of the spring wire. The morphology of the fatigue fracture caused by the spring corrosion pit is shown in **Figure 13**, and the microscopic morphology of the fatigue source area and fatigue propagation area caused by the spring corrosion pit are shown in **Figure 14** and **Figure 15**.

**Figure 13.** Morphology of fatigue fracture caused by spring corrosion pits.

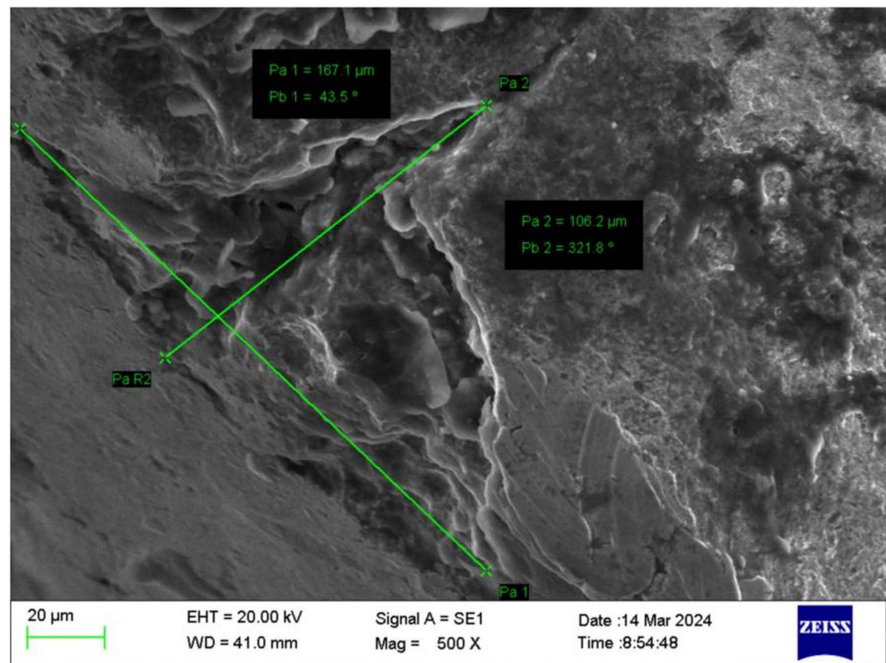
**Figure 14.** Microscopic morphology of the fatigue source area caused by spring corrosion pit fatigue fracture.

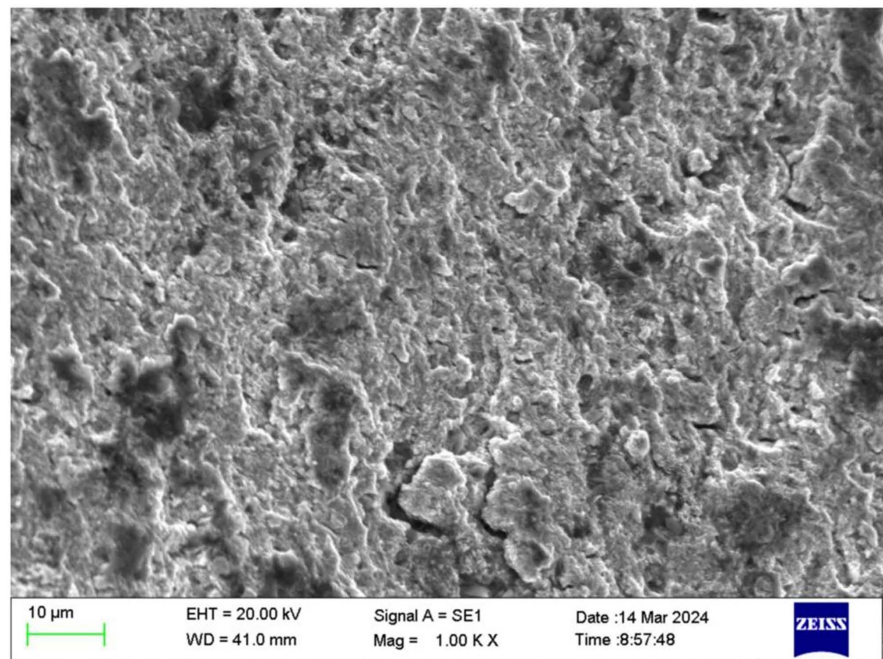
**Figure 15.** Microscopic morphology of the fatigue propagation zone caused by spring corrosion pits.

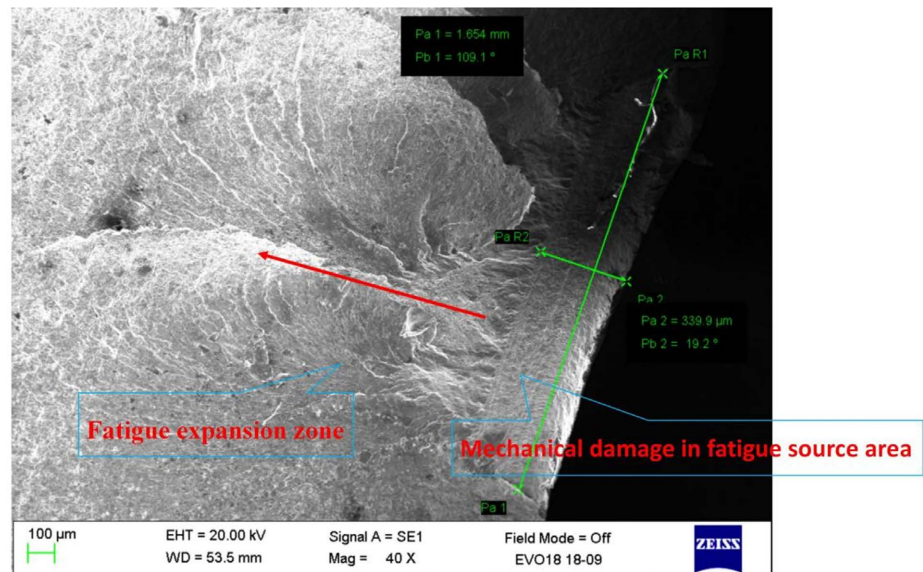
The fracture of the fatigue source area has obvious traces of mechanical damage from the source area to the surrounding area under the low magnification and microscopic morphology, the fracture of the fatigue source area has obvious traces

of mechanical damage, severe oxidation, the fatigue glow pattern in the fatigue expansion area is obvious, the final fault area is mostly U-shaped, generally the ductile fracture, the morphology of the fatigue fracture caused by spring mechanical damage is shown in **Figure 16**, the microscopic morphology of the fatigue source area and fatigue expansion area caused by spring mechanical damage is shown in **Figure 17** and **Figure 18**, comprehensive force analysis, The characteristics such as fracture morphology can determine that the spring is a bending and torsional composite fatigue fracture under mechanical load.

**Figure 16.** Morphology of fatigue fracture caused by spring mechanical damage.

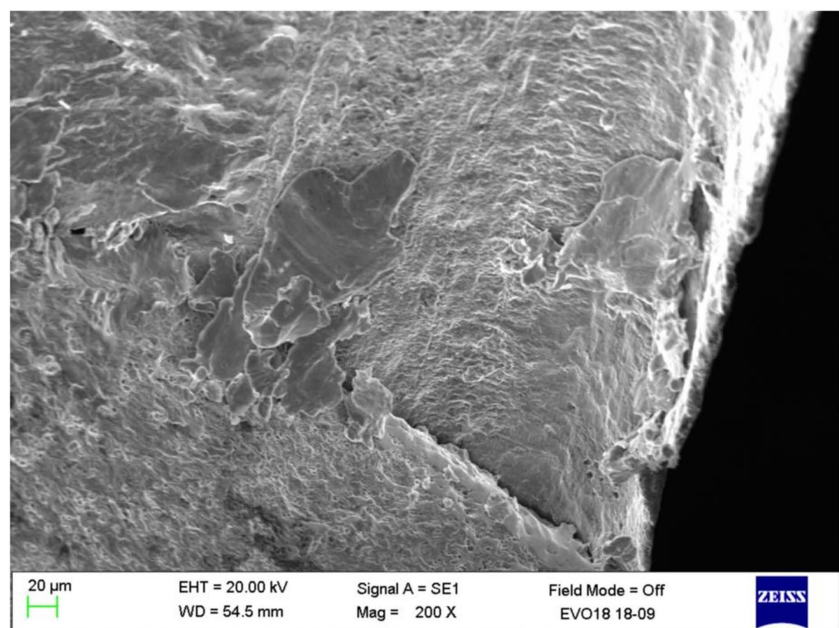
**Figure 17.** Microscopic morphology of the fatigue source area caused by spring mechanical damage fatigue fracture.

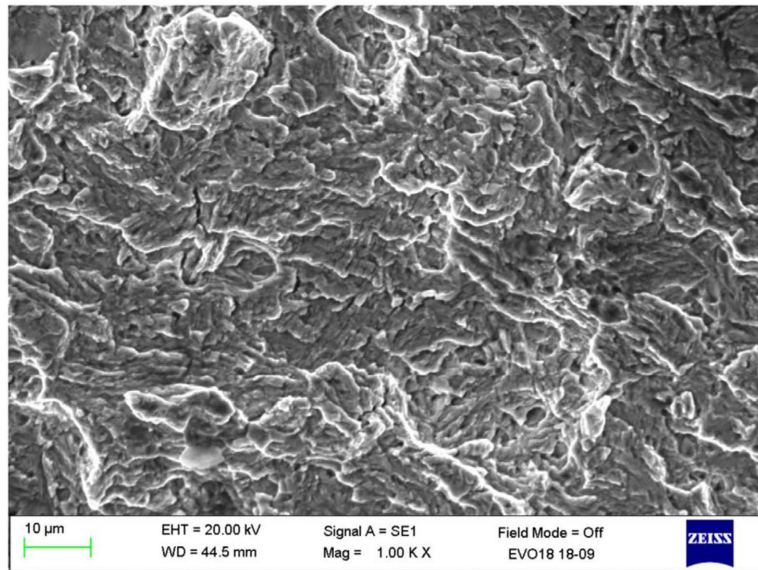
**Figure 18.** Microscopic morphology of the fatigue fracture propagation zone caused by spring mechanical damage.

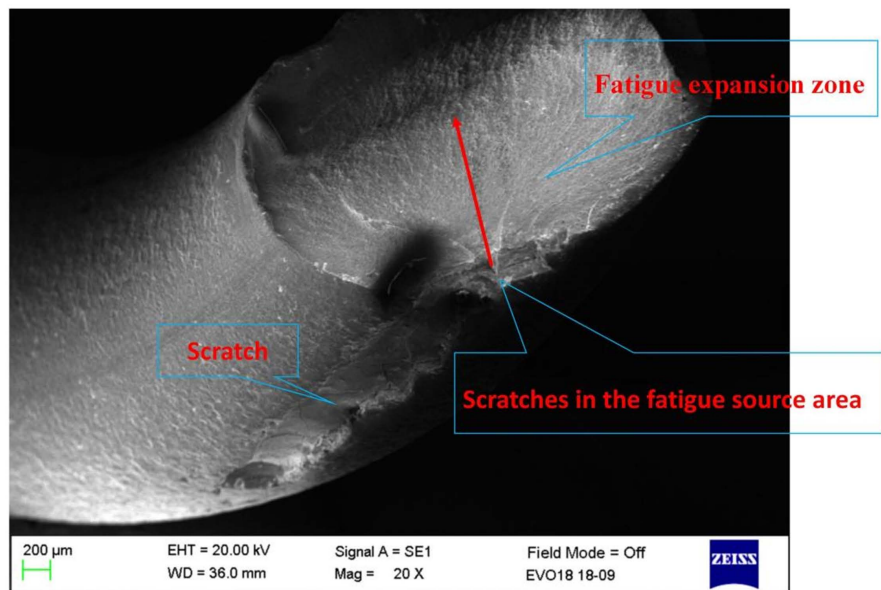
There are obvious radial fatigue propagation traces from the source area to the surrounding area under the low magnification and microscopic morphology of the spring fracture, and there are obvious long strip scratch marks at the fracture in the fatigue source area, severe oxidation, obvious fatigue glow in the fatigue expansion area, and the final fault area is mostly U-shaped, with generally ductile fractures. The fatigue fracture morphology caused by spring scratches is shown in **Figure 19**, and the microscopic morphology of the fatigue source area and fatigue expansion zone caused by spring scratches are shown in **Figure 20** and **Figure 21**.

**Figure 19.** Morphology of fatigue fracture caused by spring scratches.

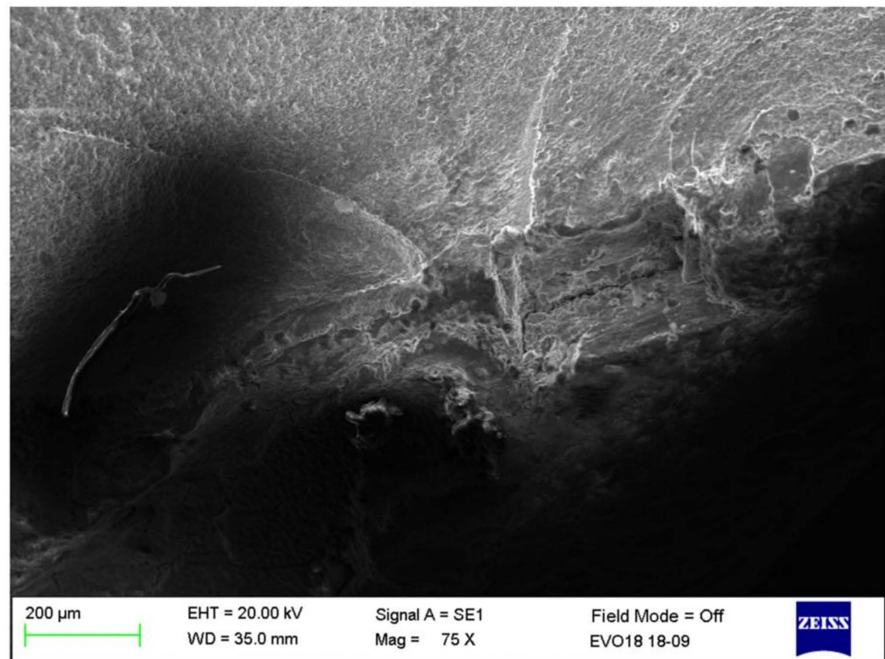
**Figure 20.** Microscopic morphology of the fatigue source area caused by spring scratches.

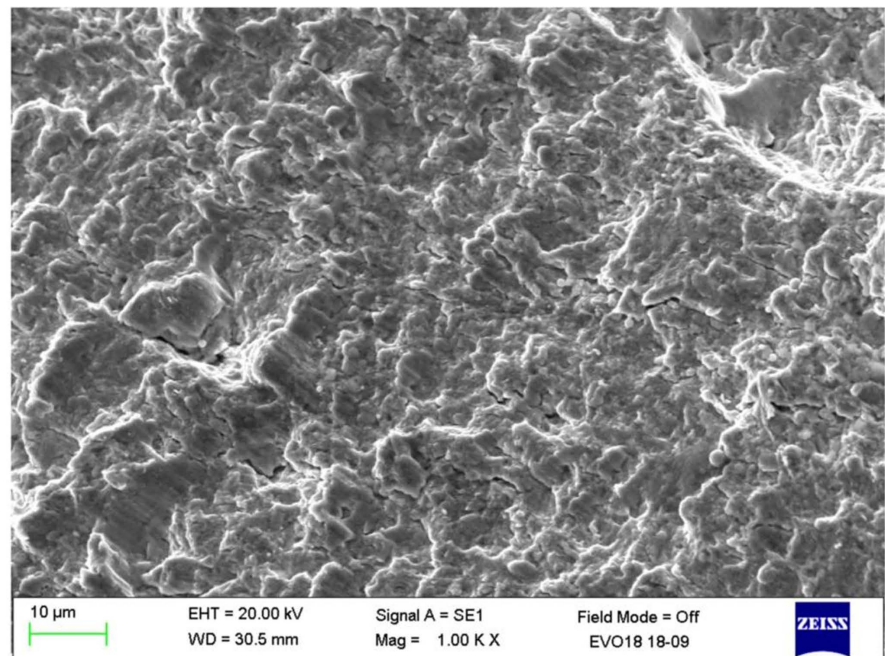
**Figure 21.** Microscopic morphology of the fatigue fracture propagation zone caused by spring scratches.

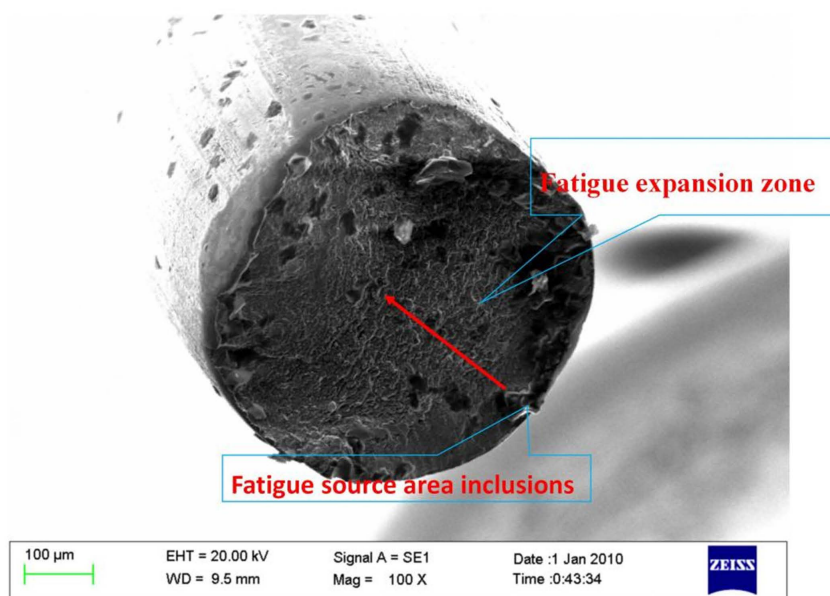
There are obvious traces of radial fatigue propagation from the source area to the surrounding area under the low magnification and microscopic morphology of the spring fracture, obvious non-metallic inclusions at the fracture in the fatigue source area, obvious fatigue glow pattern in the fatigue expansion area, and the

final fault area is mostly U-shaped, generally ductile fracture, the morphology of the fracture caused by spring inclusions is shown in **Figure 22**, and the microscopic morphology of the fatigue source area and expansion area caused by spring inclusions is shown in **Figure 23** and **Figure 24**. The results of electron microscopy analysis of non-metallic inclusions in the source area of spring fatigue are silicate inclusions, as shown in **Figure 25**, and the comprehensive force analysis, fracture morphology characteristics, and micro-electron microscopy spectroscopy can attribute the spring failure to the stress concentration generated by the inclusion edge, and finally, the bending-torsion composite fatigue fracture caused by the spring failure.

**Figure 22.** Morphology of fatigue fracture caused by spring inclusions.

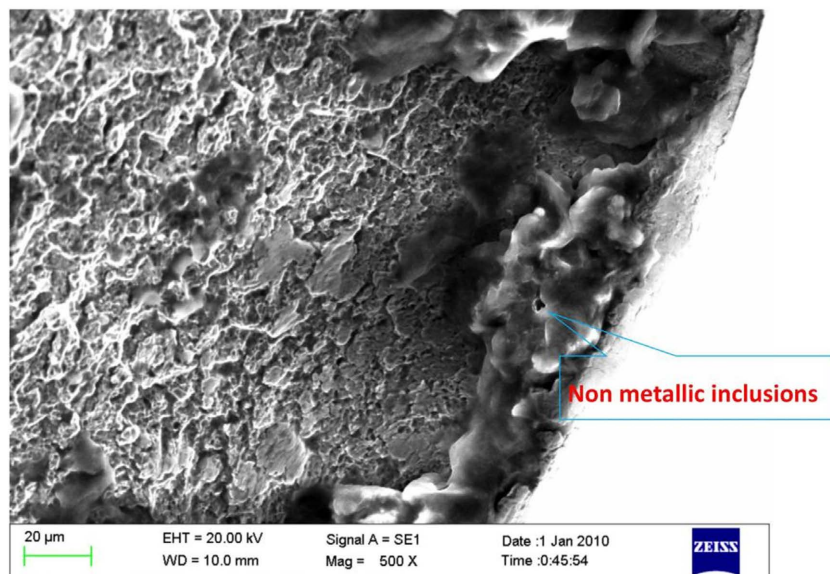
**Figure 23.** Microscopic morphology of the fatigue source area caused by spring inclusions.

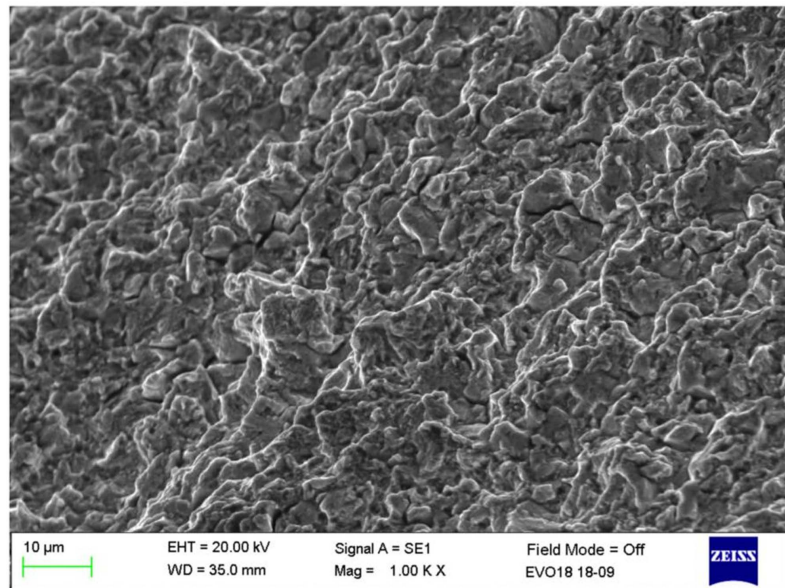
**Figure 24.** Microscopic morphology of the fatigue propagation zone caused by spring inclusions.

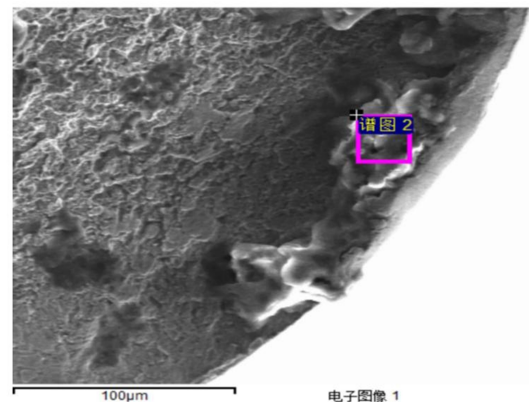
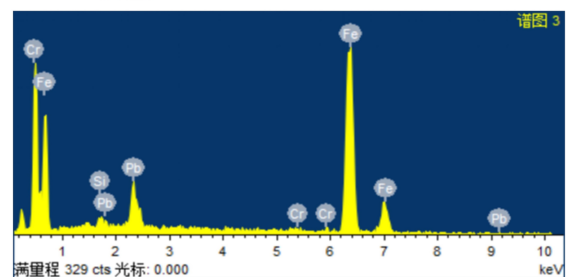
Element	Weight Percentage	Atom Percentage
O K	60.94	75.78
Na K	3.70	3.20
Mg K	2.19	1.80
Al K	3.89	2.87
Si K	8.64	6.12
S K	4.02	2.50
Cl K	4.21	2.36
K K	3.69	1.88
Ca K	2.79	1.38
Fe K	5.93	2.11
Total	100.00

**Figure 25.** Electron microscopy analysis results of non-metallic inclusions in the fatigue source area caused by spring inclusions.

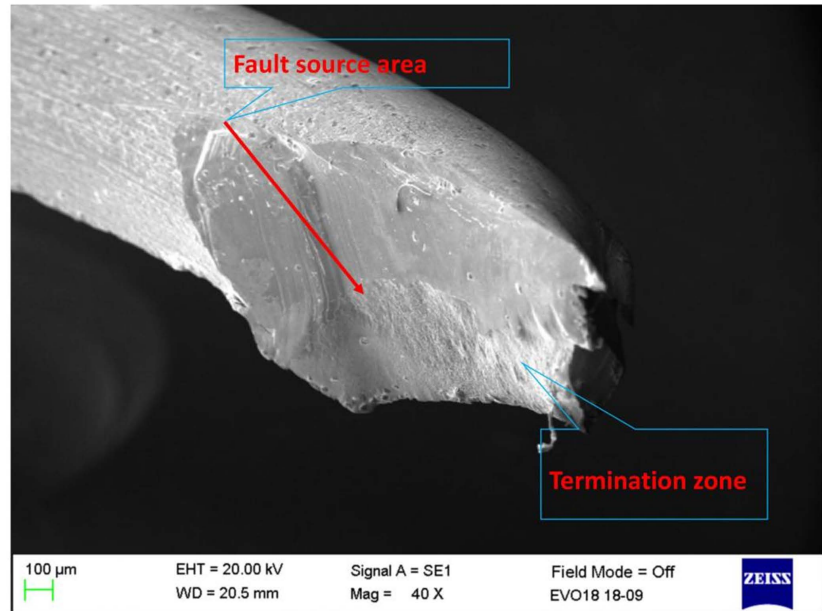
The spring is affected by an abnormal shear external force, and its fracture has obvious traces of approximate parallel expansion from the source area under low magnification and microscopic morphology, and the fracture has obvious friction failure traces, and the fracture is a shear ductile fracture. The morphology of the fracture of the spring external force damage is shown in **Figure 26**, and the microscopic morphology of the fracture of the spring external force damage is shown in **Figure 27**.

**Figure 26.** Morphology of the fracture of spring external force damage.

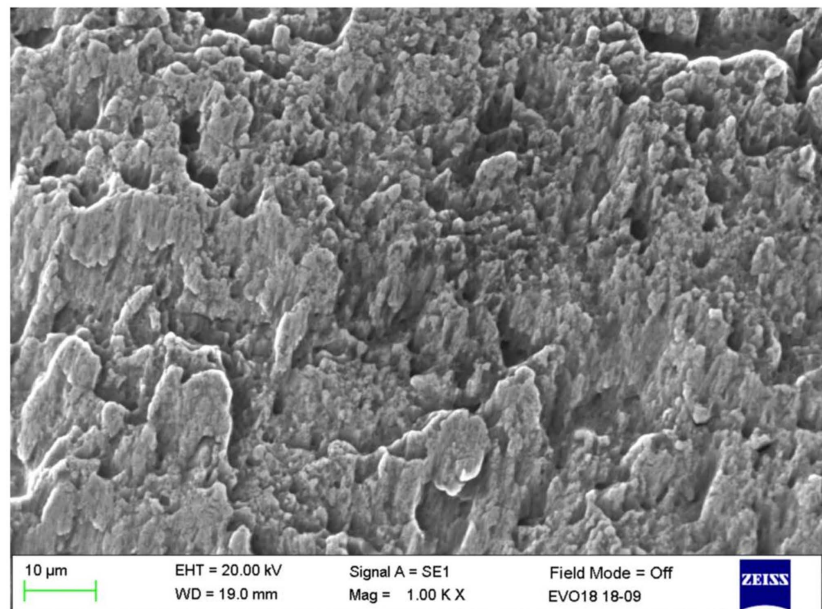
**Figure 27.** Microscopic morphology of the fracture of spring external force damage.

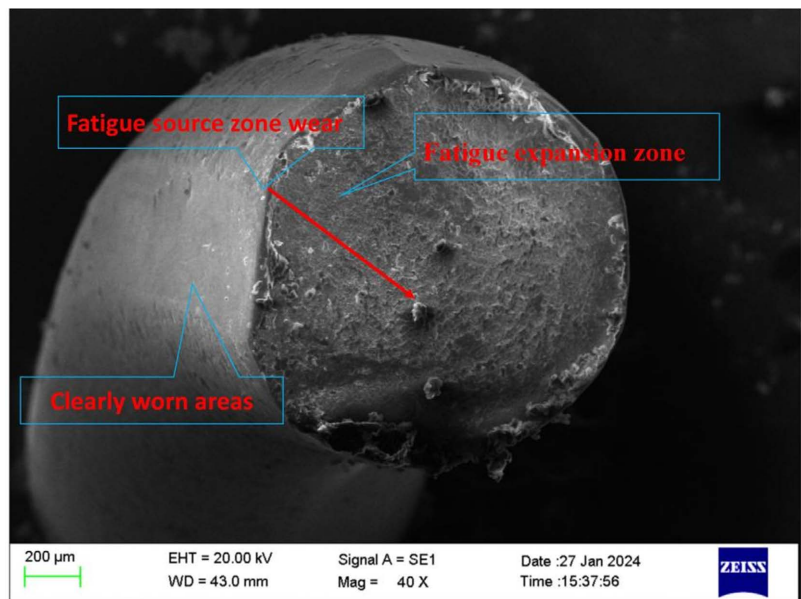
Under normal circumstances, the spring is affected by the torsional warping force of bending, and its fracture has obvious radial fatigue propagation traces from the source area to the surrounding area under low magnification and microscopic morphology. There are obvious wear marks at the fracture in the fatigue source area, and the fatigue flaring in the fatigue expansion area is obvious. The microscopic morphology of the fatigue fracture caused by spring wear is shown in **Figure 28**, and the microscopic morphology of the fatigue source area and fatigue propagation zone caused by spring wear are shown in **Figure 29** and **Figure 30**.

**Figure 28.** Morphology of fatigue fracture caused by spring wear.

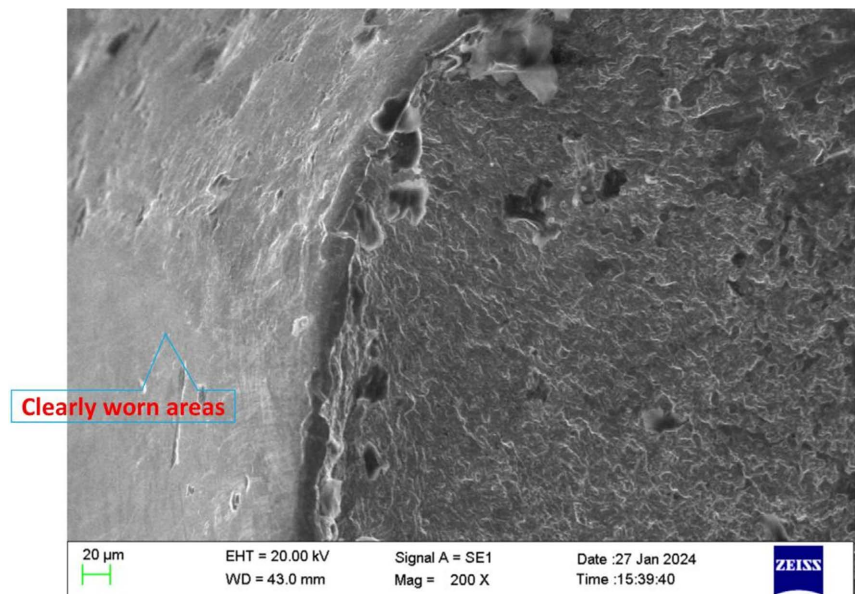
**Figure 29.** Microscopic morphology of the fatigue source area caused by spring wear.

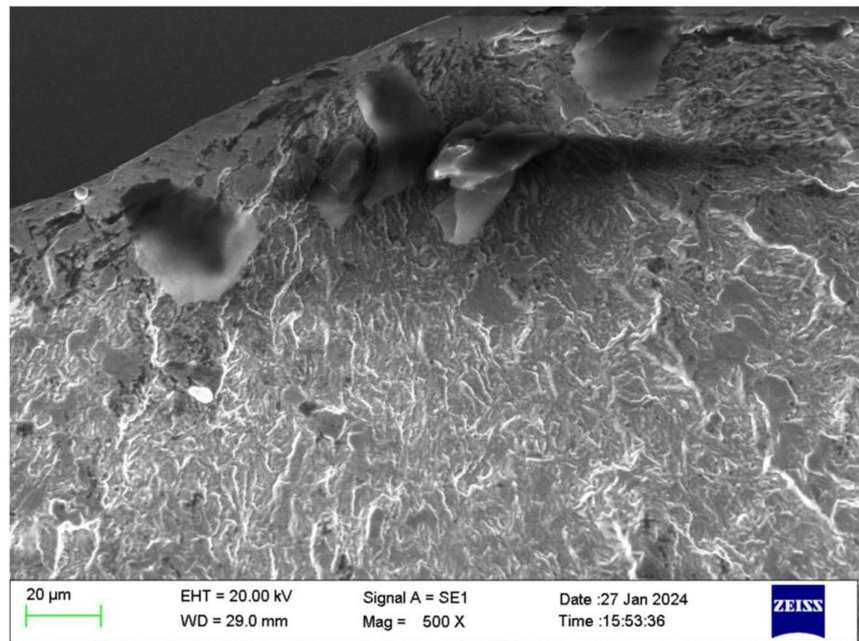
**Figure 30.** Microstructure of the fatigue propagation zone of fatigue fracture caused by spring wear.
