Detection and Cause Analysis of the Deformation of the Purlin in a Certain Portal Frame Structure Factory Building

Mingnan Ji

Inspection and Certification Co., Ltd. MCC, Beijing, China
Email: 785694396@qq.com

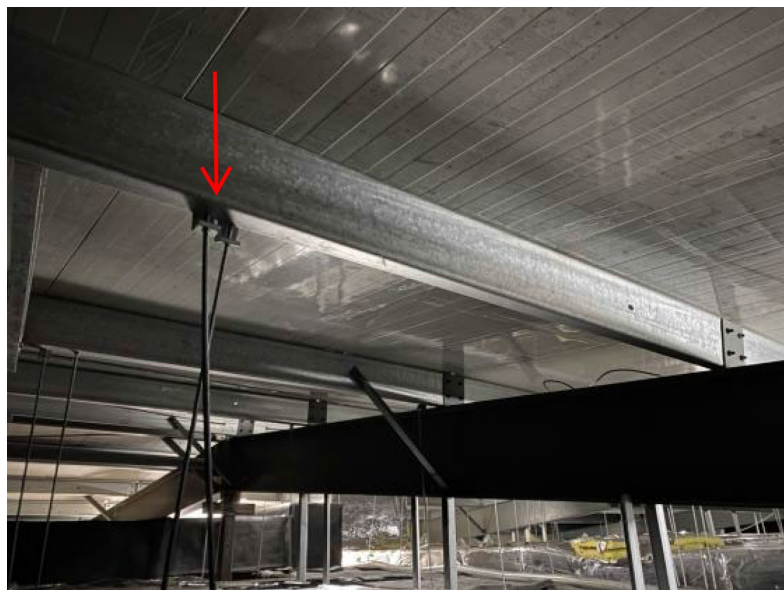
1) In the area of axes 13 to 16, the lower flange of the purlin at the hanging point of the suspended pipe load has undergone considerable deformation, as shown in **Figure 2**.

Figure 2. Local considerable deformation of the lower flange of the purlin.

- I) Hanging purlin
 - 1) It is proposed that the purlin under the measured hanging load conditions in this project, the purlin for hanging the 2500 mm × 500 mm air duct, and the purlin for hanging two or three layers of air ducts at axes 13 - 15 be strengthened.
 - 2) It is suggested that the purlin with a relatively large deformation on the lower flange, the purlin with overly dense hanging, and the purlin with hanging loads

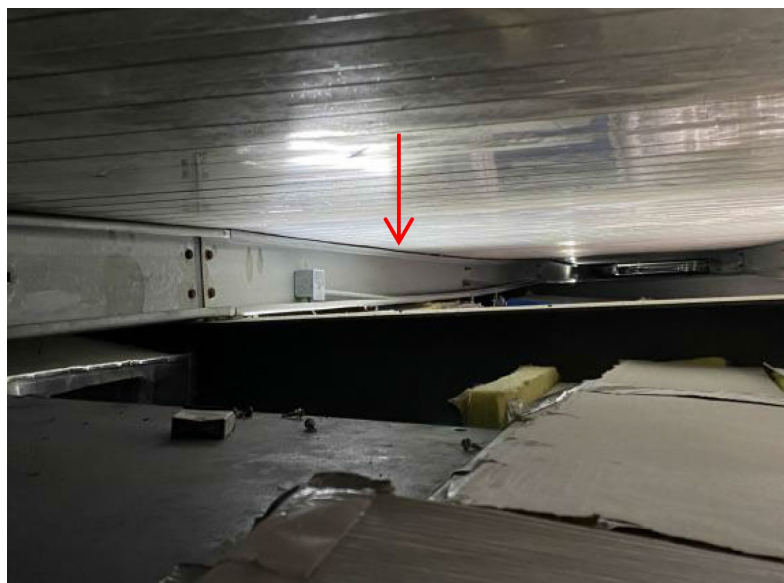
2) In the area of axes 13 to 15, the purlin has presented significant deflection, as shown in **Figure 3**.

Figure 3. Significant deflection of the purlin.

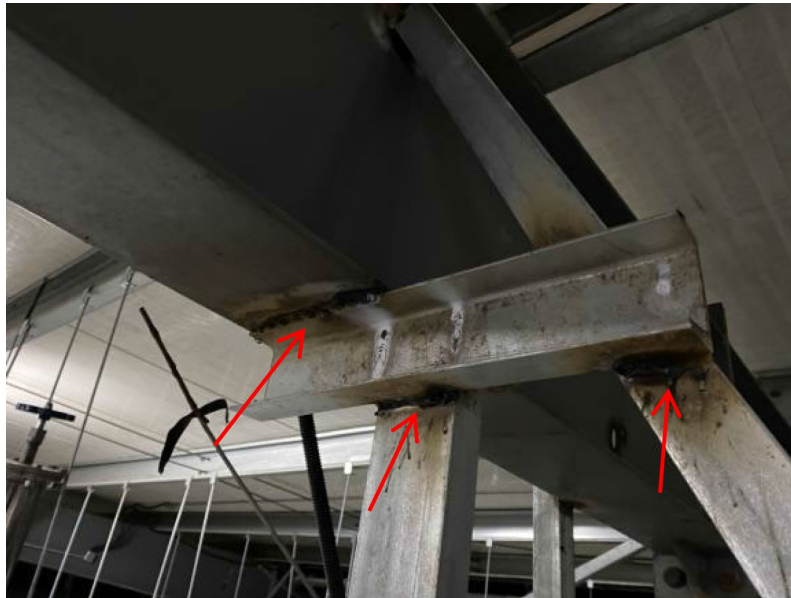
3) The welding quality of the suspended hanging pieces and the main frame is poor, as shown in **Figure 4**.

Figure 4. Poor welding quality between the suspended load fixture and the rigid frame.

3) It is recommended that the poorly welded hanging fittings of the steel frame be re-welded.

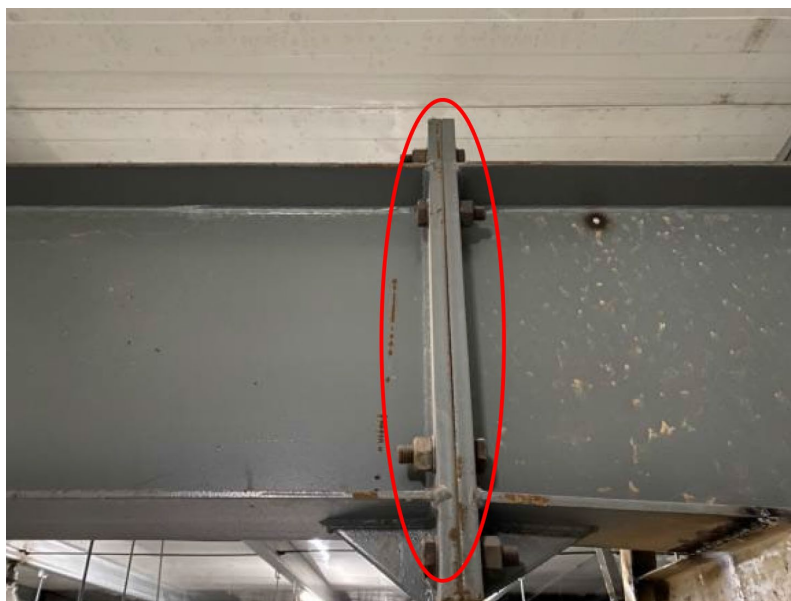
4) Corrosion exists on the bolt nodes of the main frame components, the nodes of the purlins and the tension rods, as shown in **Figure 5**.

Figure 5. Corrosion of the node bolts of the rigid frame components.

3) It is recommended that the rusted components of the roof purlin system be derusted.

2) It is recommended that the rusted node bolts of the main steel frame in the hanging load area be derusted.

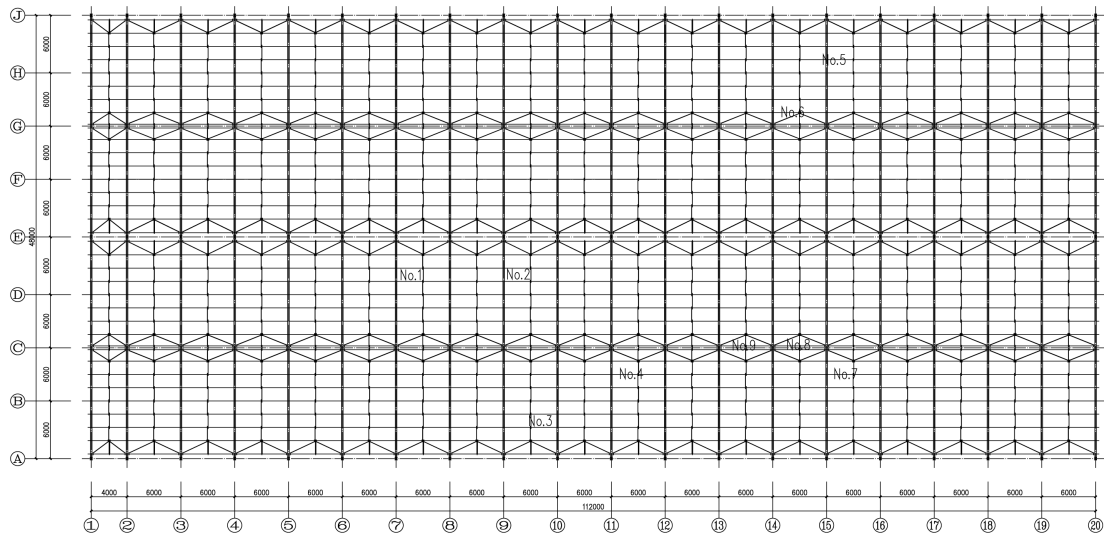
Figure 6. Plane layout of rafters under various working conditions.

capacity. The layout plans of these nine conditions are presented in **Figure 6**. According to the load of the air ducts and pipes' specifications and the on-site hanging arrangement, the calculation diagrams of the nine conditions were derived, and the bearing capacity of the purlins under the corresponding conditions was calculated [9]. The calculation results are shown in **Table 1**.

1) In the first load case, as two relatively large air ducts are fully spanned and arranged along the direction of the purlin, the purlin is subjected to a significant load, resulting in the inability of the bearing capacity to meet the code requirements and the failure of the deflection to meet the requirements.

2) In the second load case, due to the considerable weight of the 2500 mm × 500 mm air duct, even though it is single-layer and full-span arranged, the purlin still undergoes a large load, leading to the inability of the bearing capacity to meet the code requirements and the failure of the deflection to meet the requirements.

3) In the third load case, because of the large number of air ducts hung on the purlin and the multi-layer arrangement of the ducts, the purlin is subjected to a significant load, causing the bearing capacity to fail to meet the code requirements and the deflection to fail to meet the requirements.

4) In the eighth load case, as the suspended load is arranged unevenly across spans, with a large span and a three-layer arrangement of air ducts, the purlin is subjected to a significant load, resulting in the inability of the bearing capacity to meet the code requirements and the failure of the deflection to meet the requirements.

5) In the fifth load case, the bearing capacity of the purlin meets the code requirements, but the load arrangement is overly concentrated, causing excessive local deformation and the failure of the deflection to meet the requirements.

6) In the fourth, sixth, seventh, and ninth load cases, the bearing capacity of the purlin meets the code requirements, but the deflection is at the critical value of the allowable deflection. It is recommended to carry out reinforcement treatment.

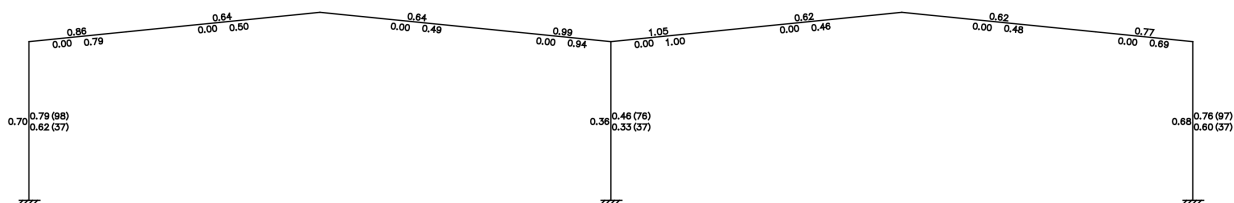
Figure 7. The stress ratio verification results of the 16th bay portal frame steel structural members.

The calculation outcomes indicate that the bearing capacity safety margin of the gable truss beam 16/E-F is 0.95, failing to fulfill the requirements of the specification.

1) It is recommended that reinforcement measures be taken for the main steel frame in the hanging load area.

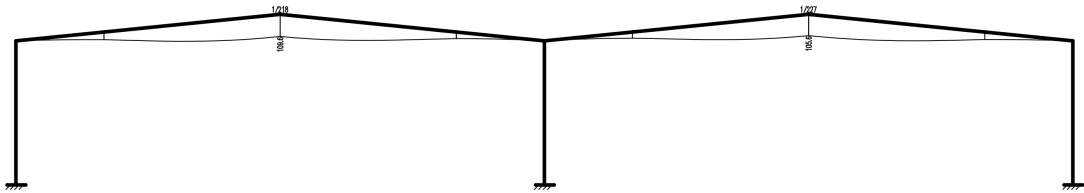
Figure 8. The calculation results of deflection of the 16th bay portal frame beams.

The calculation outcomes indicate that the deflection of the portal frame beams fails to comply with the requirements of the code, as shown in Figure 8, but the calculation results of the lateral displacement satisfy the code requirements, as shown in Figure 9 and Figure 10.

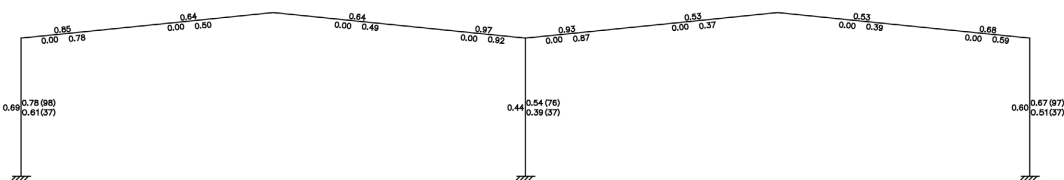
Figure 11. The stress ratio verification results of the 11th bay portal frame steel structural members.

The calculation outcomes demonstrate that the safety margins of the bearing capacity of the portal frame components are all greater than 1, fulfilling the requirements of the code.

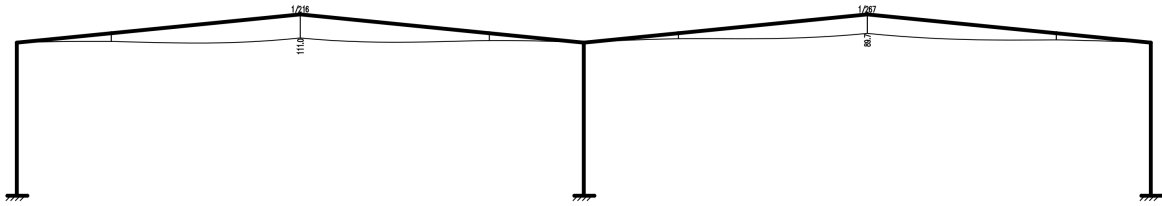
Figure 12. The calculation results of deflection of the 11th bay portal frame beams.

The computational results indicate that the deflection of the portal frame beams fails to comply with the requirements of the code, as shown in **Figure 12**, whereas the calculation results of the lateral displacement conform to the code requirements, as shown in **Figure 13** and **Figure 14**.
