Analysis of the Physical State and Operation of Hydraulic Infrastructure in the Konni Irrigated Area before Rehabilitation

Aboubacar Yerima Bako Djibo¹, Illa Salifou², Guero Yadjji³

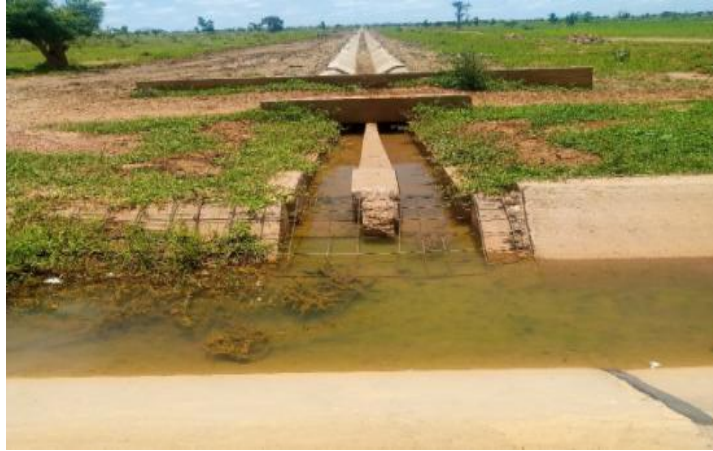
Plates in good condition concern plates 1m long. As soon as the length of the plates exceeds 2 m, cracks are apparent in the majority of the plates and the degradation of the plates intensifies. Photo 1 shows the condition of the secondary canals before the rehabilitation activities (**Figure 2**).

Figure 2. Very degraded secondary channels [8].
