Metallurgical Forensics: Investigating a Superheater Tube Failure in Industrial Process Plants

Kok Toong Leong

Engineering Department, QSM Associates, Singapore

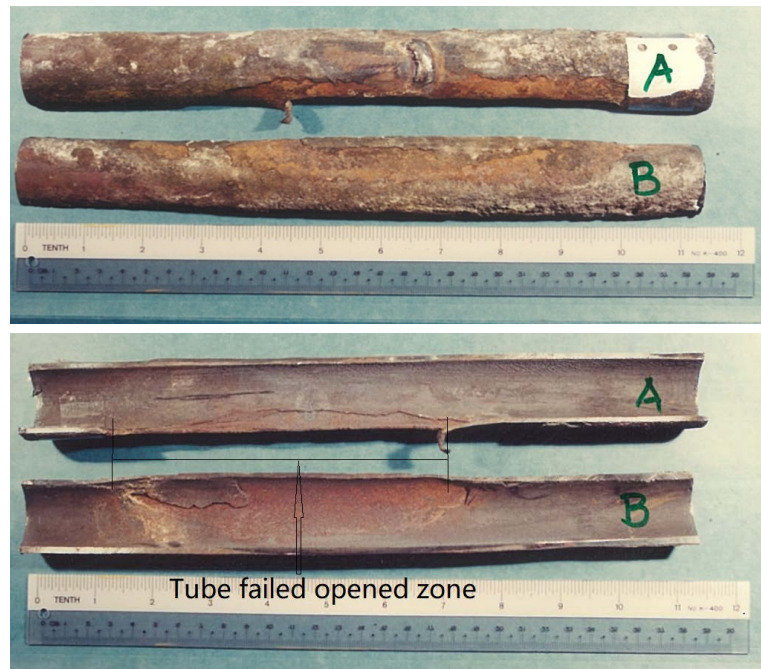
Two superheater tubes were inspected. The first tube was the failed tube with an opening, as shown in **Figure 1**. A layer of material had been lost in the failed zone near the ruptured surface. A closer inspection revealed corrosion on both the external and internal surfaces of the failed zone, as presented in **Figure 2** and **Figure 3**. It was also observed that the edges of the opening were slightly thinner compared to other areas. Further analysis using other techniques will focus on the failed zone, particularly the thinned areas and edges.

Figure 1. Picture of Failed Superheater Tube that was cut in half.

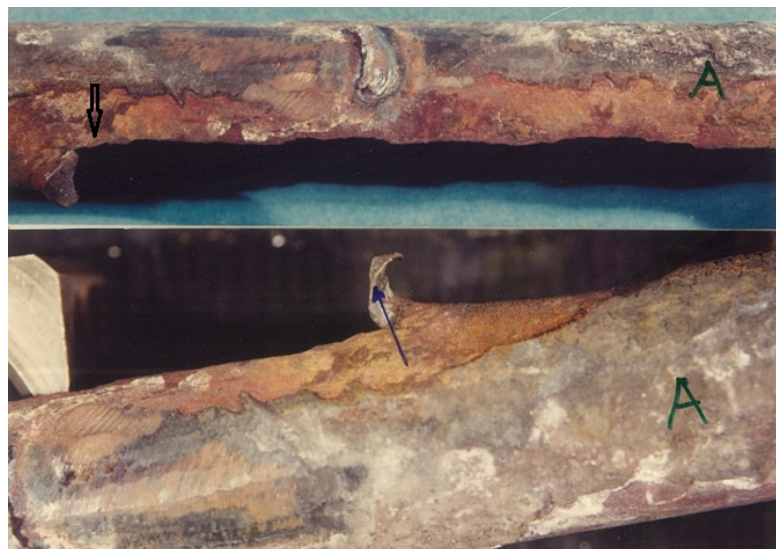
Figure 2. Corrosion seen on external surfaces (arrowed examples) of failed zone.

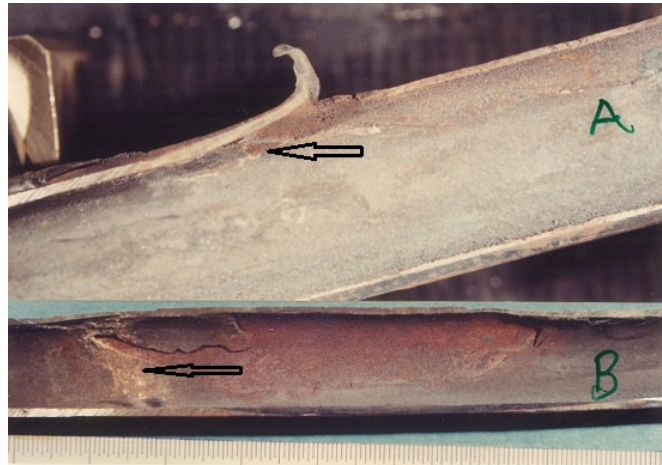
Figure 3. Corrosion seen on internal surfaces (arrowed examples) of failed zone.

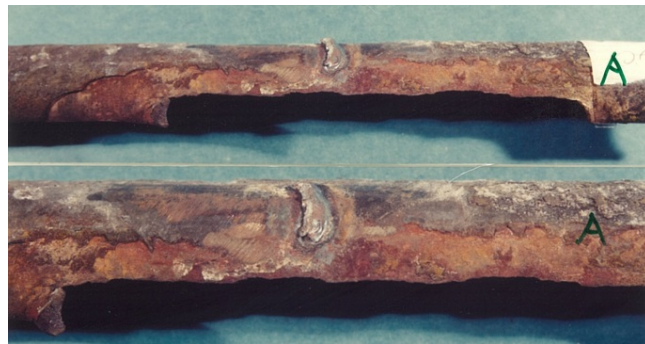
In **Figure 4**, the rupture zone had a missing rectangular slice of tube material. This intriguing feature suggests a specific degradation mechanism that caused the section to be “torn off”, and this rectangular section was not found on site.

Figure 4. Failed opening exhibited a rectangular slice of the tube material that was lost. A window fracture appearance.

The cracks started from the outside, as evidence from **Figure 7** that cracks had developed along the external surfaces and they were not seen from the inside. The failed region had a relatively rectangular opening, with some material loss around this area (**Figure 4**). The rectangular like feature appeared typical of a window fracture [8] and is a known tube failure appearance associated with embrittlement. The intergranular crack, lack of shearing seen in the microstructure and no plastic deformation [9] supported features of a brittle fracture.

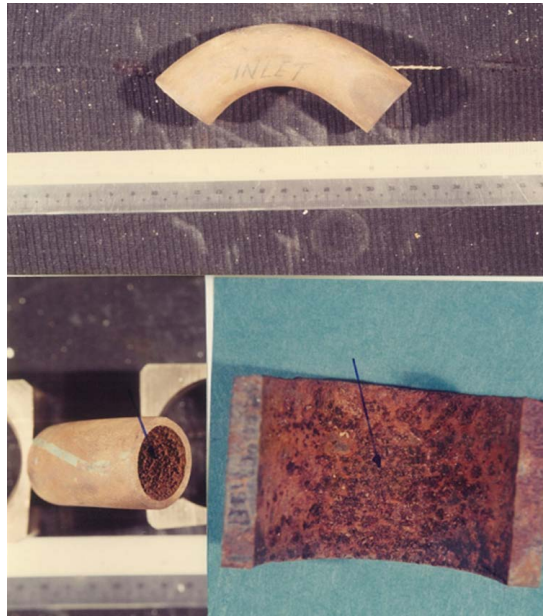
The second superheater tube was an elbow at the superheater inlet zone, away from the failed tube. **Figure 5** shows this inlet elbow, where the external condition of the elbow did not show signs of corrosion or material loss. However, internal corrosion was clearly noted.

Figure 5. Superheater Inlet Elbow. Obvious corrosion products were seen on the internal surface (arrowed example).

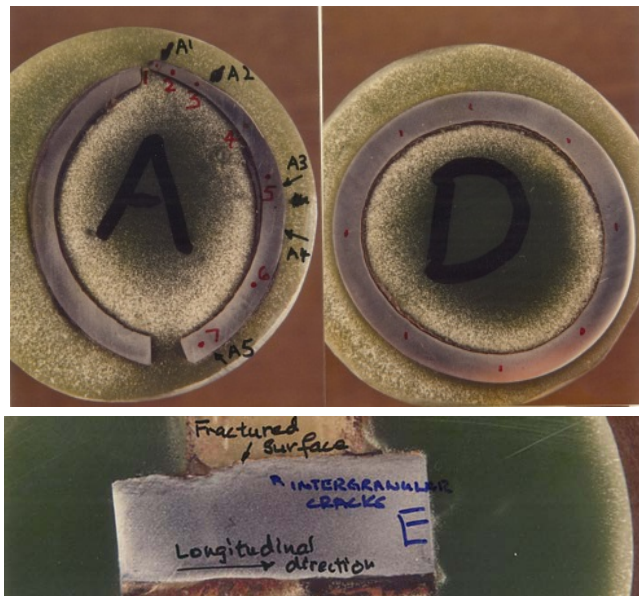
Two specimens from the failed tube were taken for metallographic investigation. Specimens were taken at the fractured zone, in both longitudinal and transverse sections. The longitudinal section specimen preserved the fractured surface for longitudinal evaluation (marked E in **Figure 6**), while the transverse section cut across both semi-circular halves of the tube (marked A in **Figure 6**). The macro views of these two metallographic specimens are shown in **Figure 6**. For the purpose of comparative reference and study, a third specimen was studied by taking a cross-section from the superheater inlet elbow (marked D in **Figure 6**).

Figure 6. Macro view of Metallographic Specimens. A & E taken from failed tube and D from inlet elbow.

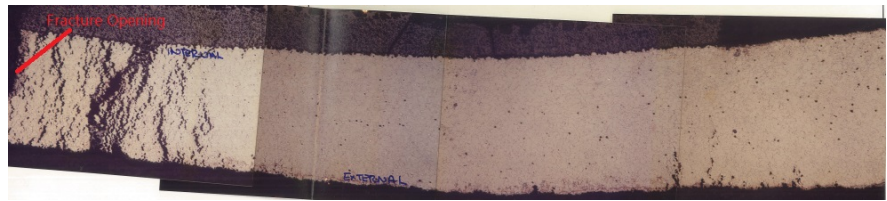
Figure 7. A 20× magnification of specimen A, starting from A1.

It can be seen that A1 to A5 were marked on the transverse section. Location A1 was at the fracture surface zone. Moving along from locations A2 to A5, reaching the opposite of the fractured surface of the semi-circular section. A 20× macro view starting from A1 (the fracture opening) is shown in **Figure 7**. In this figure moving slightly away from the fracture zone, cracks can be seen to open from the external wall.

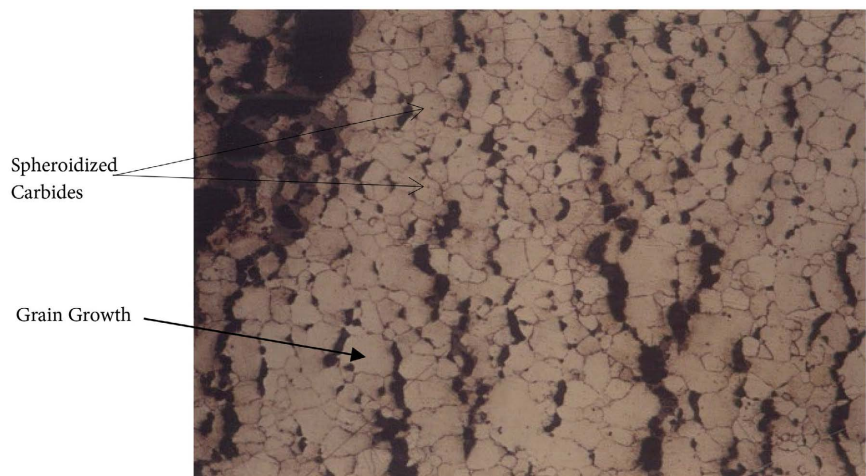
Figure 8. Micrograph of A1 at 200× magnification.

Figure 8, taken at 200× magnification, showed the microstructure at the A1 fractured surface. It displayed openings along a significant number of grain boundaries, indicating intergranular cracking. The microstructure reveals that the pearlite had undergone complete spheroidization forming spheroidized carbides with grain growth. This was a sign of severe thermal degradation.

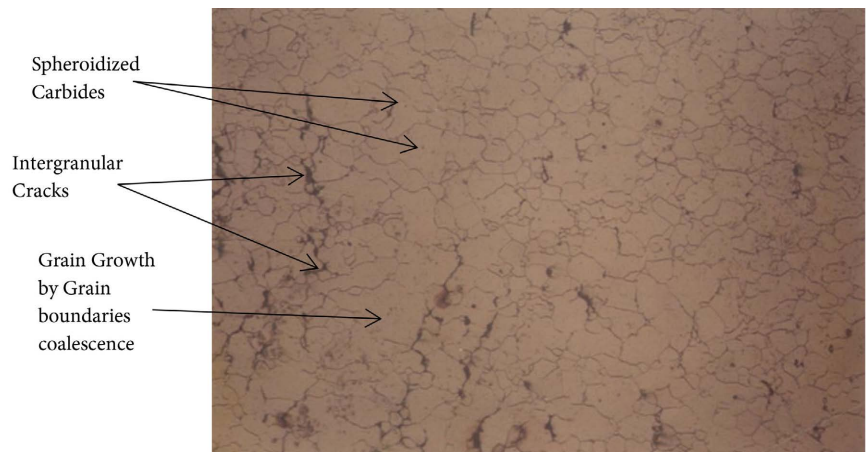
Figure 9, taken at 200× magnification, showed the microstructure at the A2 location, a short distance from the fractured surface. This micrograph also revealed that the pearlite had undergone complete spheroidization forming spheroidized carbides with grain growth. However, the extent of intergranular cracks was much less, with smaller openings.

Figure 9. Micrograph of A2 at 200× magnification. No Pearlites were seen.

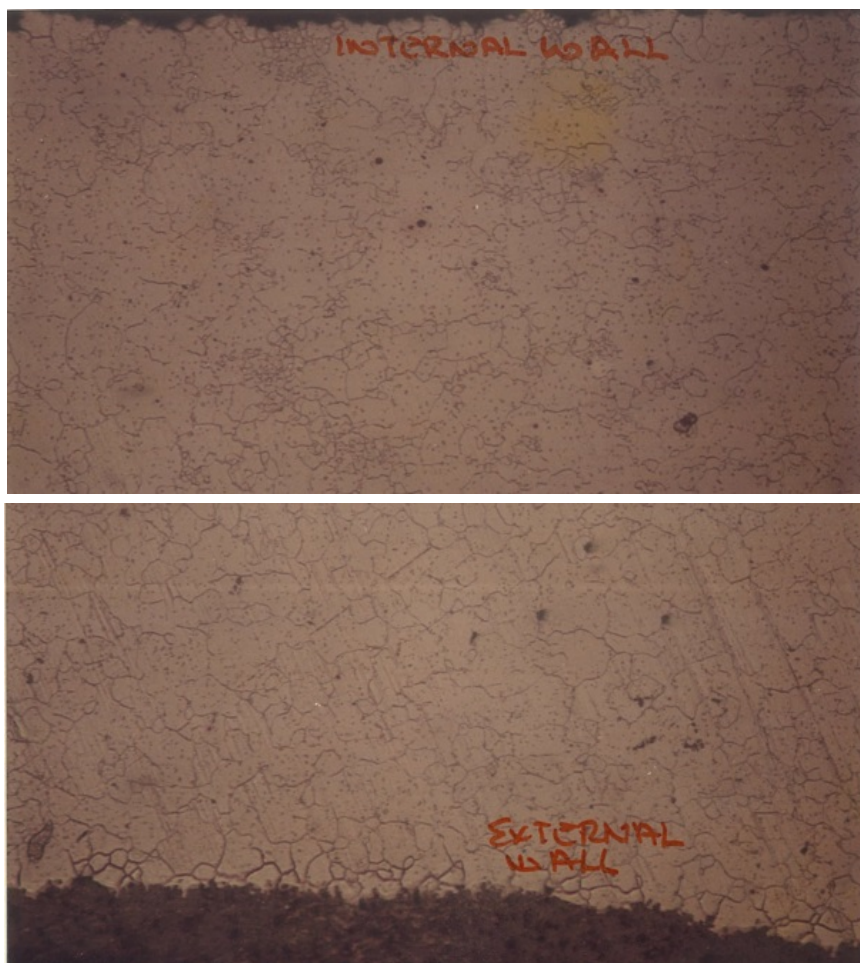
Figure 10. Micrograph of A3 at 200× magnification.

Figure 10, taken at 200× magnification, showed the microstructure at the A3 location, about a quarter of the circumference away from the fractured surface. This micrograph revealed the spheroidization of pearlite into spheroidized carbide accompanied by grain growth. Although grain growth was visible across the entire thickness of the material, it was more pronounced on the external wall compared to the internal wall.

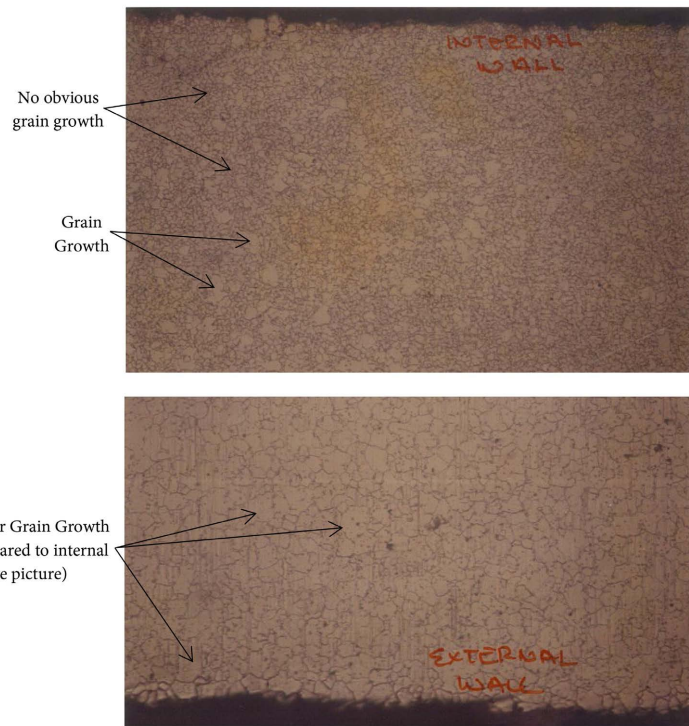
Figure 11. Micrograph of A4 at 200× magnification.

Figure 11, taken at 200× magnification, showed the microstructure at the A4 location, more than a quarter of the circumference away from the fractured surface. This micrograph also revealed that the pearlite had undergone complete spheroidization into spheroidized carbides. Grain growth was evident in the external wall region but was not much in the internal region.

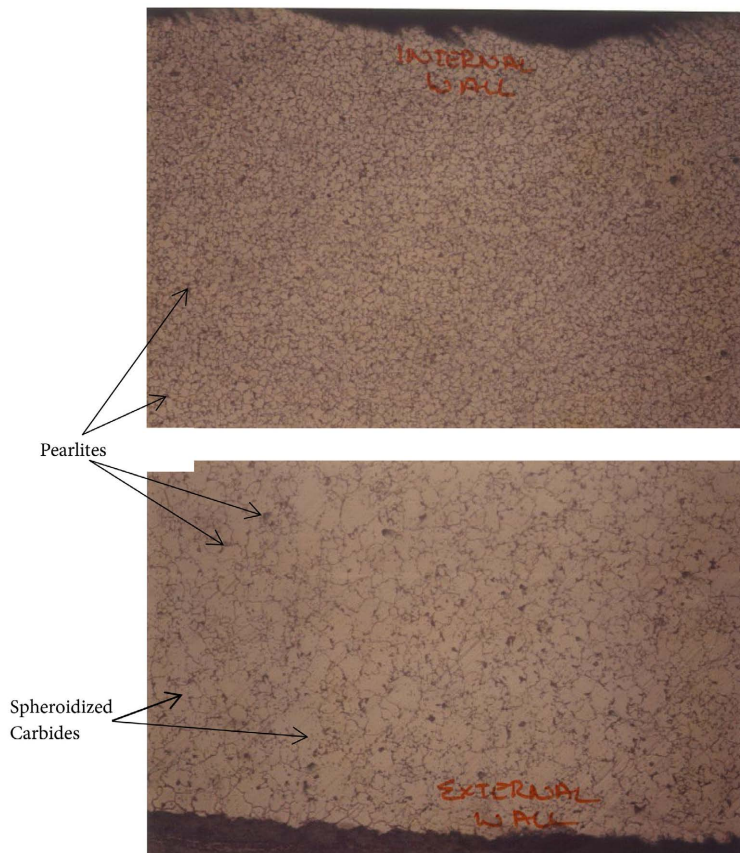
Figure 12, taken at 200× magnification, showed the microstructure at the A5 location, almost half the circumference away from the fractured surface. This micrograph revealed that the internal wall had a mixture of spheroidized carbides, pearlites and ferrite. Meanwhile, the external wall region had a mixture of spheroidized carbides, pearlite, ferrite and some grain growth. At the same magnification, the grains were obviously bigger on the external wall.

Figure 12. Micrograph of A5 at 200× magnification. Larger grain growth and greater spheroidization on external surface.

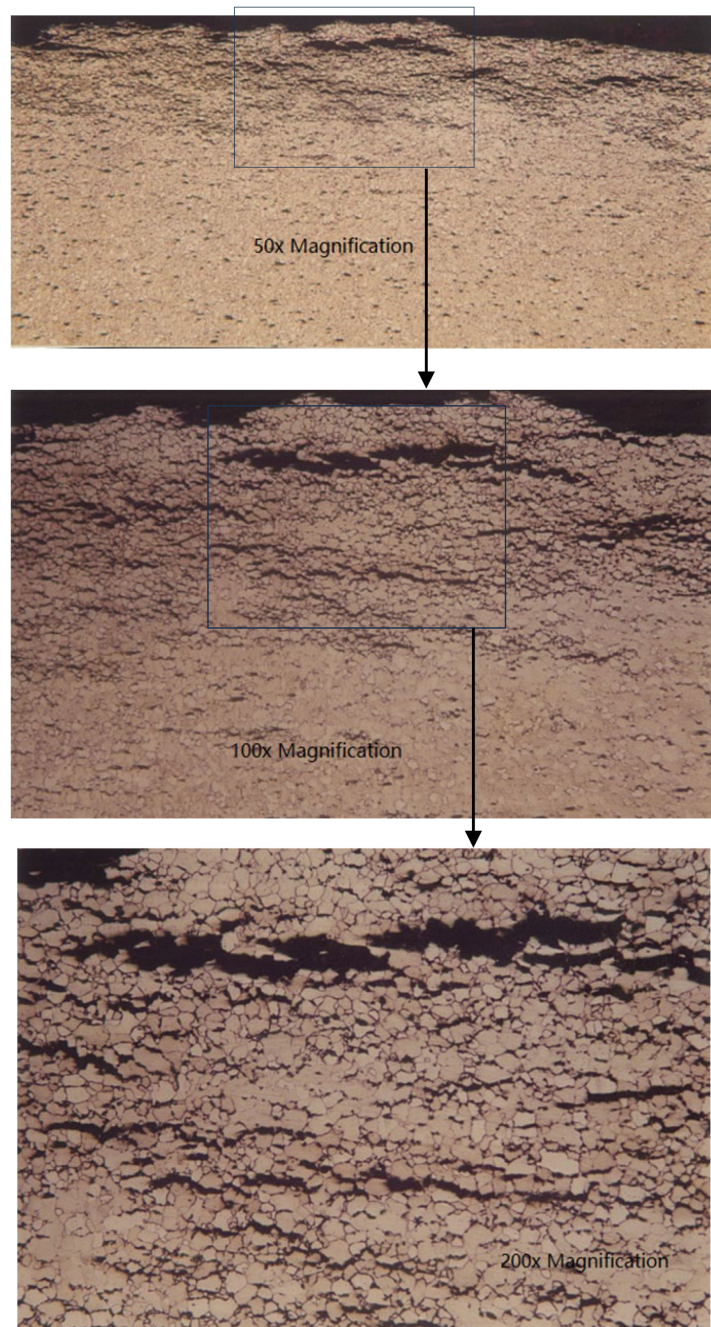
Figure 13. Micrograph of longitudinal specimen E, taken at fractures surface with 50×, 100× and 200× magnification.

Corresponding to longitudinal specimen E in **Figure 6**, the microstructure near the fractured surface was evaluated. **Figure 13** below presents the observed condition. The pearlite had undergone complete spheroidization into carbides with significant intergranular cracking and tearing at the fracture surface region. Clearly the severity of the tearing from intergranular cracking was greater when it was closer to the fractured surface.

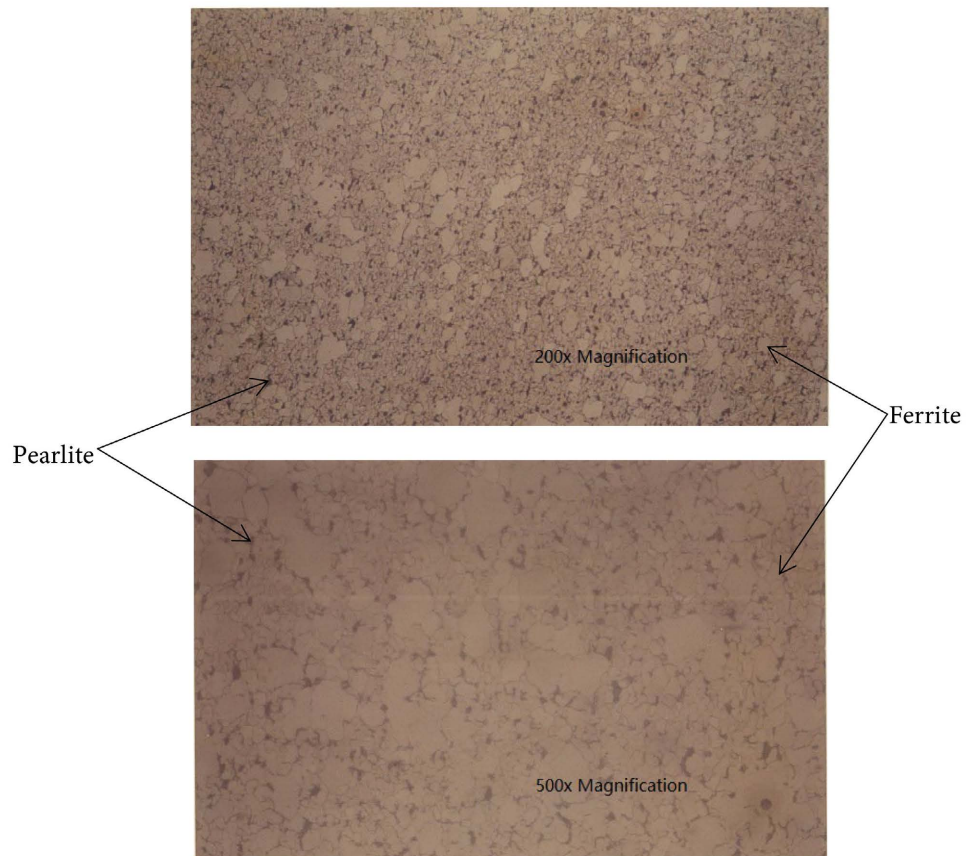
The microstructure of the superheater inlet elbow was evaluated and was presented in **Figure 14** below. This section shows a ferritic structure with pearlite and ferrite, exhibiting minor thermal degradation. This microstructure was consistent throughout the specimen.

Figure 14. Micrograph of Superheater Inlet Elbow at 200× & 500× Magnification. Ferritic structure consisting of ferrite and pearlite can be seen.

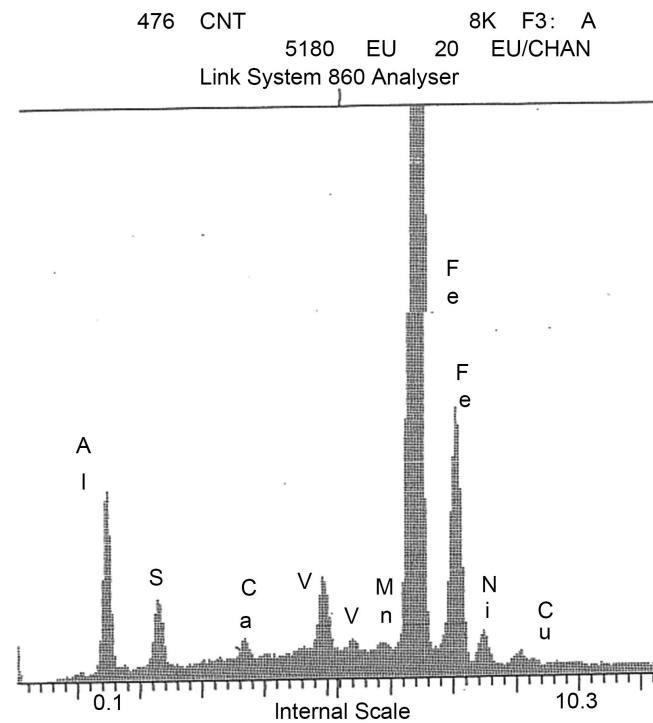
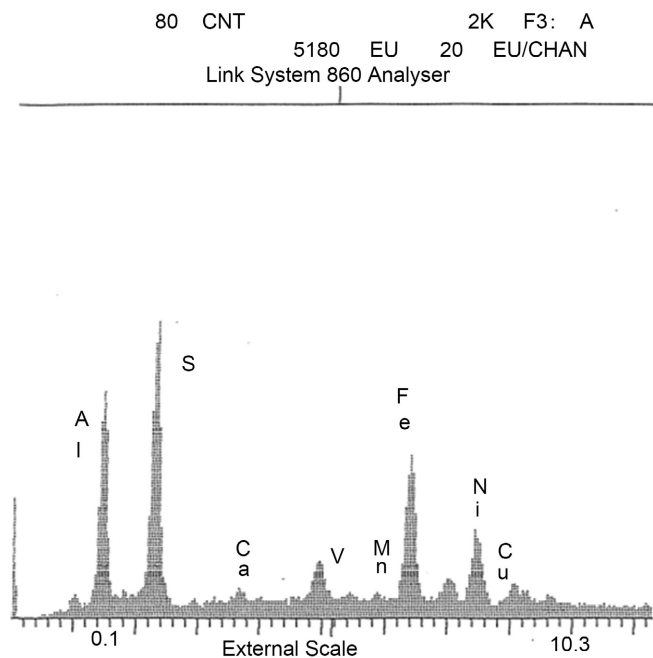
The internal and external surfaces of the failed superheater tube were analyzed. **Figure 15** & **Figure 16** presents the resulting spectra of the EDX spectra. As seen in **Figure 15**, EDX detected the presence of aluminum, Sulphur, calcium, vanadium, manganese, iron, nickel, and copper on the internal of the failed superheater tube. On the external surface spectra in **Figure 16**, the presence of aluminum, sulphur, calcium, vanadium, manganese, iron, nickel, and copper. While the elements detected were the same, the proportions displayed were different. Sulphur and copper proportional ratio was bigger on the external surface as they were from the environment.

High sulphur proportion and copper existed in both the inside and outside of the failed tube and not in the inlet elbow. The EDX spectra for the inlet elbow corrosion product was consistent with the boiler water analysis and the tube material and did not show copper being present. Copper was also not part of the chemical composition of this grade of steel [11].

An onsite study needs to be conducted to determine the source of the copper. Copper is not a usual composition or impurities in fuel oil and thus it may have been from other sources.

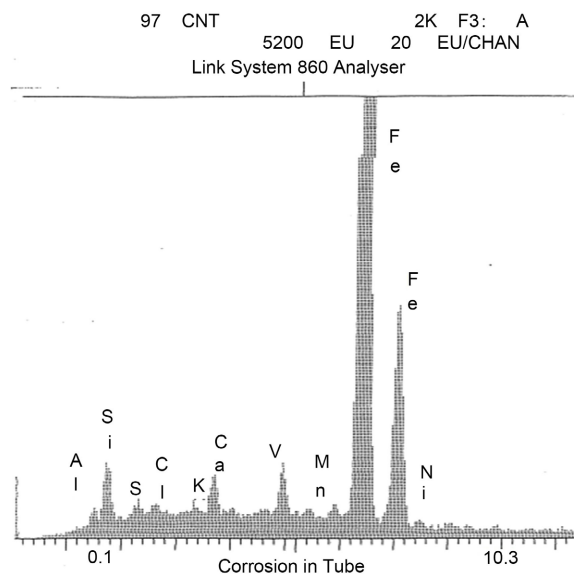
Figure 17. Superheater inlet elbow Internal Surface EDX Spectra.

EDX was also performed on the internal scale of the inlet elbow. **Figure 17** presents the detected elements. EDX detected the presence of aluminum, silicon, sulphur, chloride, potassium, calcium, vanadium, manganese, iron and nickel. Most of these were elements from the based material (See **Table 3**) and others from the boiler water.
