Detection and Genesis Analysis of Cracks in Prestressed Box Girder of a Certain Project

2. Project Overview

In a certain project, the left box girder of DY42-DY43 underwent the initial tensioning of prestressing tendons three days after pouring, and the final tensioning was carried out five days after the initial tensioning. After the tensioning was completed, crack defects were found on the side and bottom surfaces of the end of the top slab of the box girder. To grasp the crack morphology, causes and treatment suggestions of the box girder, the left box girder from DY42 to DY43 was subjected to crack and structural inspection.

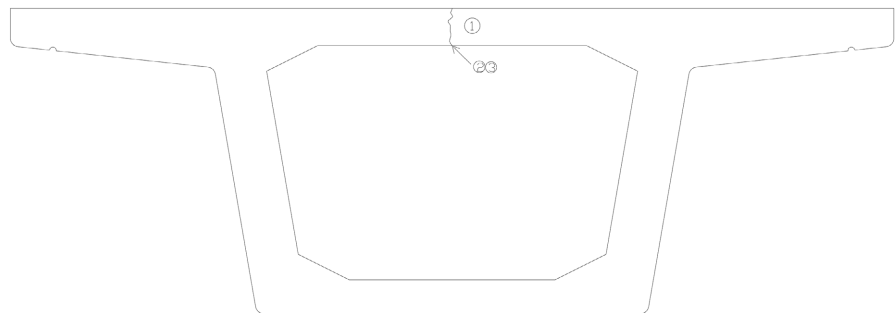
On-site crack detection of the left box girder of DY42-DY43 in a certain project was carried out using tools such as a tape measure and a crack width observation instrument. The specific crack descriptions are detailed in **Figure 1** to **Figure 2**, and the crack detection results are shown in **Table 1**.

Figure 1. Diagram of side crack at the end of the top slab of left box girder DY42-DY43.

No.	Crack Length (mm)	Maximum Crack Width (mm)
1	342	0.40
2	891	0.60
3	1030	0.20

During on-site inspection, it was discovered that a vertical crack existed at the end of the top slab of the left box girder from DY42 to DY43 in a certain project. Along this crack, two longitudinal cracks formed on its bottom surface, and the crack width gradually decreased from the port to the deep part.

Since the anchorage end of prestress often arranges a large number of prestressing tendons in a very small area in a concentrated manner, when the tensioning force is applied, the pressure on the local bearing surface is too large, causing longitudinal cracking along the direction of prestress. It usually develops longitudinally along the direction of the prestressing tendons and disappears after the local bearing stress diffuses outside the anchorage area.

In view of the above analysis, it is initially inferred that the crack at the end of the box girder top slab is a local bearing pressure crack at the anchorage end. The generation of this crack is also related to the early strength of the box girder and the tensioning quality. To avoid adverse effects of the crack on the durability of the anchorage agent of the prestressing tendons, the crack should be repaired and treated.

Concrete Structures”, for components with a crack control level of three, cracks are allowed at the tensile edge. The maximum allowable crack width of the component when working in a cracked state is 0.2 mm. The crack width inspected in this project does not satisfy the limit requirements and therefore, requires treatment. As the crack depth in this project is less than 0.1 H (the thickness of the component), the surface repair method should be adopted for treatment.

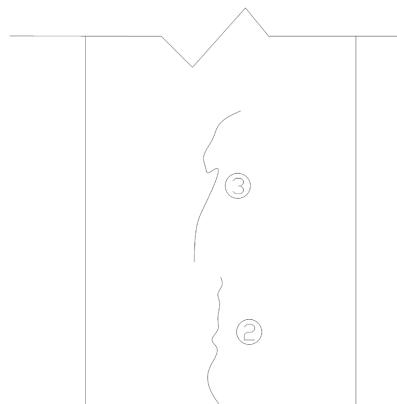
Figure 2. Diagram of bottom crack at the end of the top slab of left box girder DY42-DY43.

The ultrasonic method was adopted on-site to detect the depth of the cracks on the top plate of the box girder. The test results indicated that the depths of the top plate cracks were 0.24 mm and 0.22 mm, respectively.

Cracks caused by temperature variations typically emerge or intensify after passing through summer or winter. Significant temperature differences can induce cracking in components. This section has been poured for a considerable period and has undergone temperature change cycles, being influenced by certain temperature variations. There exist branch-shaped cracks inside the longitudinal direction of the left box girder from DY42 to DY43, with small widths, short lengths, and the surface cracks conform to the morphological distribution of temperature cracks. Hence, it is inferred that the cause of the branch-shaped cracks at the end of the box girder top slab is related to temperature.
