# Determination of the Degradation Index by Detection of Pavement Distress with Transfer Learning and Image Processing

**How to cite this paper:** Yabi, C.P., Dehounhessi, E., Godonou, E.F.G., Gibigaye, M. and Alamou, E. (2025) Determination of the Degradation Index by Detection of Pavement Distress with Transfer Learning and Image Processing. *Engineering*, 17, 680-705.

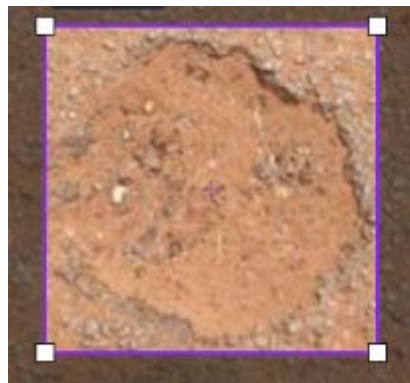
**Figure 1.** Annotation of a severity 2 pothole with a bounding box.

Image annotation is the step that allowed us to label all the degradations located on the normalized images to provide to our models for training. For this, we utilized the Roboflow platform, which features two tools: the “Bounding Box” tool and the “Polygon” tool. During the annotation, we directly specify the severity of each degradation with numbers 1, 2, and 3, indicating the severity levels 1, 2, and 3, respectively. Severity levels 1, 2 and 3 correspond respectively to low, medium and high levels of distress. For example, in the case of rutting, level 1 indicates a shallow rut depth ( $h < 2$  cm), level 2 a moderate rut depth ( $2 \text{ cm} \leq h \leq 4$  cm), and level 3 a deep rut ( $h > 4$  cm). **Figure 1** shows the annotation of a pothole of severity 2 with the bounding box while **Figure 2** shows the annotation of some distress with polygon tool.

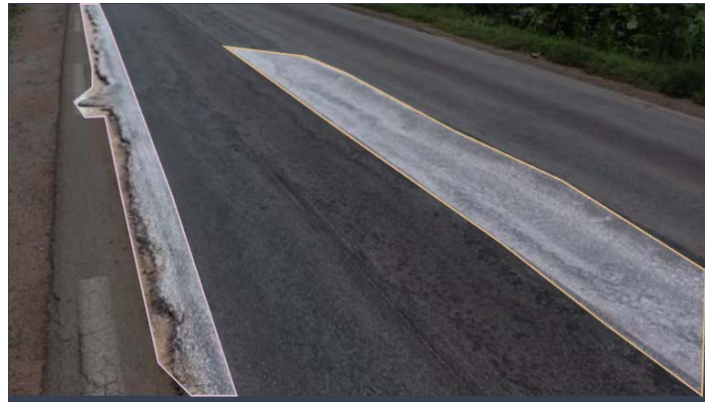
**Figure 2.** Annotation of a 3-beam and a 3-rut with the polygon tool.

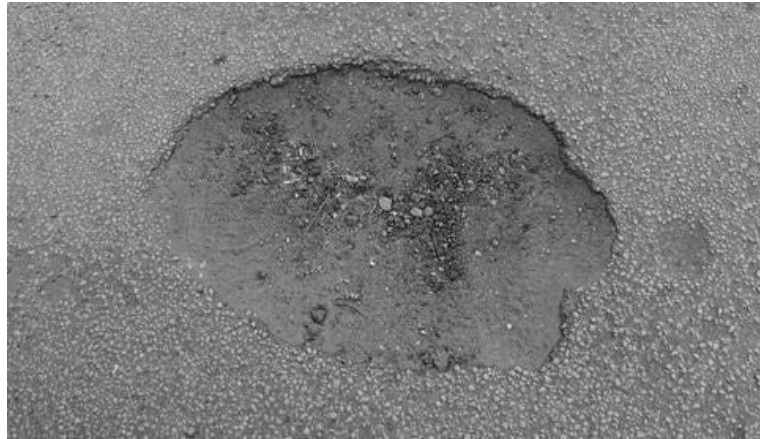
**Figure 3.** Pothole image converted to grayscale with BGR2\_GRAY filter.

other databases containing only grayscale images using a Python script called “Gray\_Convertor”, written in the Pycharm IDE and which uses the CvtColor method with the BGR2\_GRAY filter from the OpenCV library, as shown in **Figure 3** and **Figure 4**.

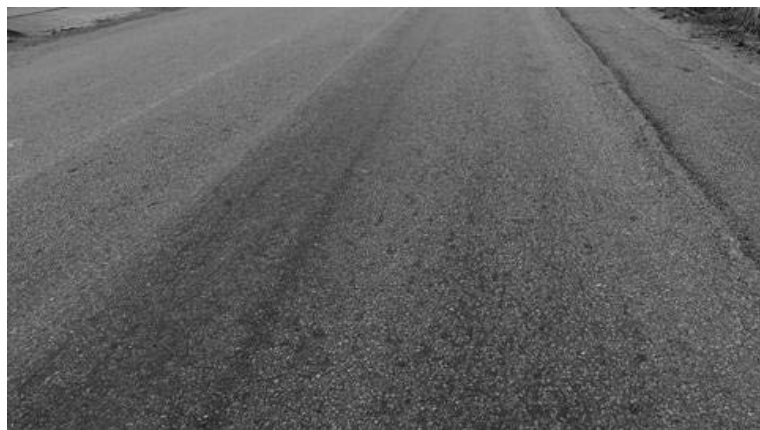
**Figure 4.** Image of rut converted to grayscale with the BGR2\_GRAY filter.

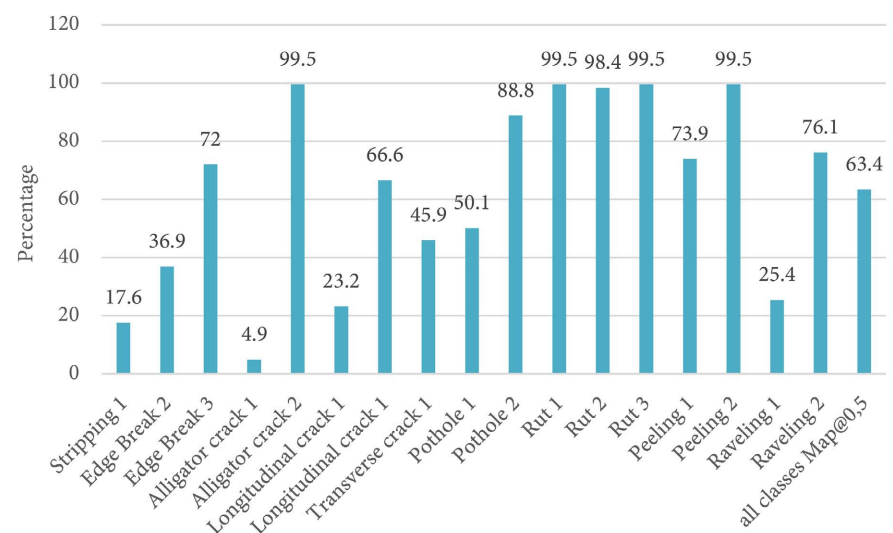
**Figure 5.** mAp50 accuracy of each degradation class by YOCNN1 on Dataset\_831.

This Figure shows very good detection performance of all rut severities, the second severity of alligator, and the second severity of peeling up to 99%. The confusion matrix is as follows in **Figure 6**.

Figure 5 shows the mAp50 accuracy of each degradation class by YOCNN1 on Dataset\_831.

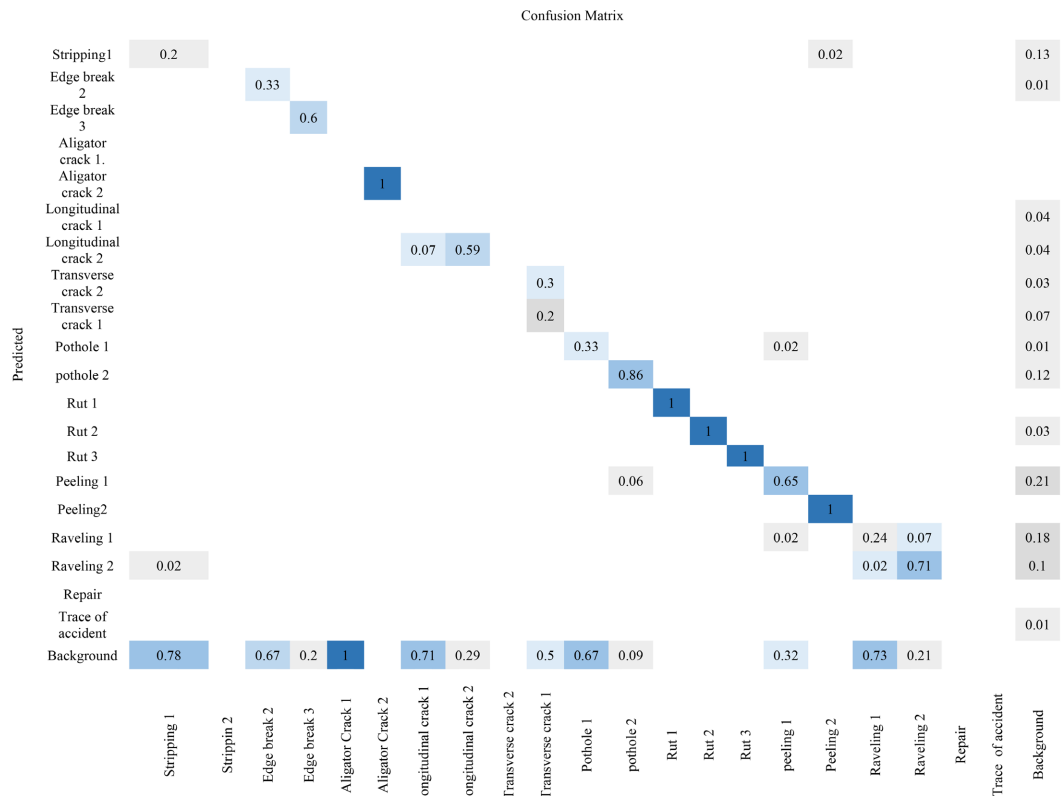
**Figure 6.** YOLOv9 confusion matrix on Dataset\_831.

This matrix allowed us to understand that the model makes more false predictions at the level of degradation, presenting a low performance, and makes several background errors. These background errors are related to the predictions that the model makes at the level of the background of our images, where we left unannotated degradations.

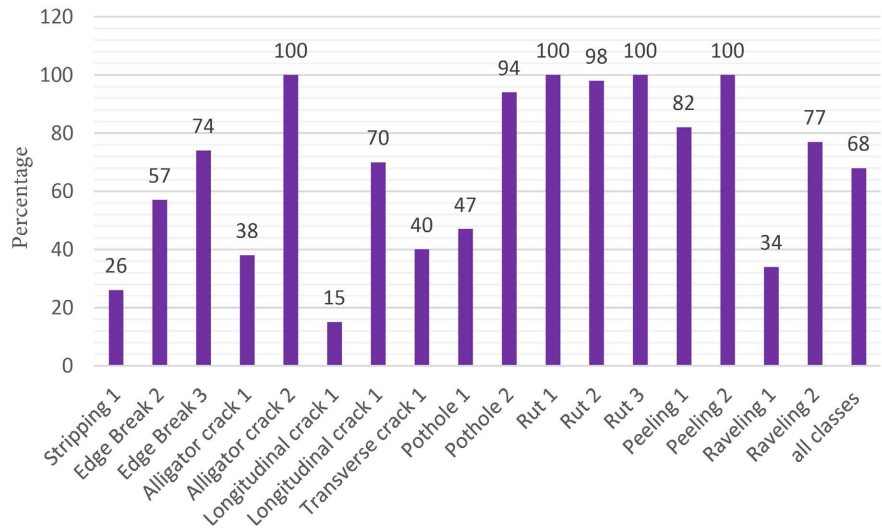
Figure 7. mAP50 accuracy of each degradation class by ROCNN1 on Dataset\_831.

This model shows a 13.9% performance improvement in accuracy compared to the YOCNN1 model. This proves it's slightly more interesting learning and it's good identification of certain degradation classes in **Figure 7**.

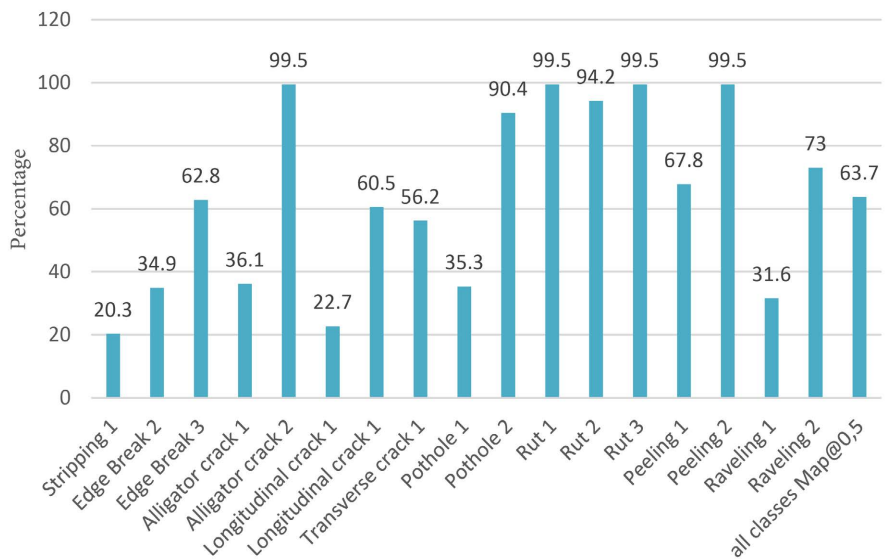
Figure 8. mAp50 accuracy with Dataset\_831 converted to Grayscale.

With the conversion to grayscale, we observe a 4% increase in P accuracy as well as a performance improvement in some degradation classes such as transverse crack 1, stripping 1, alligator crack 1, pothole 2, and raveling 1.

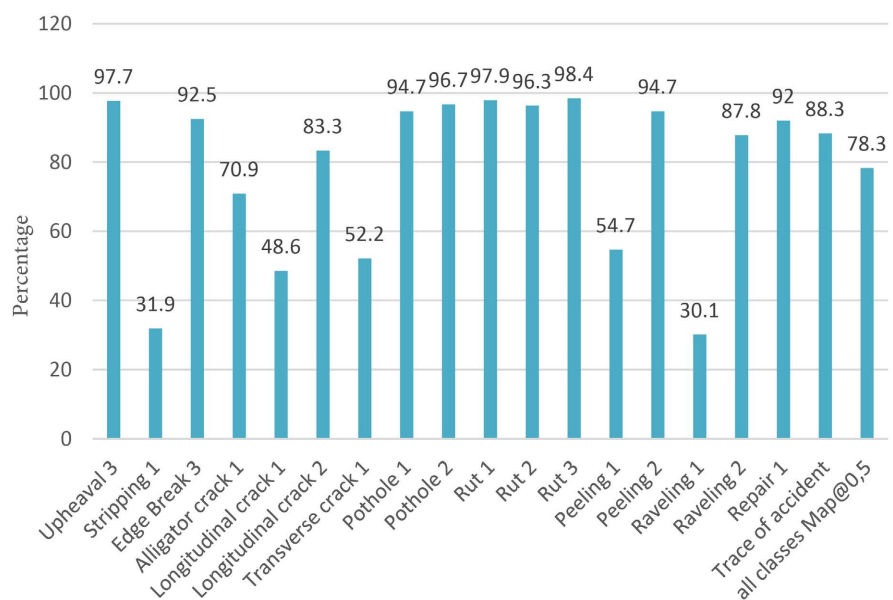
**Figure 9.** mAp50 accuracy of each degradation class by YOCNN2 on Dataset\_3720.

There is a slight improvement in performance across the different classes, but it is not as significant as expected. The confusion matrix is as follows in **Figure 10**.

The performance at each degradation class level is observed in **Figure 9**.

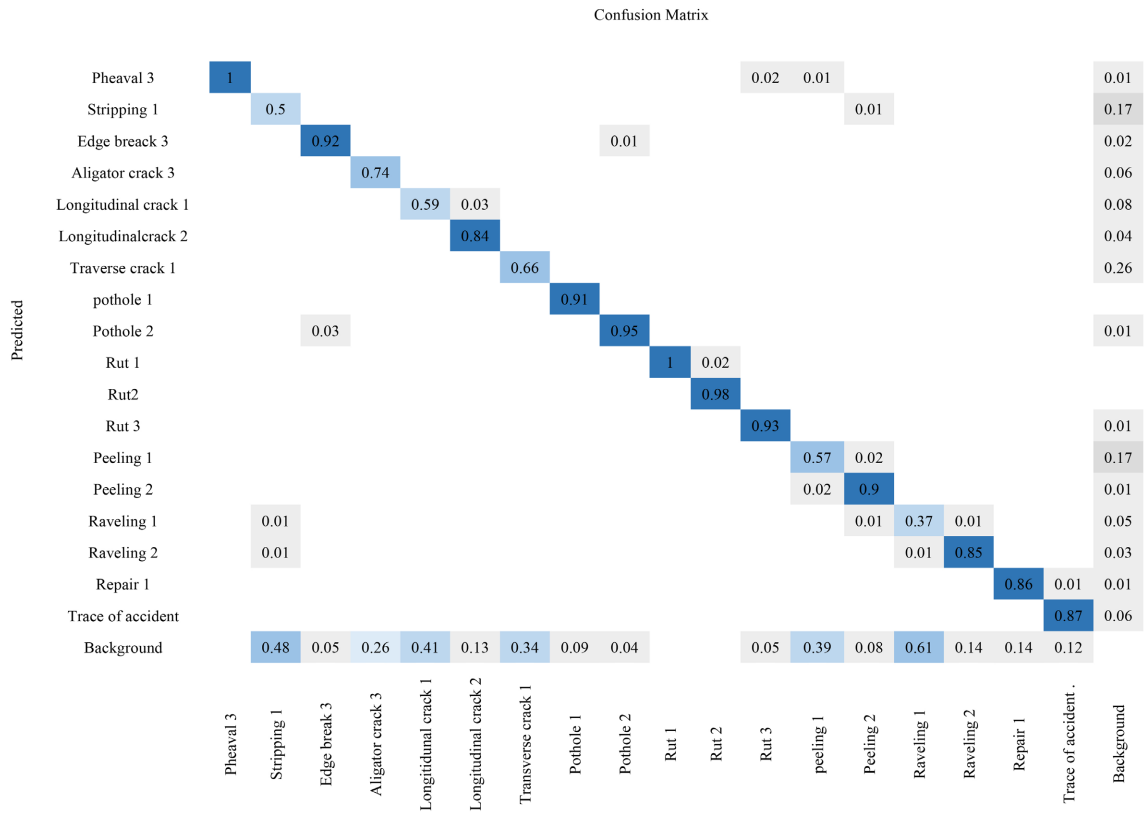
Figure 10. YOLOv9 confusion matrix on Dataset\_3720.

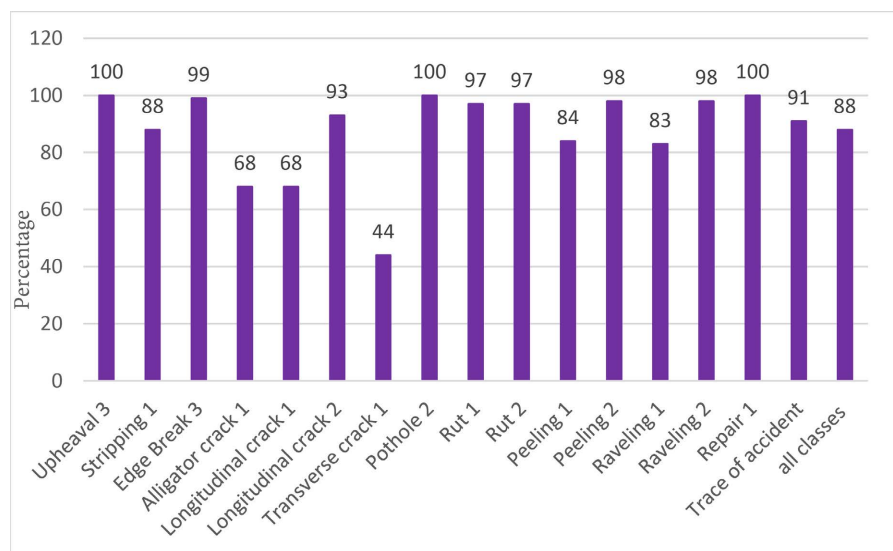
Figure 11. mAP50 accuracy of each degradation class by ROCNN2 on Dataset\_3720.

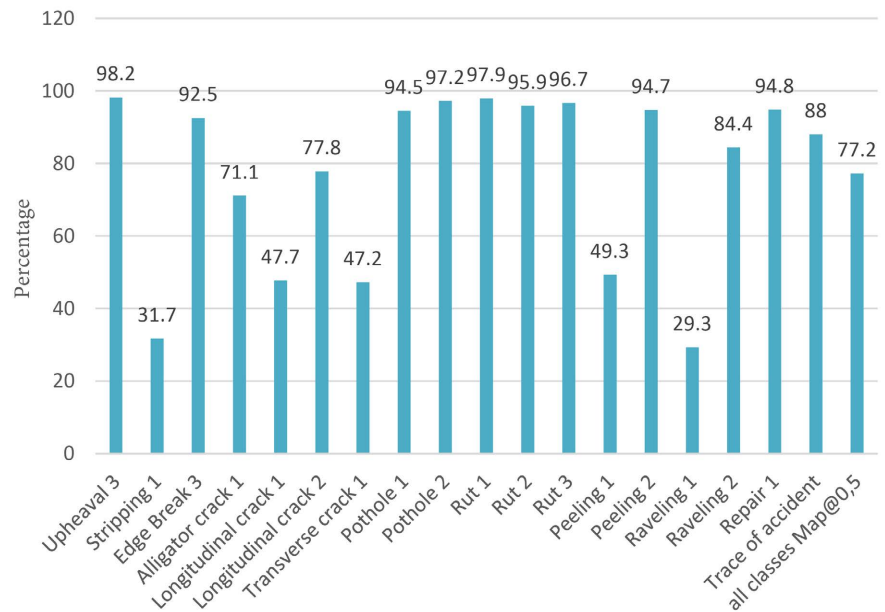
**Figure 12.** mAp50 accuracy with Dataset\_3720 converted to Grayscale.

A 2% improvement in overall accuracy is seen with this grayscale conversion. This translates into slight performance improvements across the various degradation classes.

The performance at each degradation class level is observed in **Figure 12**.

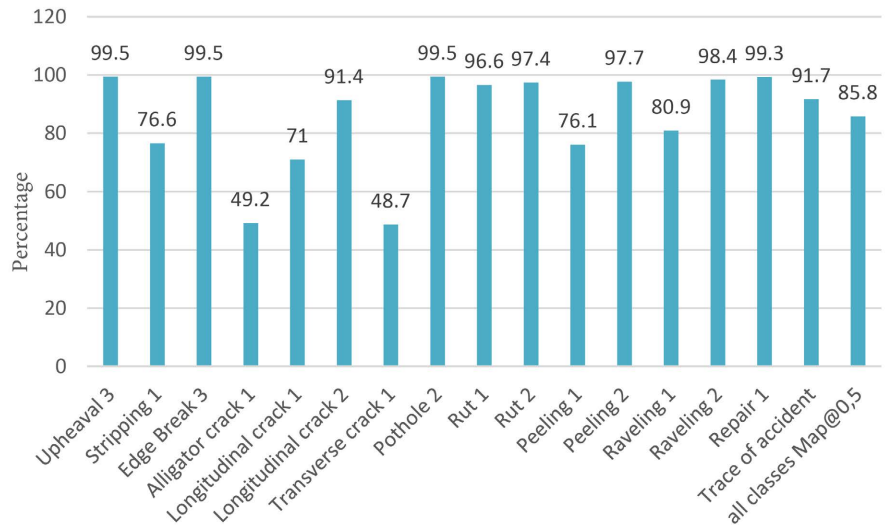
This model consistently shows better performance on deformations and averages on other classes, reducing the overall performance to a mAp accuracy of 83.2%. The confusion matrix resulting from model training is shown in **Figure 14**.

Figure 13. mAp50 accuracy of each degradation class by YOCNN3 on Dataset\_4770.

The performance at each degradation class level is observed in **Figure 13**.

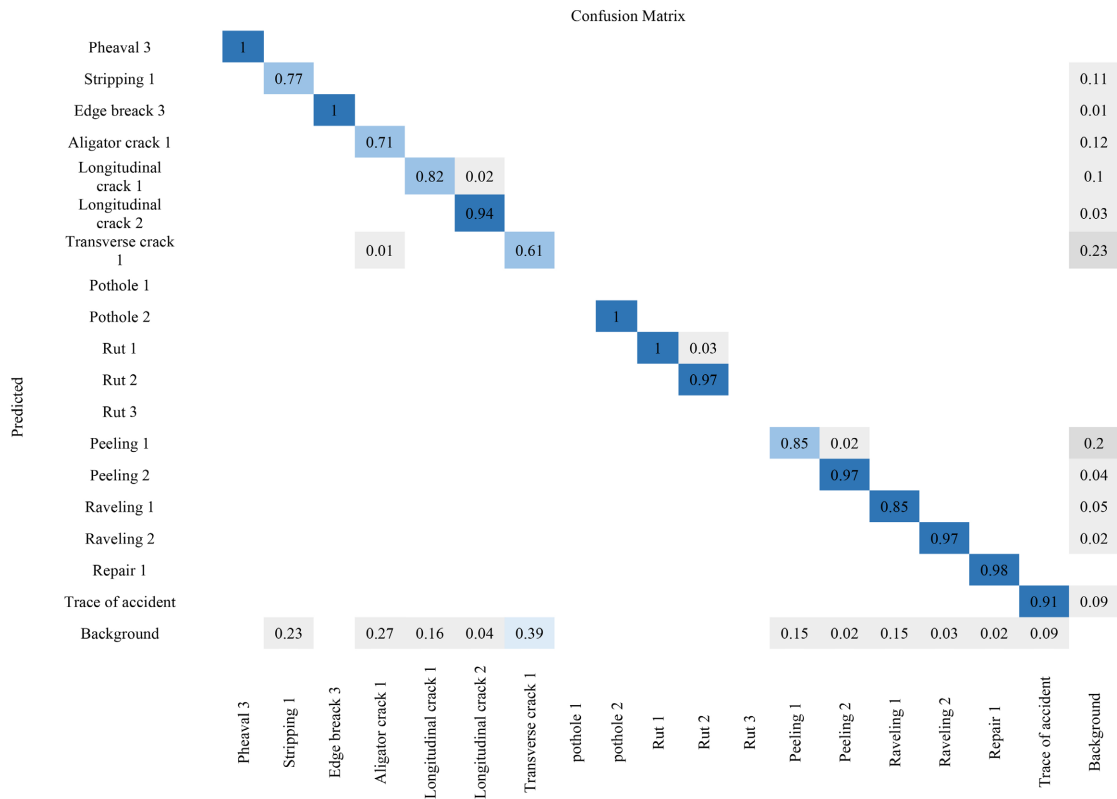
Figure 14. mAp50 YOLOv9 confusion matrix on Dataset\_4770.

The matrix shown in Figure 14 concerns the model’s ability to identify degradations with fewer false predictions. Similarly, background errors have decreased, but not enough to help us achieve our goal.

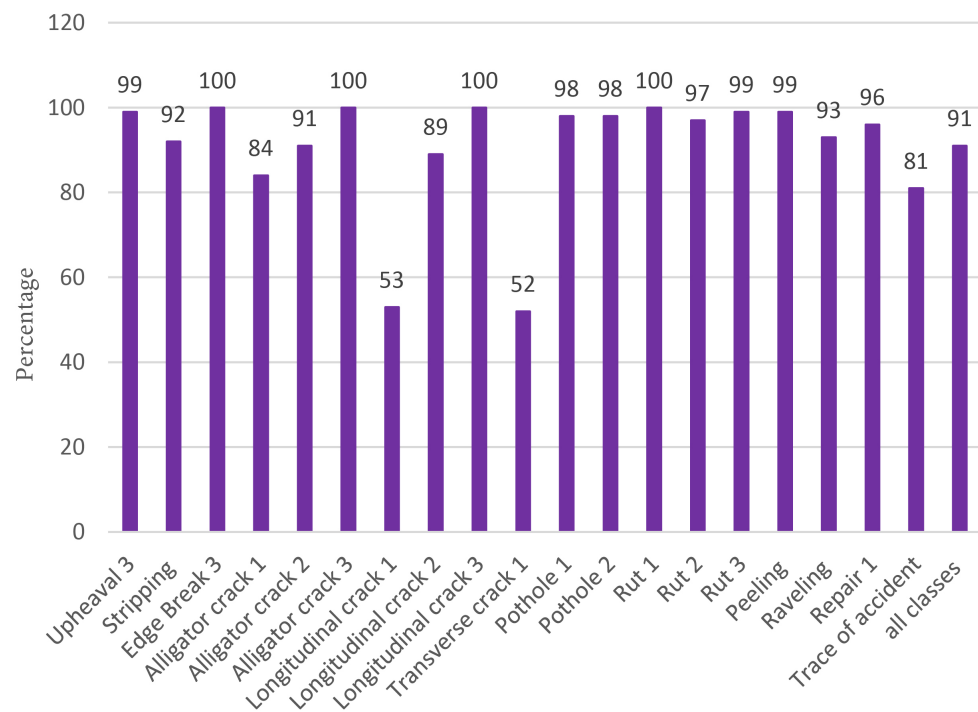
The different detection performances of each degradation class can be seen in **Figure 15**. **Figure 15** shows better learning of the model, which allows it to reach 90% at the mAP level. All deformations and tears present very good performances. Alligator cracks and cracks are also well identified by the model, except for longitudinal cracks 1 and transverse cracks 1, at which the model remains average. The confusion matrix resulting from model training is shown in **Figure 16**.

**Figure 15.** mAP50 accuracy of each degradation class by ROCNN3 on Dataset\_4770.

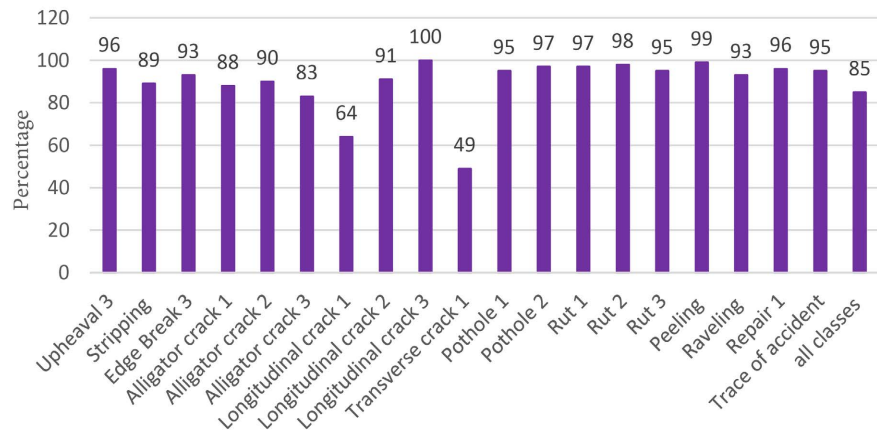
This new database converted to grayscale increases the recall R by more than 4%, but the precision P and the mAP decrease. This explains the oscillation observed within the different classes, where some show an improvement and others a decrease. However, all the metrics are better compared to those obtained during the training of Dataset\_4770 with YOLOv9.

Figure 17. mAP50 accuracy with Dataset\_4770 converted to Grayscale.

The performances obtained at the level of each degradation class can be seen in Figure 17.

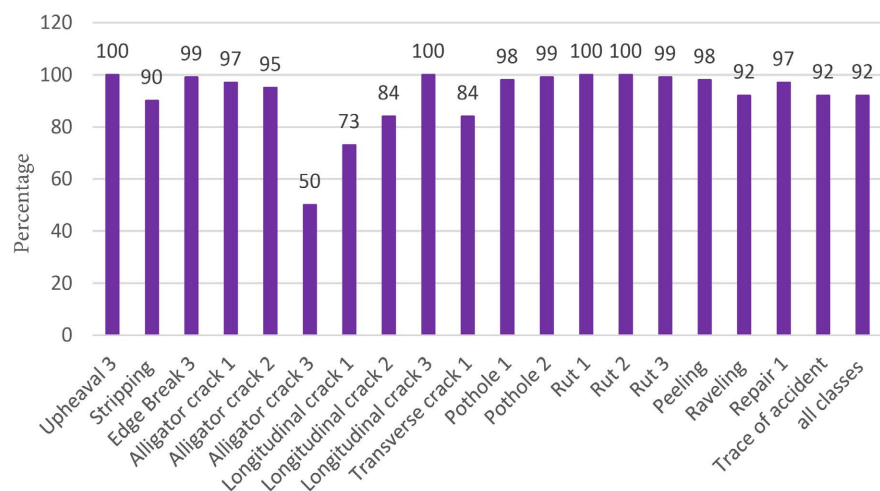
Figure 18. mAP50 accuracy of each degradation class by ROCNN4 on Dataset\_4770A.

Except for alligator crack 3, this model learned to recognize each of the degradations very well, which allows it to have an overall accuracy stabilized above 90% during training. The confusion matrix resulting from this training is as follows in

Details of the training and the different performances of the degradation classes can be seen in Figure 18.

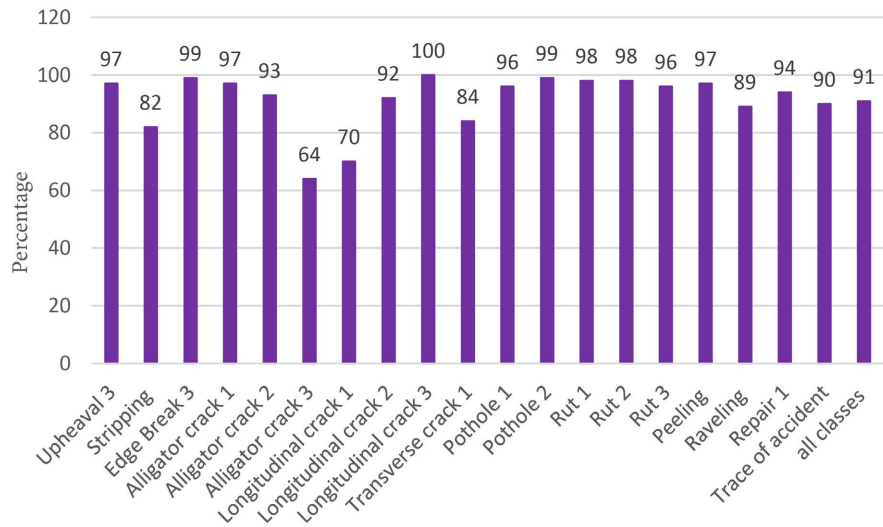
**Figure 19.** mAp50 accuracy with Dataset\_4770A converted to Grayscale.

This matrix shows the model’s ability to make correct predictions while minimizing errors across all classes.

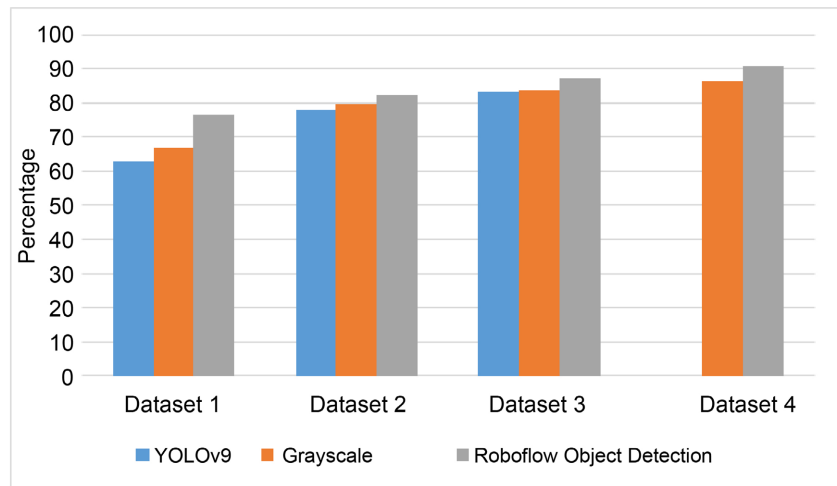
**Figure 21** shows the performance of the four datasets after training. It is noted that accuracy grows with the number of images used for training. After the conversion to grayscale (performed in the PyCharm IDE), which offers superior performance to that of YOLOv9 trained with images coming directly from the collections, the Roboflow 3.0 Object Detection model is the one that demonstrates the best accuracy with its training on the unconverted Dataset\_4770A.

Figure 21. Comparison of model accuracy on the four datasets.
