# Resilience of Building Structures in Mining Communities in Ghana

Geotechnical and Materials Engineering Division, CSIR-Building and Road Research Institute, Kumasi, Ghana

Ground vibrations produced by mine blasting negatively impact nearby structures. In Ghana, there have been allegations of blast induced ground vibrations resulting in building cracking in communities around mining pits. A pre-mining building condition survey was undertaken in selected mining communities in Ghana, a total number of 1904 buildings were surveyed in five mining areas. The results show majority of the building are not engineered and the thickness of the foundations are less than 450 mm. The age distribution of the building is between 1 and 100 years. Sandcrete blocks are the main wall cladding with a percentage of 60%, landcrete wall cladding are about 24%, cement rendered landcrete blocks are 11% and wood cladding are 5%. The commonest defects identified with structures includes the crocodile skin crack, surface cracks, horizontal cracks, vertical cracks, through cracks and diagonal cracks, and spalling-off of the mortar from the walls due to improper bonding. The study showed that, most of the st

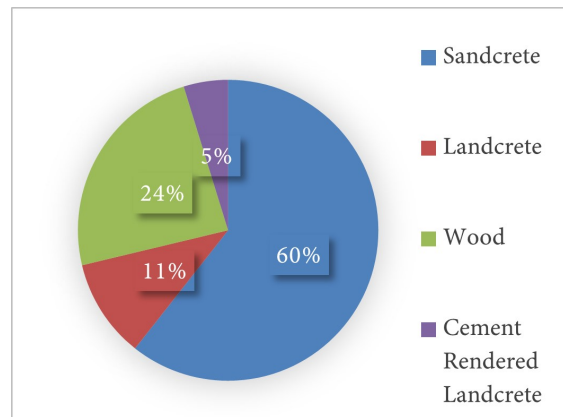
**Figure 2.** Distribution of wall fabrics in the communities.

Most of the buildings were residential, engineered with proper foundations and some are also non-engineered without proper foundations to support the structure. **Figure 1** shows the distribution of wall fabrics in the communities, the dominant wall fabrics are the sandcrete blocks. The most used materials for wall plastering are cement/sand mortar; some landcrete structures were not plastered exposing the buildings to erosions on the walls and the foundation level. Predominant roofing type was the corrugated iron sheets and a few thatch roofs located in the remote areas. The doors and window are made of wood, glass and metal. **Table 2** and **Figure 2** show the age distribution of wall fabrics in the communities.

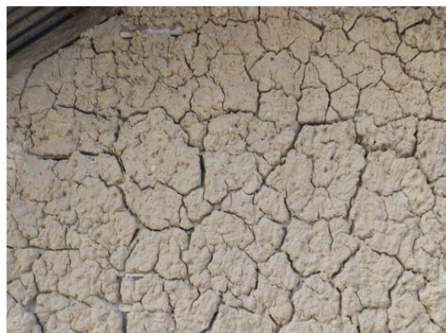
Major building material used in its construction is the earth material. The commonest defects identified are the crocodile skin crack. These cracks usually originate from the shrinkage of clay in the earth material. The floors were made of rammed earth which had resulted in very deep cracks on the building floors. Through cracks can be located on both the interior and exterior surface of the walls; it cut through the walls to the other side. There were also vertical, horizontal, diagonal cracks on the building walls. The foundations of these buildings have been eroded by rain. A typical landcrete structure with associated defects is shown in **Figure 3**.

**Figure 3.** Crocodile skin cracks on landcrete wall.

Soils used for landcrete construction has high clay content. Since clay is an expansive soil, seasonal variation in the moisture content causes expansions of the materials thereby inducing cracks in the building. Wattle and daub wall constructions, when not covered externally by earth/cement mortar plaster have been shown eroded by driving rain. Combination of building materials used in the construction are susceptible to chemical reactions. The combination of cement and Atakpame can result in a reaction between sulphate from the earth material and cement. Cracks develop at the joint between cement and the earth material.

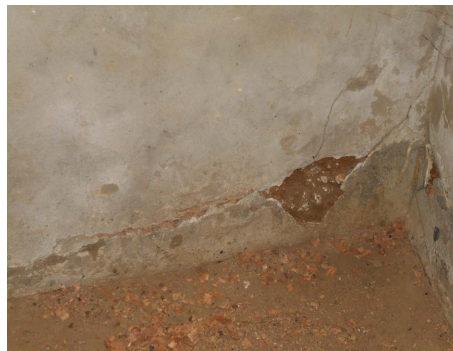
These buildings types have been constructed with earth material and are similar to the landcrete building but the walls have been rendered with cement mortar. Defects associated with these types of buildings spalling-off of the mortar from the walls due to improper bonding between them and different water absorption rates (Figure 4). Tiny hair line cracks were observed on the rendered surface. Vertical and diagonal surface cracks exist in the mortar plaster on the adobe and wattle and daub walls. The cracks originate from the corners of doors/window frames and propagate either downwards towards the ground or upwards towards the support of rafters on the walls. Horizontal cracks are identified at the edges of the door frames. Figure 5 shows vertical through on a cement rendered landcrete wall.

Figure 4. Spalling-off on cement rendered landcrete wall.

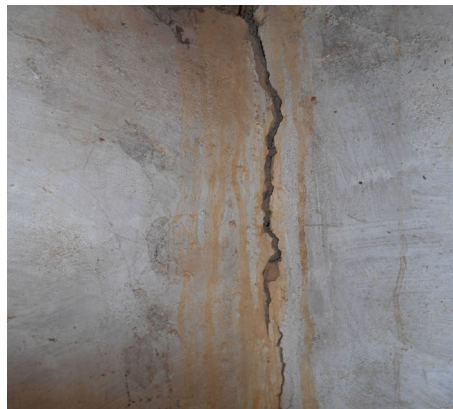
Figure 5. Vertical through crack on cement rendered landcrete wall.

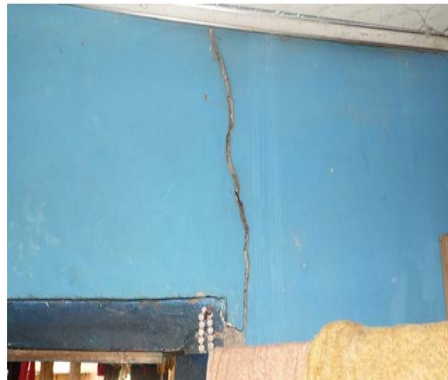
Defects associated with these structures include all the major cracks: surface cracks, horizontal cracks, vertical cracks, through cracks and diagonal cracks. Older buildings (>10 years) were predominant with vertical through cracks from the door frames to the gable level. Surface cracks which were mostly located at the

plinth level of the structure appeared to have been caused by persistent movement of rain water around the foundation and the rise of water table resulting in the wetting of the walls by capillary action of the walling material. Defects on the new structures were few and in most cases no defects were identified. **Figure 6 & Figure 7** are typical defects found on sandcrete structures.

**Figure 6.** Vertical crack from lintel to door frame.

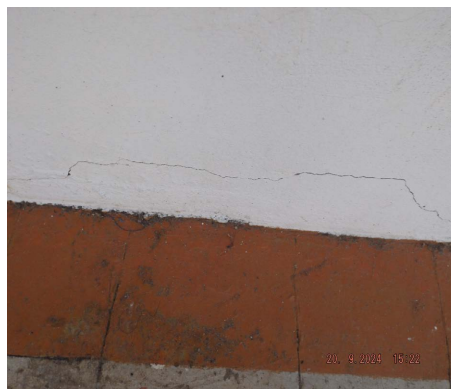
**Figure 7.** Horizontal crack emanating from a door frame.

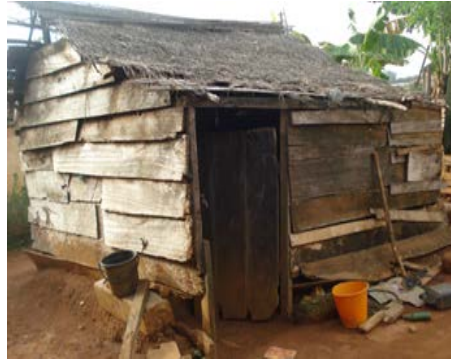
These are structures constructed with wooden material, mini shops, local restaurants (chop bars), bathrooms, toilets are the main structures constructed with wooden materials in the community. The only defects associated with these structures were the deterioration of the wooden structure due to environmental factors and termite infestation. Where the floors of the structures were made with cement/sand mortar, cracks exist. **Figure 8** illustrates a typical deteriorated wooden structure.

**Figure 8.** Deteriorated wooden structure.
