# Research of Landslide Areas Developed in the Influence Zone of the Right Slope of the Zhinvali Reservoir to Determine Their Dynamics for the Purpose of Traffic Safety

The article presents the results of field, office and laboratory research of landslide areas developed on the right slope of the Zhinvali Reservoir section of the Georgian Military Road, according to which the area of spread of these events, the dynamics of development, the threats arising from them in terms of restricting traffic, and a plan for developing landslide prevention measures are recorded. The underlying rocks of the slopes have been studied, cross-sections have been created, their types and physical and mechanical characteristics have been determined, and the natural and anthropogenic (technogenic) factors that contribute to the origin and development of the aforementioned phenomena have been identified. Based on the results of the study, it can be said that landslide areas developed along the transportation lane are mostly associated with erosion processes developing in small ravines, where the rocks forming the slope are highly eroded and disintegrated. Unregulated surface water runoff has a great imp

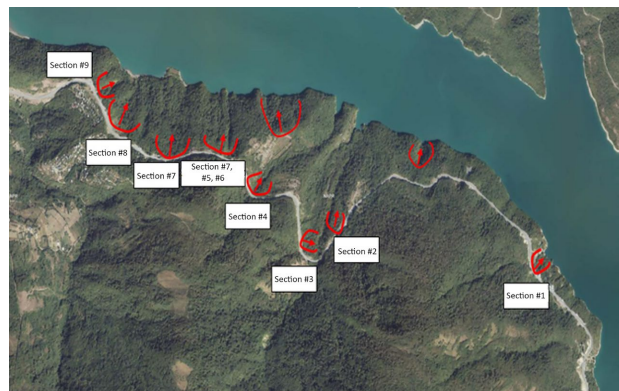
**Figure 3.** Landslide areas on the right slope of the Zhinvali Reservoir.

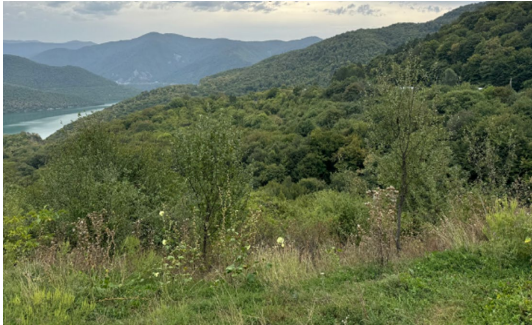
**Figure 4.** General view of landslide site #4.

Area #4 is developed in the bed of an eroded ravine and includes both of its slopes, the tongue of which reaches the banks of the reservoir, shown in Figures 3-8.

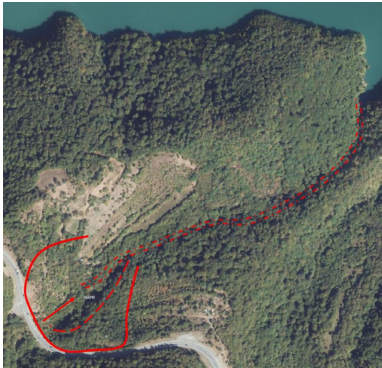
**Figure 5.** Top view of landslide #4.

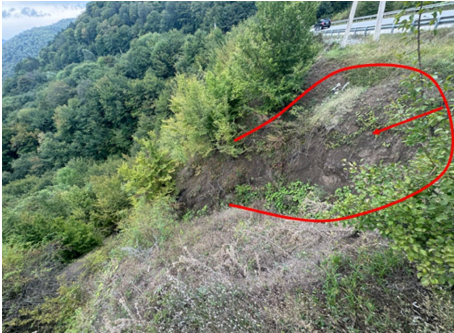
**Figure 6.** Main rupture of the landslide (#4).

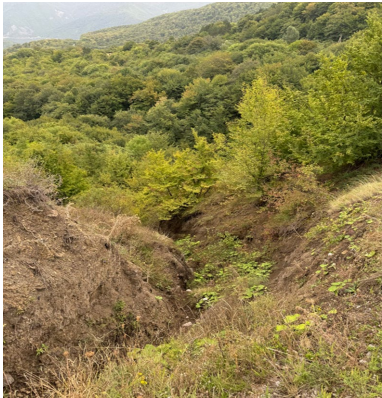
**Figure 7.** Erosion on landslide body #4.

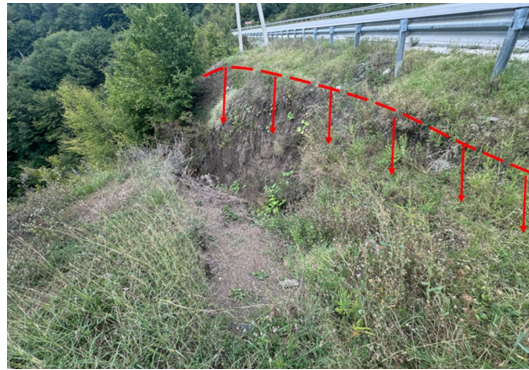
**Figure 8.** The main rupture stage of the landslide body, which is close to the roadway.

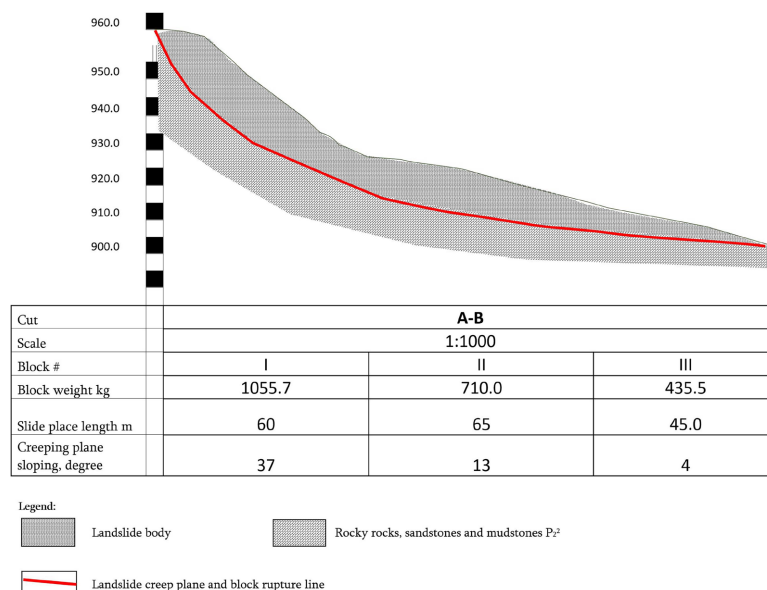
**Figure 9.** Geological section of landslide body #4.

In this regard, samples of the undisturbed structure of the cover rocks were taken. Their physical properties were determined. Their mechanical characteristics were selected based on normative documents. Based on the existing topographic maps and field survey drawings, the estimated landslide creep plane was determined and a schematic section was constructed, on which the slope stability characteristic K coefficient was calculated (Figure 9, Table 1), considering various natural factors (seismic events and rock moisture) (Lomtadze, 1977; Lapiashvili, 2013; Abbaspour et al., 2018; Zhang et al., 2022). Below are the results of the calculations.

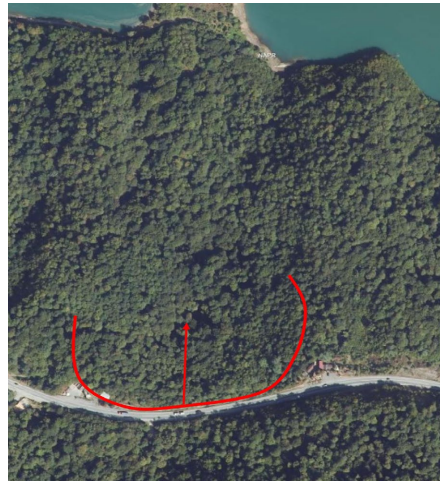
**Figure 10.** Geological section of landslide body #4.

Similar studies were conducted at landslide site #7, shown in **Figures 10-15** and **Table 2**.

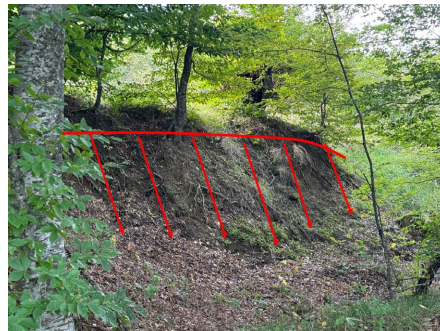
**Figure 11.** Fragment of the main landslide cutoff.

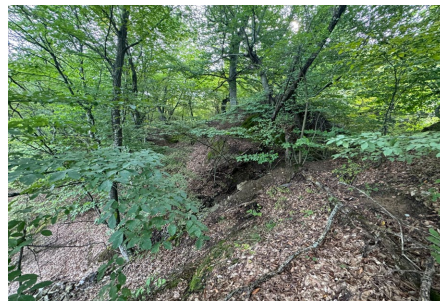
**Figure 12.** Creeping blocks observed in the landslide area.

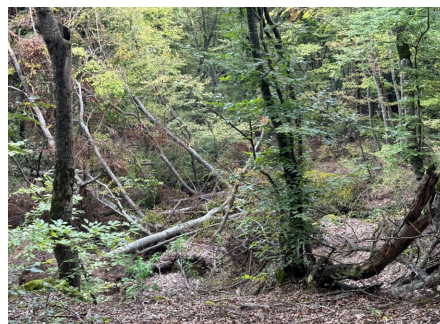
**Figure 13.** Landslide area, “Drunken Forest”.

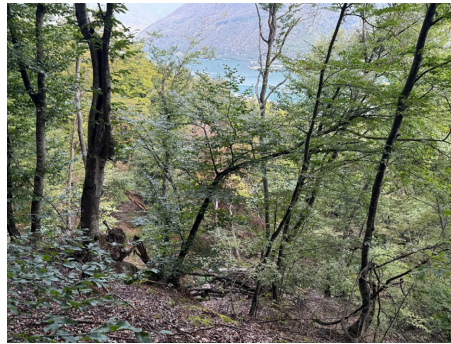
Figure 14. Blocky-stepped relief typical of the landslide area.

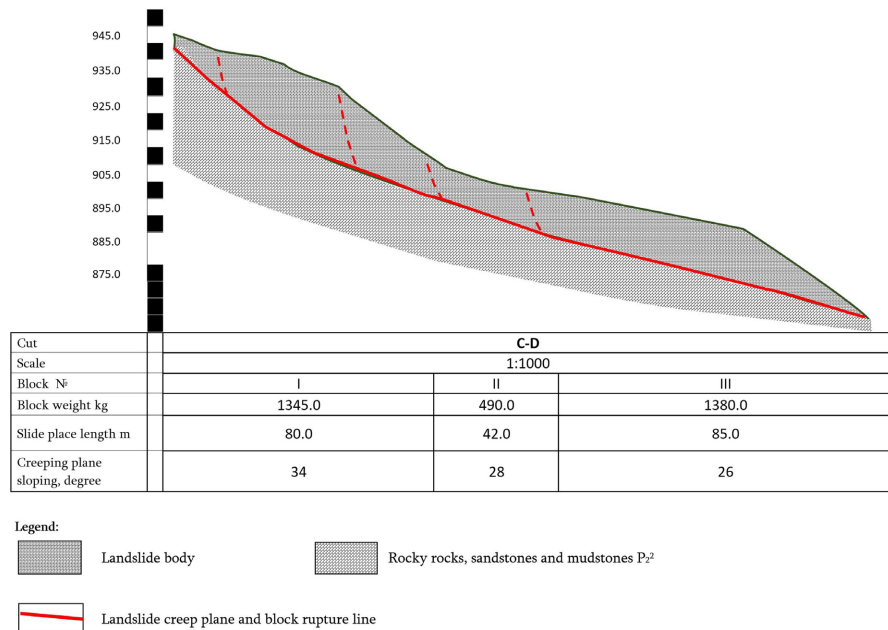
Figure 15. Geological section of landslide body #7.
