Riverbank Erosional Features in the Stanley Pool of the Congo River and Some Geotechnical Classifications of the Sands

Abstract

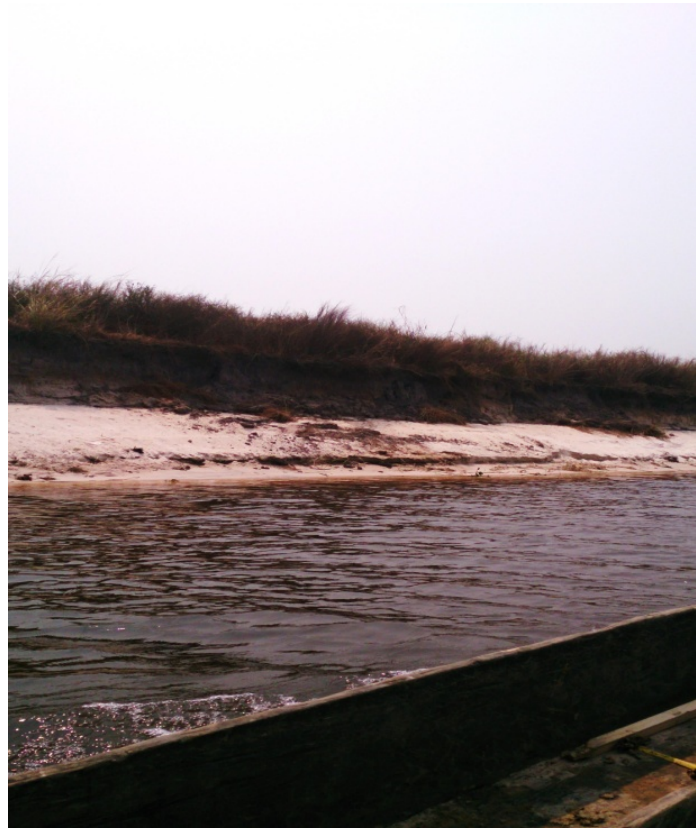
Figure 2. Sand deposit on a clay soil at the riverbank.

The sedimentation of suspended matter encountered on the channel (Organic matter in general) in large quantities and over hundreds of meters is undoubtedly due to the water erosion of the riverbanks and this prevents good navigation, although this is accentuated by the low water level of the river (**Figure 2**).

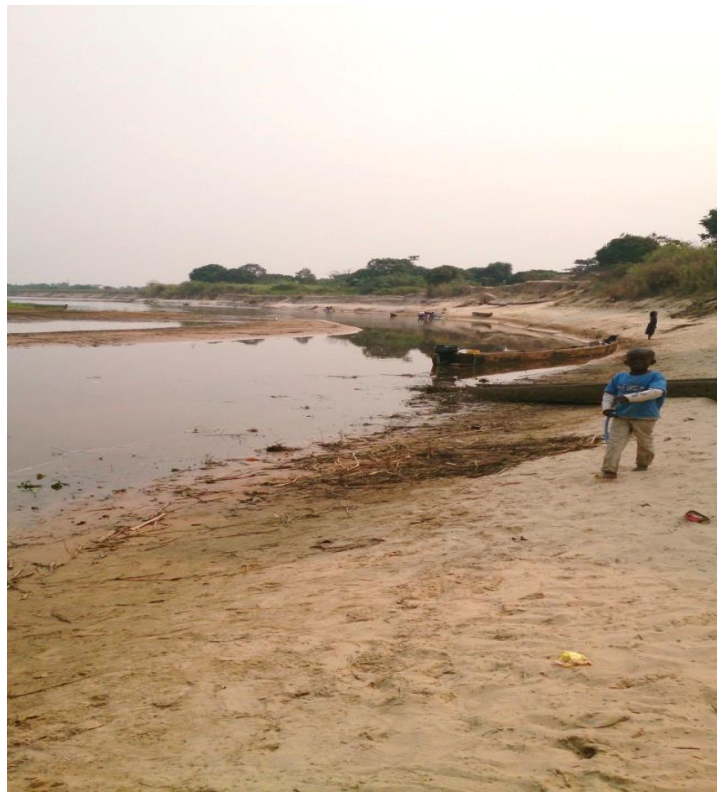
Figure 3. Golf courses caused by erosion on silt ground.

The golf phenomena observed on the shorelines of the shores sufficiently shows that this was also due to the water erosions of the riverbanks (**Figure 3**).

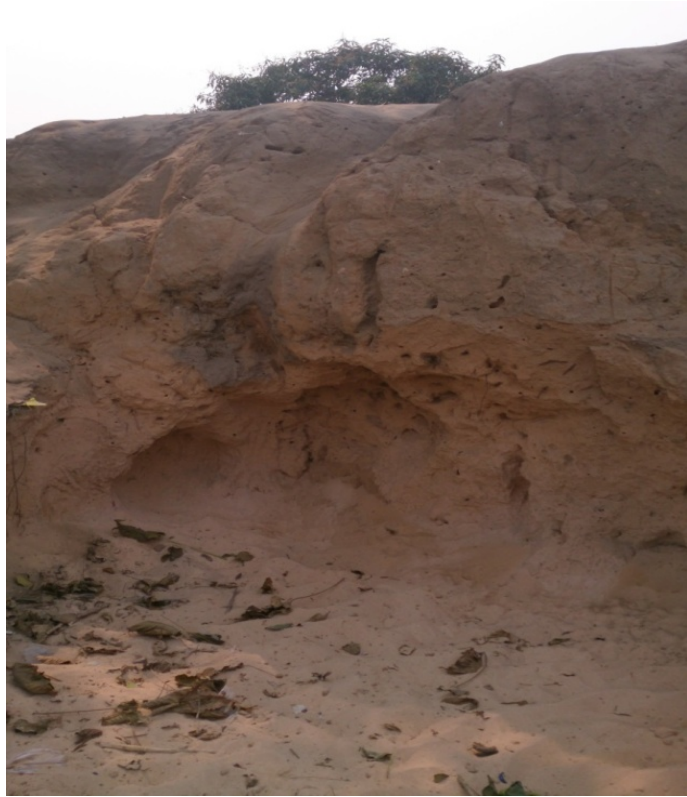
Figure 4. Escapement at the foot of the riverbank in a clay soil.

The undermining caused by the waves and the scouring of the water create crevasses enclosing part of the river bed (**Figure 4** and **Figure 5**). These crevasses will develop many phenomena and hydraulic interactions which will inevitably lead to more accentuated deformations of the riverbanks in the zones of their manifestation.

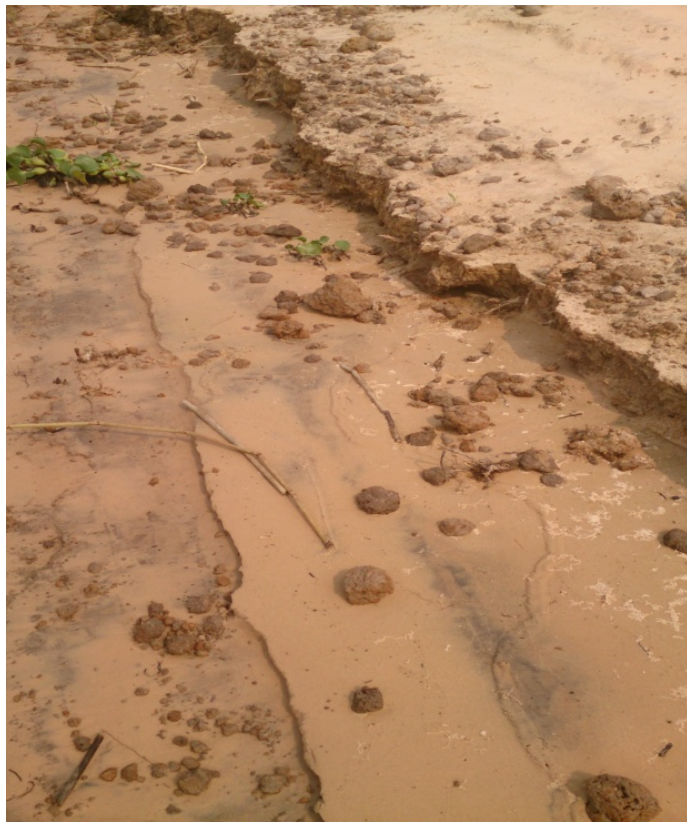
Figure 5. Surface erosion due to wave action.

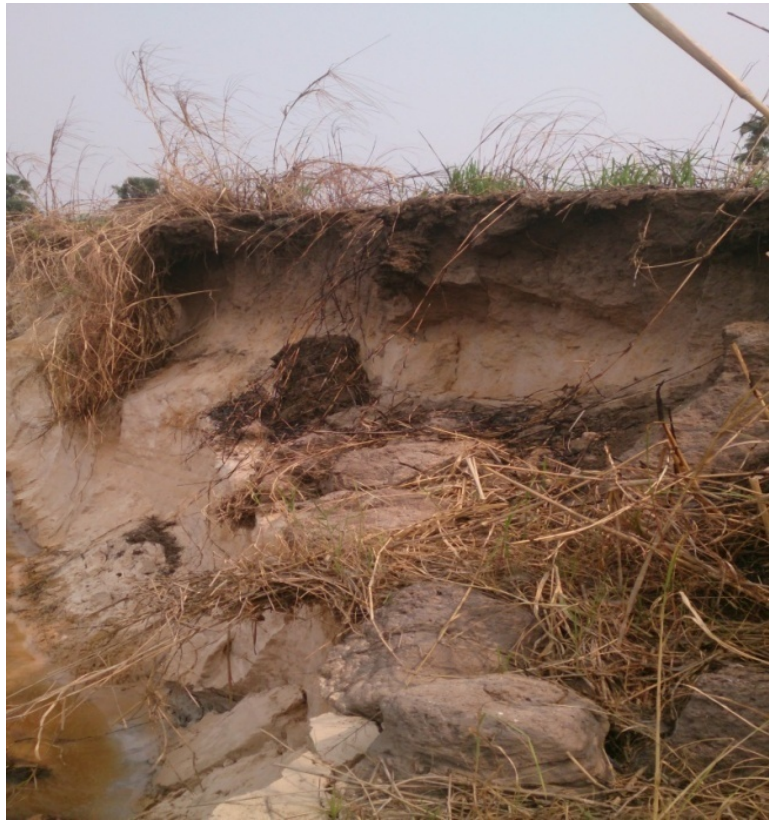
Figure 6. Collapse of sandy riverbanks.

Landslides that occurred at our passage (in December during the rainy season) further confirm that the riverbanks are unstable and therefore subject to potential water erosion (**Figure 6** and **Figure 7**).

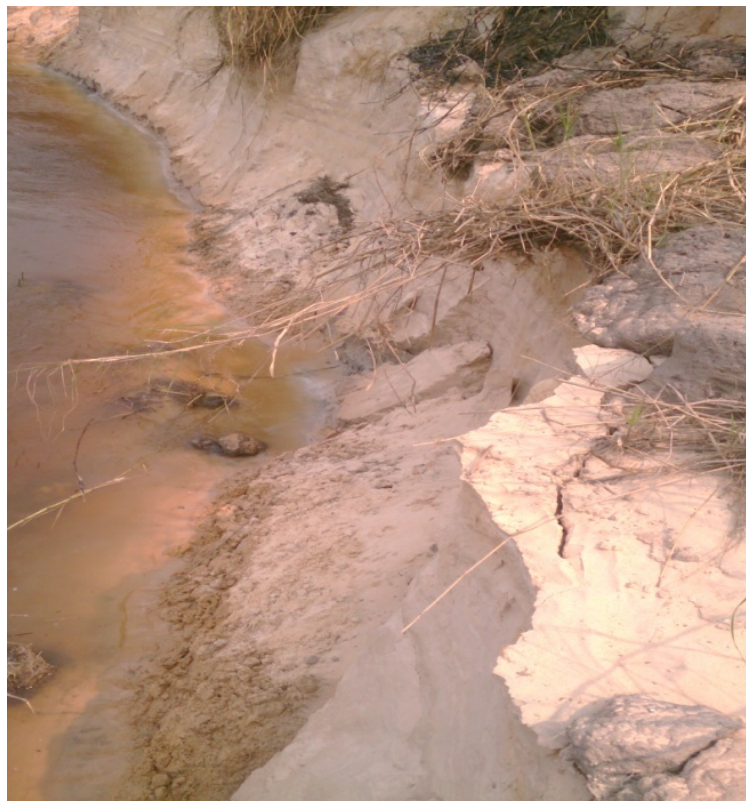
Figure 7. Landslide of sandy riverbanks.

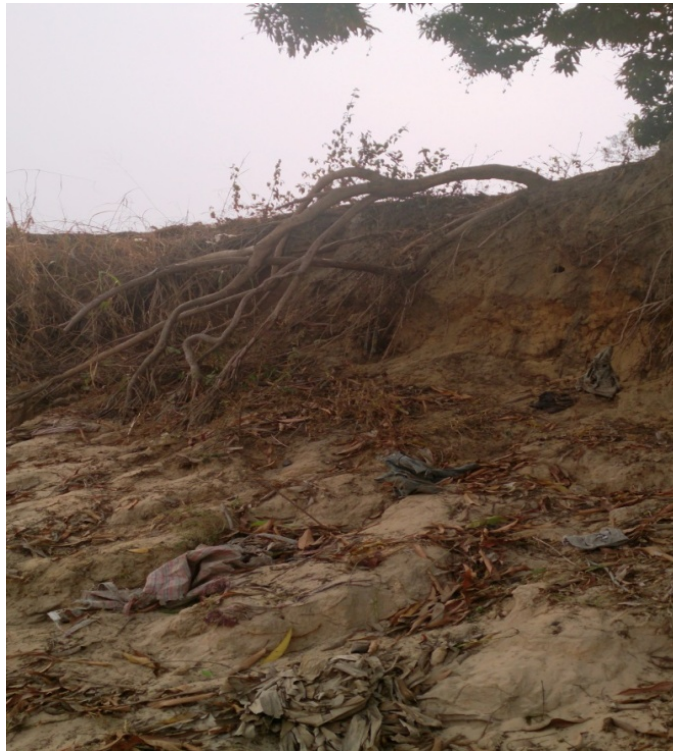
Figure 8. Sliding and scouring on silty soil.

The uprooting of vegetation observed in certain places sufficiently shows the extent of damage caused by hydraulic and hydrological activity during the peaks at major river beds on the riverbanks (**Figure 8** and **Figure 9**).

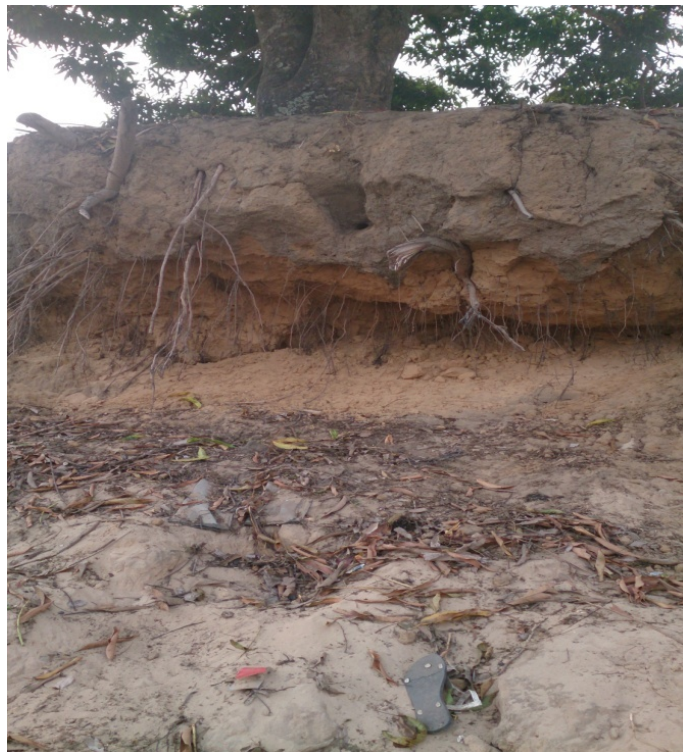
Figure 9. Scouring sequence of riverbanks causing landslides of silty soils.

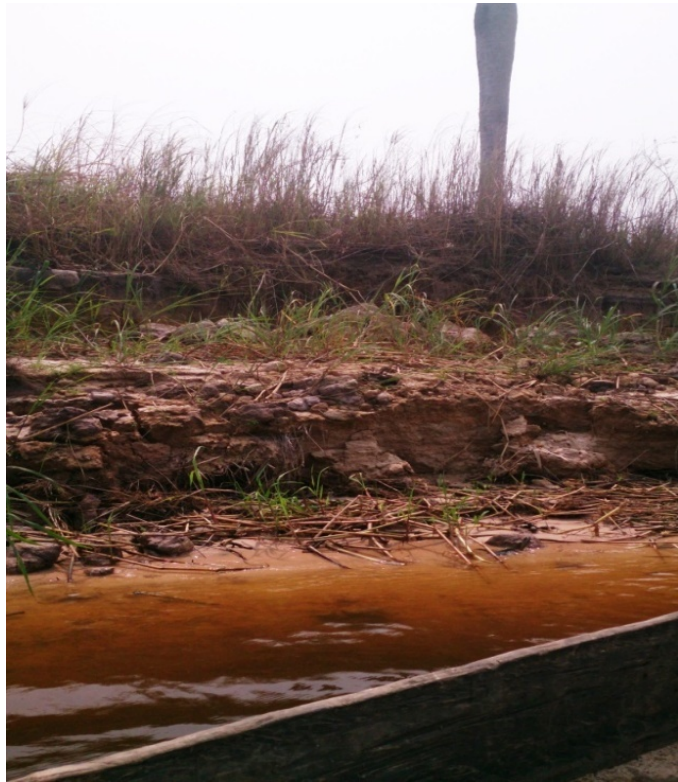
Figure 10. Erosion sequence on clay soil Erosion sequence on clay soil (Black line illustrates the first erosion sequence and the dashed line illustrates the second erosion sequence).

The degradation of the relief observed at certain embankments of the riverbanks (structure of the soil materials not very regular in its transverse stratification)

makes it possible to understand that these riverbanks were subjected to the action of erosive phenomena (**Figure 10** and **Figure 11**).

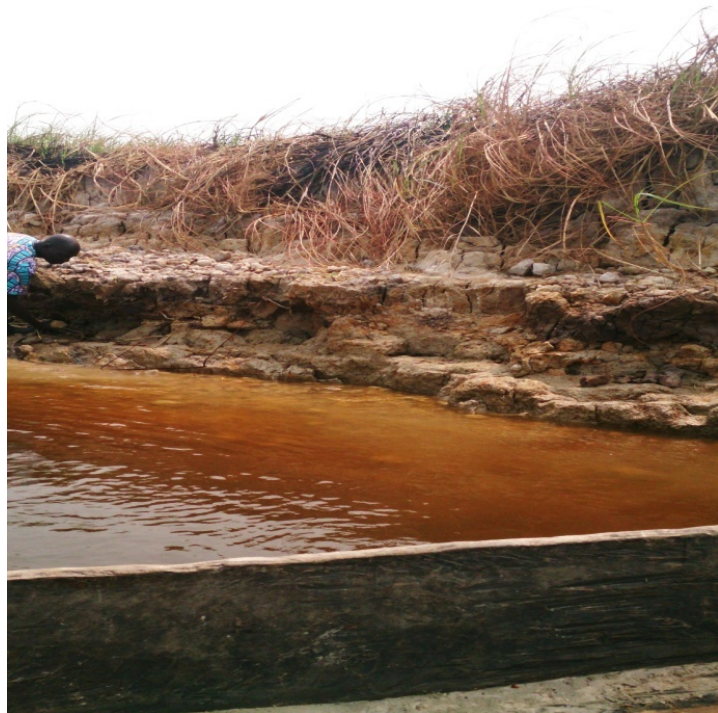
Figure 11. Erosion following desiccation of clayey soil.

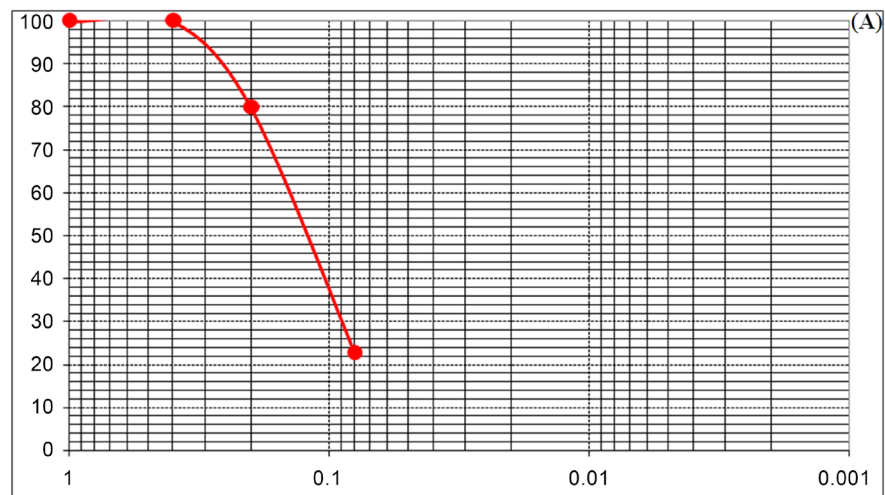
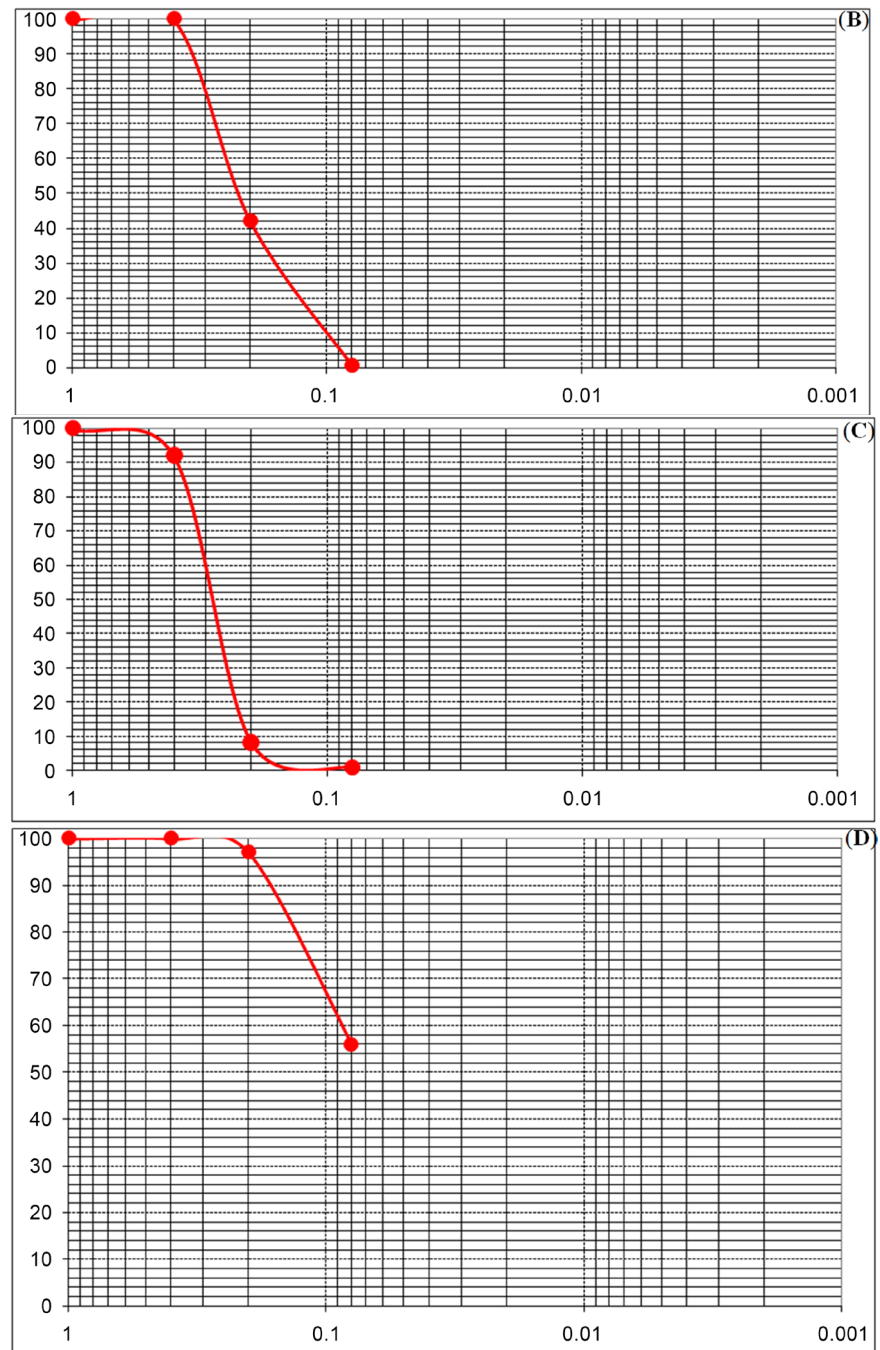
Figure 12. Particle size distribution curves of soil samples from the riverbanks of Stanley Pool Island for: (A) Zone 1 Sample 1; (B) Zone 2 Sample 2; (C) Zone 2 Sample 3 and (D) Zone 3 Sample 4.

The majority of the results obtained in the three critical zones of the Stanley Pool show that the soil materials analyzed are sands with very fine grains because the fineness modulus (MF) is between 0.97 and 1.99; Since “d” the smallest dimension of the aggregates is less than 0.5 mm, these sands will be of class 0/D, i.e. class 0/0.200 to 0/0.5. The D50 values are 0.130 mm, 0.230 mm and 0.280 mm respectively (**Table 1** & **Figure 12**).

The respective particle size curves are shown in the figures below (**Figure 12**).

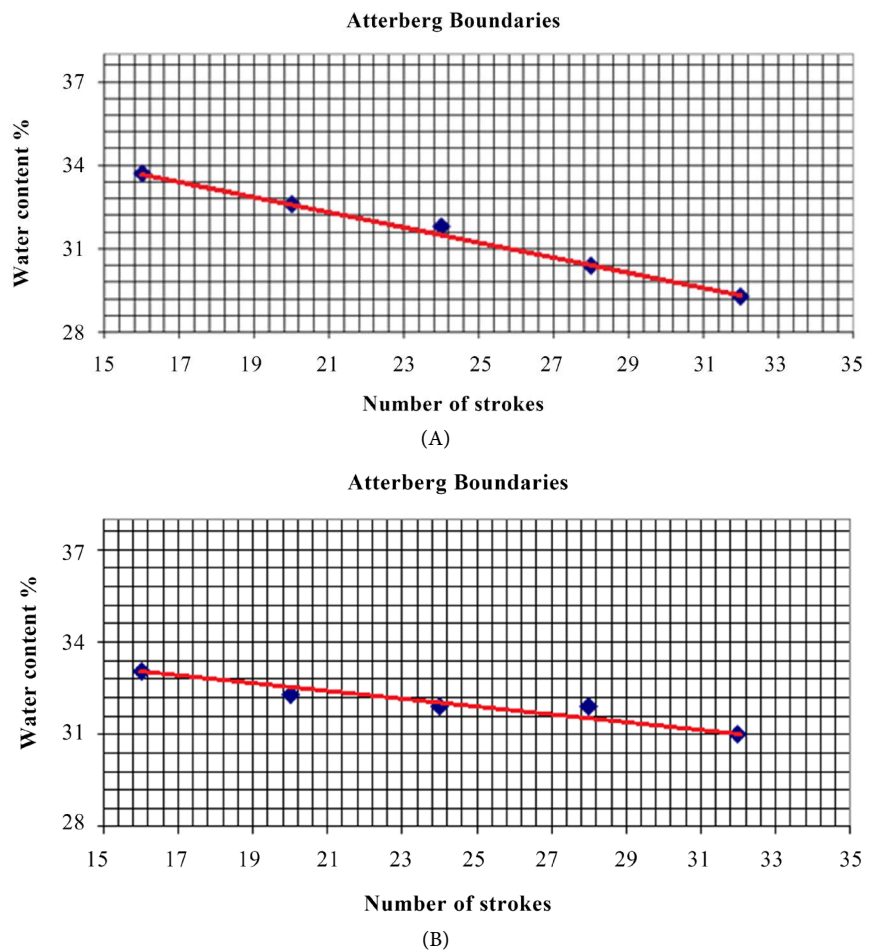
Figure 13. Atterberg Boundaries Curves: (A) Sample 4 and (B) Sample 5 in zone 3.

ilar liquidity limits, the sandy clays in sample 4 (±eroded soils) have much higher plasticity limits than the sandy clays in sample 5 (16.6 and 12.7 percent, respectively) resulting in lower PIs than the other (15 percent versus 19 percent). This is because the Atterberg limits define the water content characteristic of certain changes of state and the liquidity limit corresponds in theory to a water content for which the soil has a cohesion identical to that of the interstitial liquid. In practice, humidity is sought which corresponds to the lowest possible cohesion and for which the furrow traced on the wetland surface is erased after a defined number of tremors (Casagrande apparatus) (Mettauer et al., 1983). To do so, a representation of the landingberg limits was schematized in **Figure 13** for samples 4 and 5, and shows that the correlation coefficient values are clearly strong close to 1.

It can be seen that the materials of these samples are respectively not very plastic and plastic (respectively with an IP of 15% for sample 4 and 19% for sample 5).
