Estimating Heights of Buildings for Construction and Monitoring Changes Using Drone Imagery

Geoffrey Gichuru M'Nkanatha^{1*}, Eunice Nduati¹, Mark Boitt², Mercy Mwaniki¹

How to cite this paper: M'Nkanatha, G.G., Nduati, E., Boitt, M. and Mwaniki, M. (2025) Estimating Heights of Buildings for Construction and Monitoring Changes Using Drone Imagery. *Journal of Building Construction and Planning Research*, 13, 202-217.

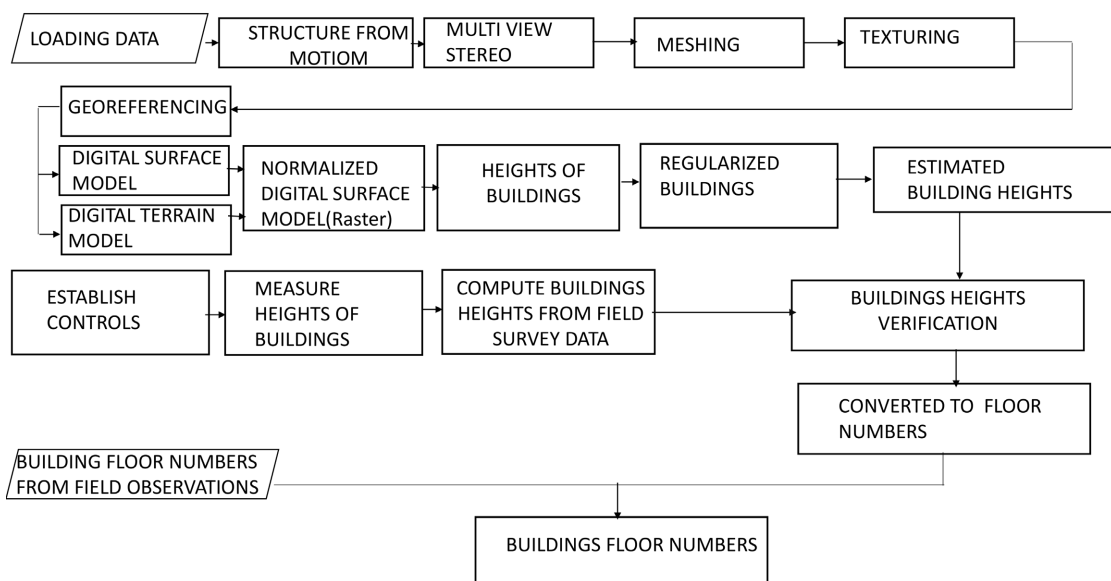
Figure 2. Methodology flow chart.

Figure 2 summarizes the methodological steps followed to estimate building heights and floor numbers. Data was acquired using the DJI Zenmuse L1, an integrated aerial LiDAR solution that combines a LiDAR module, a 1-inch RGB camera, and a high-accuracy IMU for 3D data acquisition and reconstruction, mounted on the DJI Matrice 300 RTK. An application was made to the Kenya Civil Aviation Authority (KCAA) and permission was granted. Weather patterns were observed and found to be conducive. Potential hazards were checked; it was realized that the area had many trees and tall buildings. The problem was solved by locating the operator on the roof of a building to monitor the movement of the drone. The captured data was processed using Open Drone Mapping (ODM) software [7]. Key steps included Structure from Motion (SfM), which applies overlapping photogrammetric techniques to estimate 3D objects from image sequences, followed by Multi-View Stereo, which reconstructs 3D models from multiple overlapping image pairs. Meshing was then performed to connect data points, and texturing added color to the mesh. The data was georeferenced to align the imagery with its actual location on the Earth's surface.

A Digital Surface Model (DSM) was generated by extracting the maximum elevation values from the point cloud, capturing both terrain and structures such as buildings and trees. A Digital Terrain Model (DTM) was derived from points classified as ground. The difference between DSM and DTM produced the Normalized Digital Surface Model (nDSM), which represents all features above ground—such as buildings, trees, and vehicles. To isolate buildings, additional processing was applied. Building floor numbers were estimated by dividing the derived building heights by 3 meters.

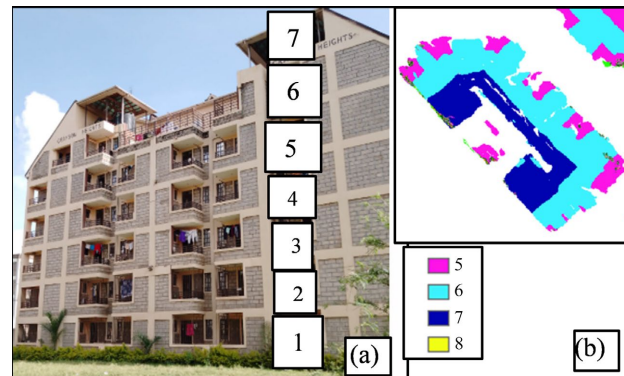
Figure 8. (a) Photo showing building with water tanks provision, (b) floor numbers as captured by drone data representing the building.

Discrepancies in estimated floor numbers were also observed in buildings with elevated water storage structures. For example, **Figure 8(a)** shows a photo of the actual building with six floors, while **Figure 8(b)** presents the drone-derived floor count, which includes the water tank provision as an additional floor resulting in a total of seven floors. In contrast, **Figure 9** demonstrates strong agreement between drone data and field observations. The side view in **Figure 9(a)** and the front view

Additional structural features such as elevated water tanks, roof height provisions, and flat roof side walls exceeding 1.5 meters also contributed to variations in estimated floor numbers (e.g. **Figure 8**). For example, a five-story building with 2.7-meter floor heights would measure 13.5 meters, while the same building with 3-meter floor heights would reach 15 meters. The difference in total height, combined with elevated features above 1.5 meters, aligns with the drone's 3-meter-per-floor estimation logic. Buildings with such elevated features accounted for approximately 5% - 8% of the study area. While this proportion is relatively small, it highlights the potential of discrepancies in computing floor numbers.

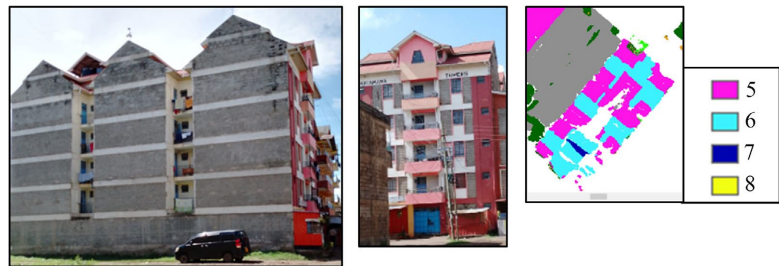
Figure 9. (a) Side view of a sampled Building showing five floors, (b) front of view of the sampled building which is seen to be six floors, (c) estimated floors numbers.

in **Figure 9(b)** both confirm the correct number of floors, as reflected in the drone-based floor count shown in **Figure 9(c)**. Another variation is illustrated in **Figure 10(a)** and **Figure 10(b)**, where the building appears to have an extra floor above the sixth. In the color-coded scheme shown in **Figure 10(c)**, the actual six floors are represented in cyan, while the additional floor is not been captured as a separate level.

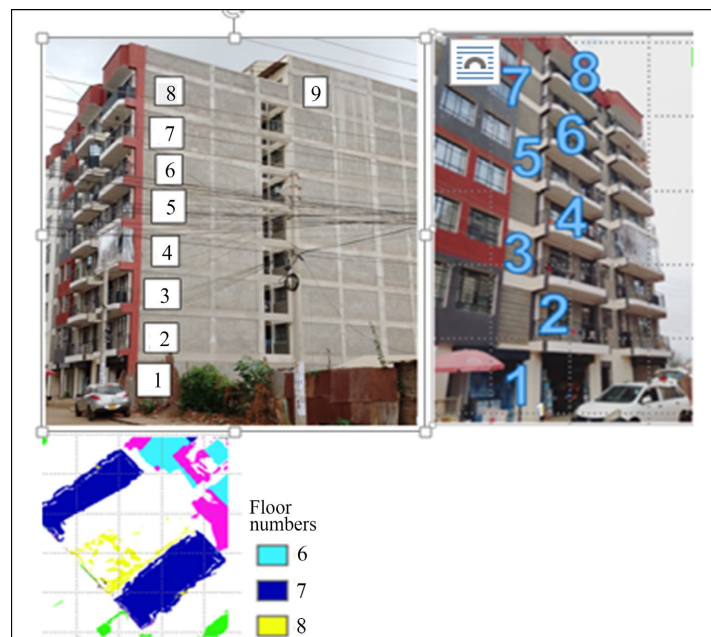
Figure 11. (a) Side view of the building, (b) front view of the building, (c) floor numbers as estimated from the drone data.

Similarly, **Figure 11(a)** shows the side view of a building, while **Figure 11(b)** presents the front view. Although the building has eight actual floors, the drone-estimated data in **Figure 11(c)** identifies only seven floors, represented in blue. A similar discrepancy is observed in **Figure 12**. The building shown in **Figure 12(a)** includes a 1.5-meter wall above the seventh floor, which ideally should have been recognized as an additional floor in the drone data. However, as seen in **Figure 12(c)**, the structure is still represented with seven floors in blue, indicating that the wall height was not captured as a separate level. This oversight results in an underestimation of the total floor count, which should have been eight. **Figure 13** reflects a comparable situation, where a similar wall structure leads to the same undercount in the drone-based floor estimation. **Figure 13(a)** shows seven floors **Figure 13(b)** shows the extended floor zoomed in, from the zoomed it seems to
