# Non-Destructive Detection and Evaluation of Heavy Metal Pollution in Tailings Reservoir

**How to cite this paper:** Qi, Z.H., Hu, J.H. and Zhang, J.W. (2024) Non-Destructive Detection and Evaluation of Heavy Metal Pollution in Tailings Reservoir. *Journal of Environmental Protection*, 15, 921-933. <https://doi.org/10.4236/jep.2024.159053>

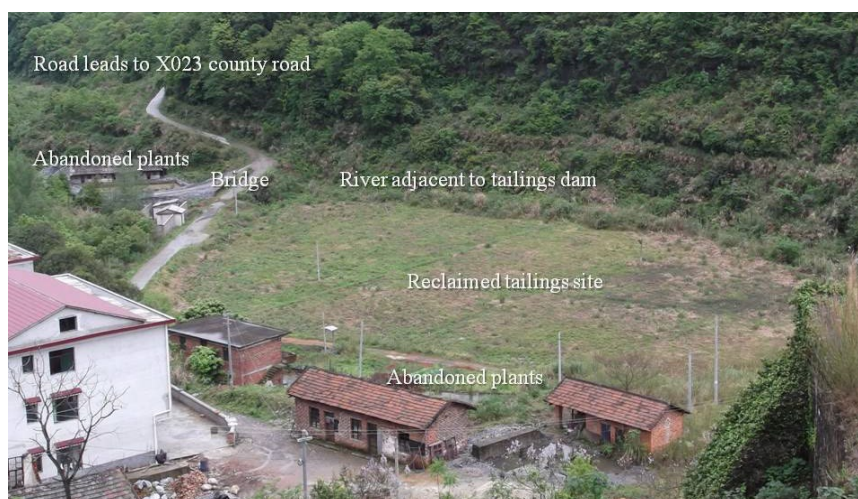
**Figure 1.** Surrounding environment of the tailings site.

An abandoned tailings reservoir was taken as the research object. It is located in Qingjiang town, Zixing County, Hunan Province. It was built in 1980s and closed in 2008. Due to the lack of design documents and standard regulation, parameters of this tailings site were inadequate. Based on site survey, it was found that tailings had been discharged directly on hillside. Tailing dam was constructed with waste rocks. The thickness of accumulated tailings was approximately 3 m. On the east of this tailings site, a path led to X023 county road. A river beneath the feet of tailing dam flowed into Dongjiang Lake. Minimum distance between the tailings dam and Dongjiang Lake was less than 2 kilometers, as shown in **Figure 1**.

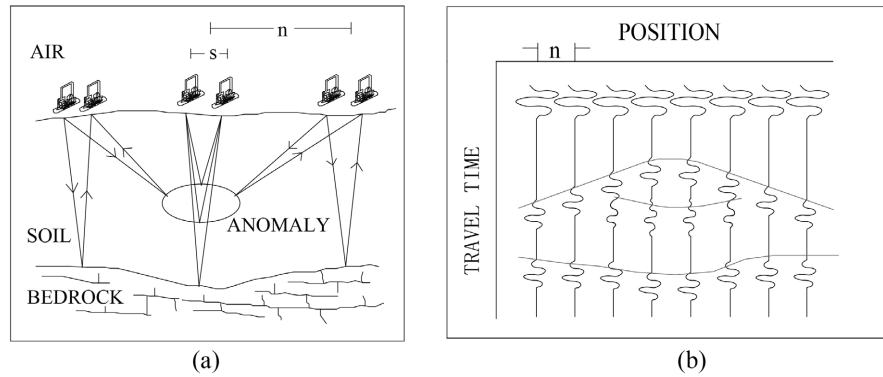
**Figure 2.** (a) Schematic illustration of common-offset single-fold profiling. (b) Format of GPR reflection section with radar events shown for features as depicted in (a).

The most common mode of GPR operation is single-fold, fix-offset reflection profiling as illustrated in **Figure 2(a)**. This mode of operation gives rise to data such as shown conceptually in **Figure 2(b)**.

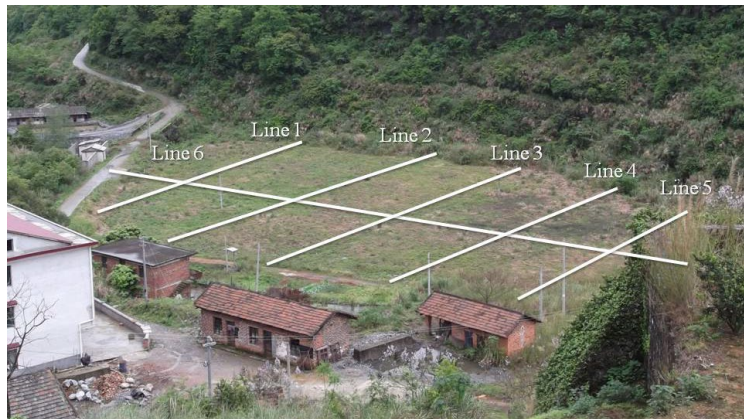
**Figure 3.** Design of GPR detection lines.

Six survey lines were arranged on reclaimed tailings site considering site conditions (**Figure 3**). Five of those lines (from line No. 1 to No.5) were set as X direction, the other one (line No.6) was set as Y direction. Respectively, the length of survey lines from No.1 to No.6 was 85 m, 94 m, 88 m, 66 m, 48 m, and 130 m.

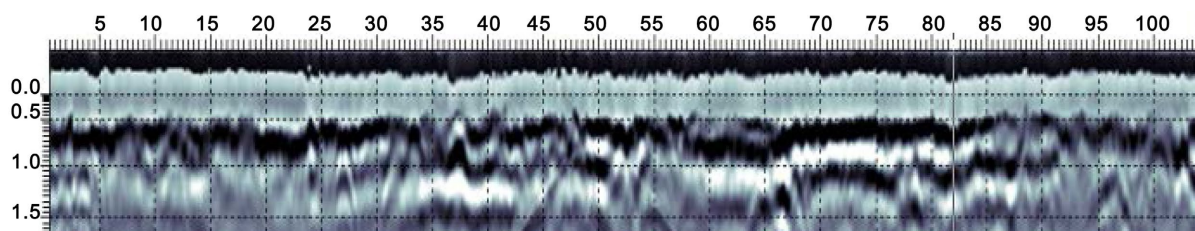
**Figure 4.** Results from surface to 1.7 m depth of survey line 6.

There was quite clear interface between reclaimed soil and tailings layer showed in each survey line's result. There were little changes of thickness in reclaimed soil. Thickness ranged from 0.6 m to 1 m (seen in **Figure 4**).

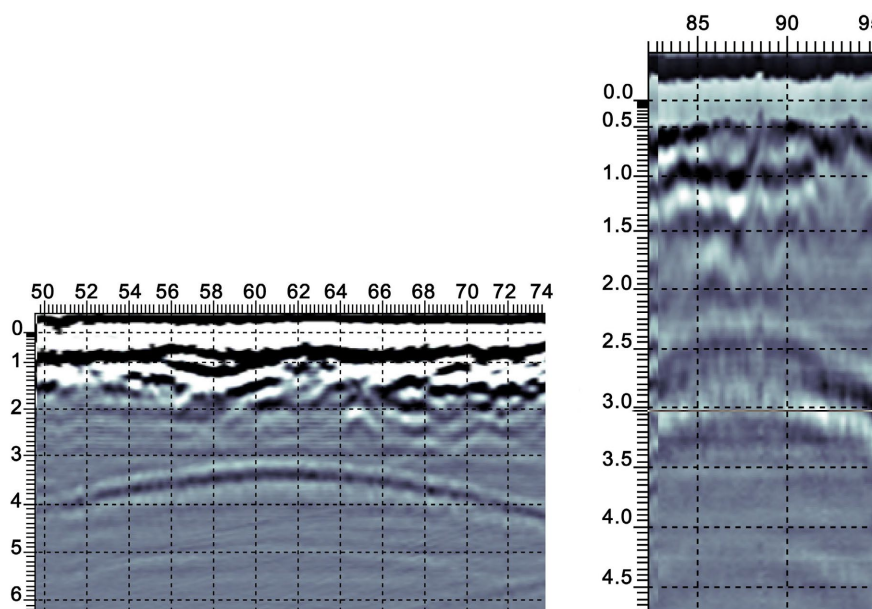
**Figure 5.** Anomaly detected in the intersection of line 1 (above) and line 6 (below) at depth about 3 m.

There was an anomaly detected (shown in **Figure 5**) by radar near the intersection of line 1 (60 - 65 m) and line 6 (85 - 90 m). The anomaly was about 3 meters deep. It was speculated to be a geometrical shape of tubiform based on the form of reflection. It was estimated to be pipe lines installed before.

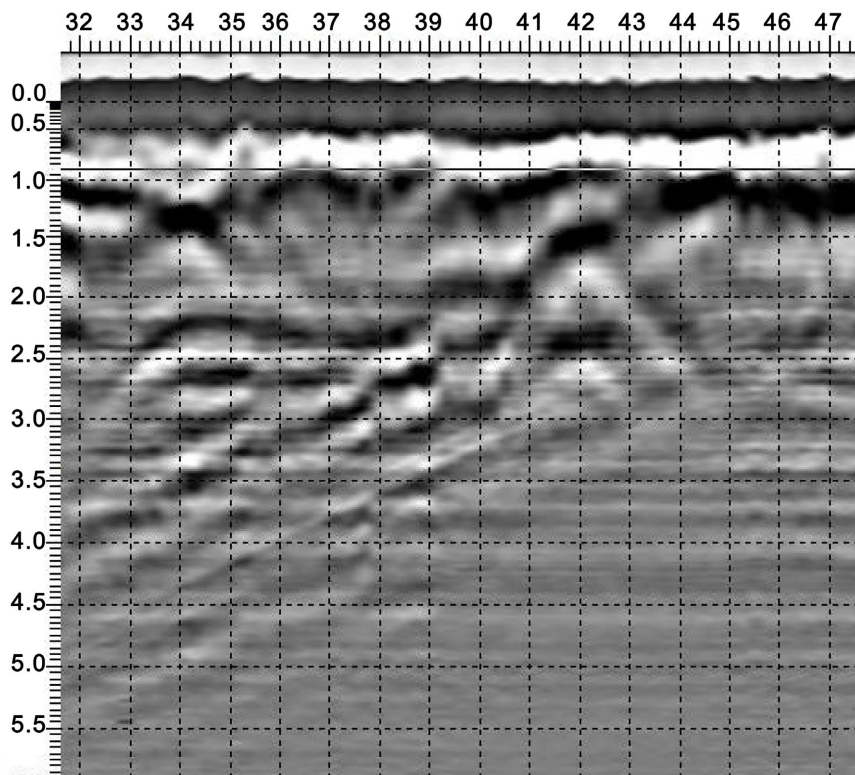
**Figure 6.** Scattered small reflectors and inclined reflection presented in survey line 5.

tailings dam was constructed with backfill materials, they were speculated to be reflection of that structure. such as gravels, bricks and other wastes. Survey line 5 was closest to the filling dam, so it was found of the largest number of that scattered small reflections. As shown in **Figure 5**, there was an inclined reflection presented in survey line 5. It could be caused by the structure of tailings dam as well.

When GPR was working near the wire, it was interfered. Significant signal disturbance appeared in the results of three survey lines. After excluding the interference of wires, there were rarely abnormal reflections received under the depth of 3 m, as shown in **Figure 6**. Therefore, it was concluded that there was rarely interface of two different medium in terms of electromagnetic properties. In other words, it could be speculated that subsoil had been mixed up with tailings. Downward migration of heavy metals occurred in this tailings site.

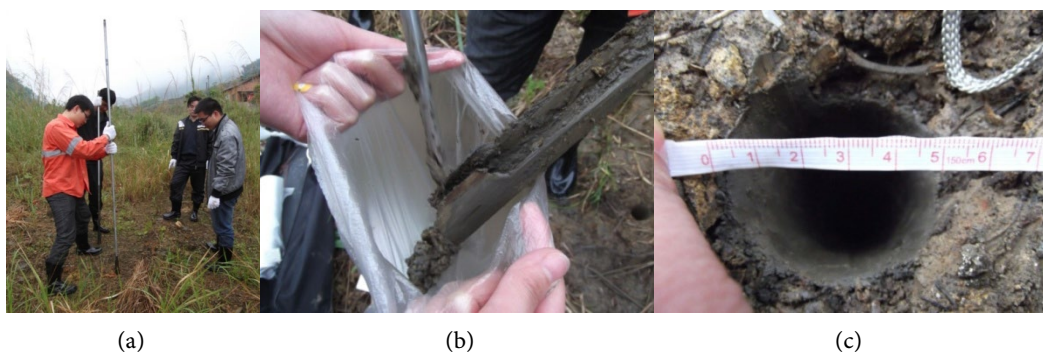
**Figure 7.** Sampling with luoyang shovel (a); sample collection (b); dimension of sampling holes (c).

In order to verify the results of GPR detection, two points along survey lines were selected as the sampling holes (shown in **Figure 7**). Samples were analyzed by X-ray fluorescence method to determine chemical composition. The depths and numbers of each samples were shown in **Table 1**. National standard GB15618-1995 of China was set as reference to determine contamination degree in all

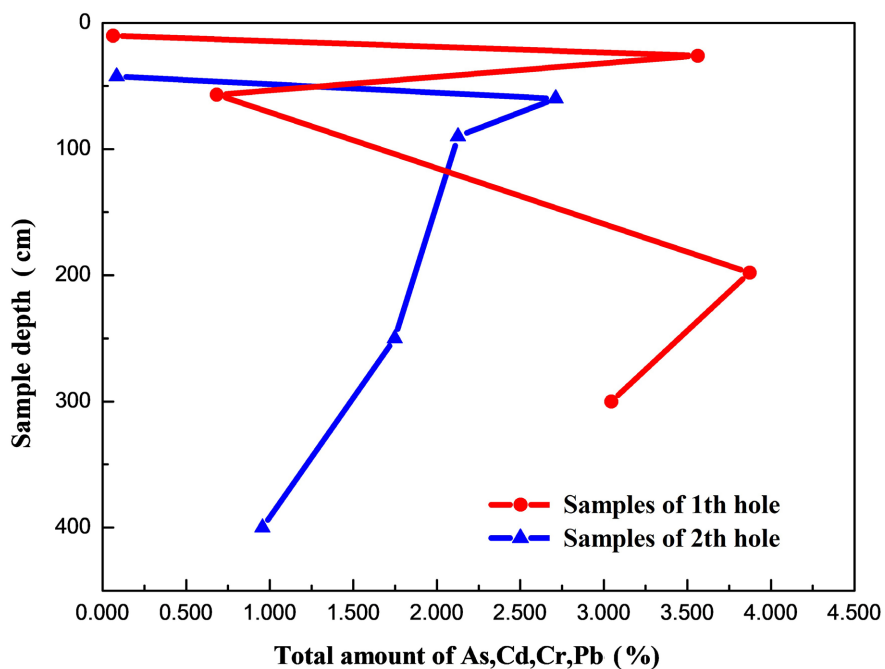
**Figure 8.** Total amount of As, Cd, Cr, Pb vs Sample depth.

1) Total amount: The total amount of the four elements was illustrated in **Figure 8**. It could be found that there were also heavy metals in surface soil, and the concentration were the lowest, but peak value of heavy metals concentration was not found in deepest samples.

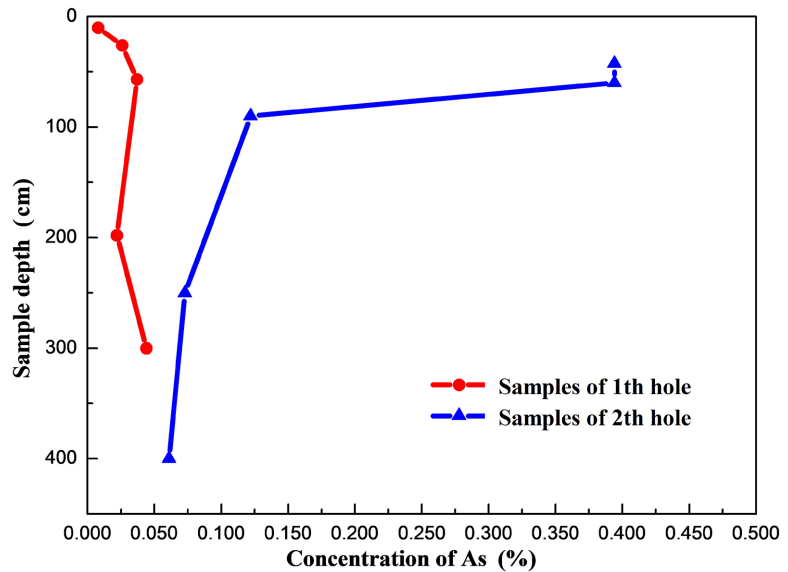
**Figure 9.** Concentration of As vs Sample depth. Critical concentration of As specified in class III national soil quality standard is 0.003% for paddyfield, 0.004% for dryland.

2) As: Arsenic was found in both sampling holes (trivalent arsenic). Concentration of arsenic in all the samples was found exceeded class III soil standard specified in GB15618-1995. The highest concentration of As in samples was 98.5 times limit value of dry land (**Figure 9**).

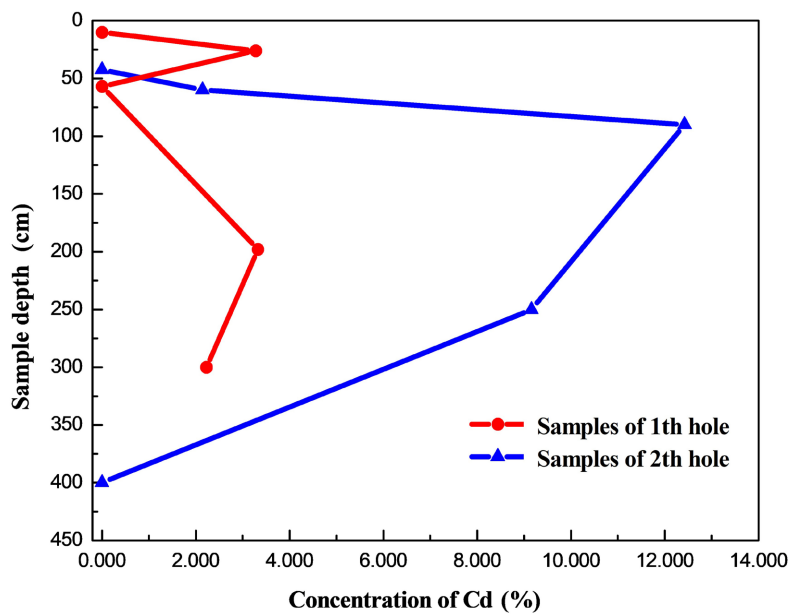
**Figure 10.** Concentration of Cd vs Sample depth. Critical concentration of Cd specified in class III national soil quality standard is 0.0001%.

3) Cd: There was no cadmium found in four samples. The number was 1-1, 1-3, 2-1, 2-5, respectively. Cadmium concentrations of remaining samples exceeded the standard value. Highest value of cadmium concentrations was 21,000 times standard value. Cadmium in soil usually existed in the form of cadmium carbonate, it was difficult to be dissolved and migrated with water flow. Therefore, it was not evenly distributed in the soil. It was indicated that distribution of Cd was random in the contaminated soil area (Figure 10).

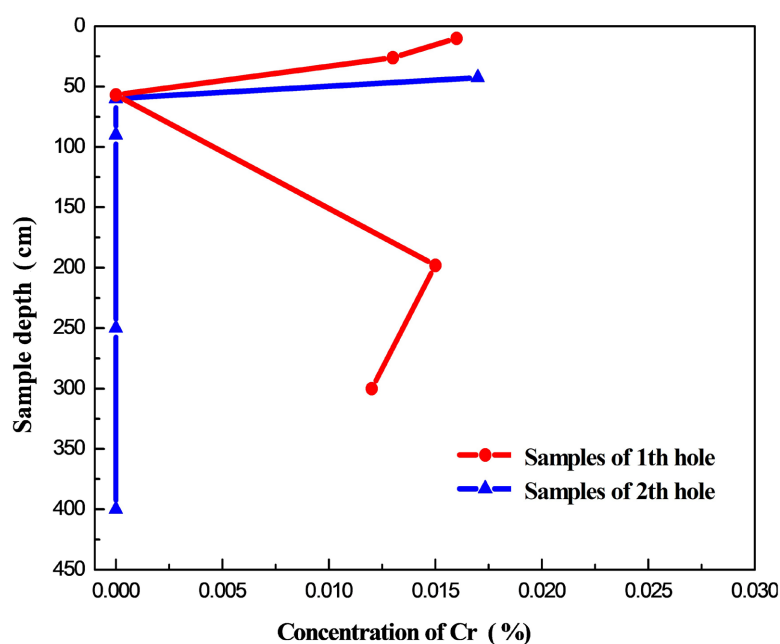
**Figure 11.** Concentration of Cr vs Sample depth. Critical concentration of As specified in class III national soil quality standard is 0.04% for paddyfield, 0.03% for dryland.

4) Cr: Concentration of Cr in all samples was lower than level specified in national standard, Cr component was distributed in the soil randomly, Owing to the insolubility of chromium oxide. There was no Cr found in some samples (Number 1-3, 2-2, 2-3, 2-4, 2-5 showed in **Figure 11**).

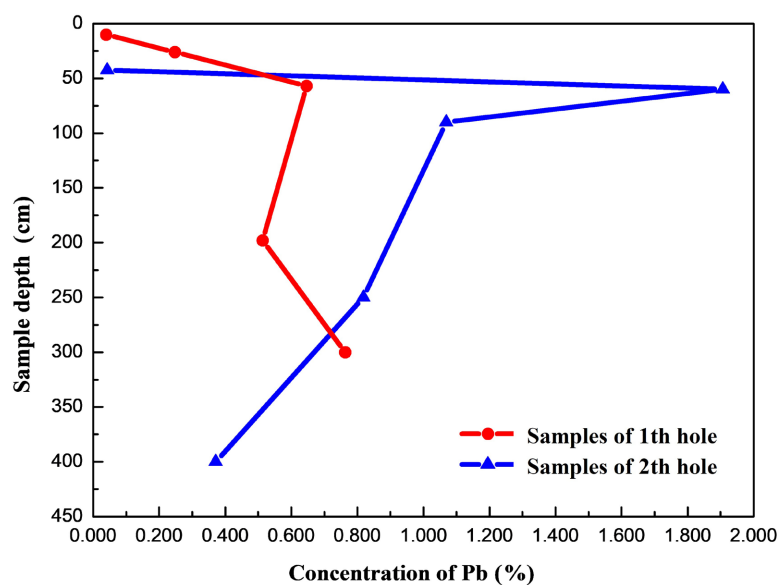
**Figure 12.** Concentration of Pb vs Sample depth. Critical concentration of Pb specified in class III national soil quality standard is 0.05%.

5) Pb: It was found in all samples. Concentration of Pb was not substandard in surface soil samples. However, Concentration of Pb in other samples was all exceeded to standard (**Figure 12**).
