# Evaluation of the Effectiveness of Traditional and Nano Materials Used in Consolidation of Sandstone Used in Ramesses III Temple, Karnak, Egypt

**How to cite this paper:** Mohamed, E.H., Ahmed, M.Z. and El-Latif, M.L.A. (2025) Evaluation of the Effectiveness of Traditional and Nano Materials Used in Consolidation of Sandstone Used in Ramesses III Temple, Karnak, Egypt. *Journal of Minerals and Materials Characterization and Engineering*, 13, 18-30.

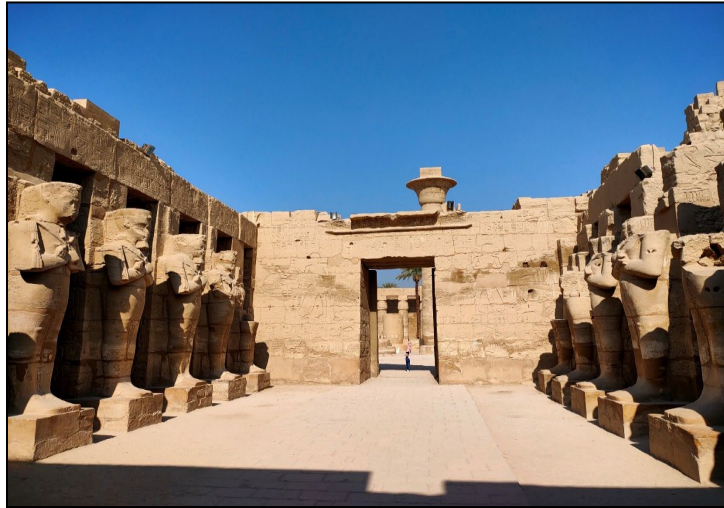
**Figure 1.** The first hypostyle hall of Ramesses III Temple.

The Temple of Ramses III, situated within the Karnak temple complex in Luxor, showcases ancient Egyptian architecture's grandeur (Figure 1, Figure 2) [12]. Sandstone degradation accelerates in harsh environments, characterized by temperature fluctuations, moisture and pollution, environmental factors, including temperature swings and moisture, exacerbate sandstone deterioration, thermal expansion-induced cracking threatens sandstone integrity in fluctuating environmental conditions.

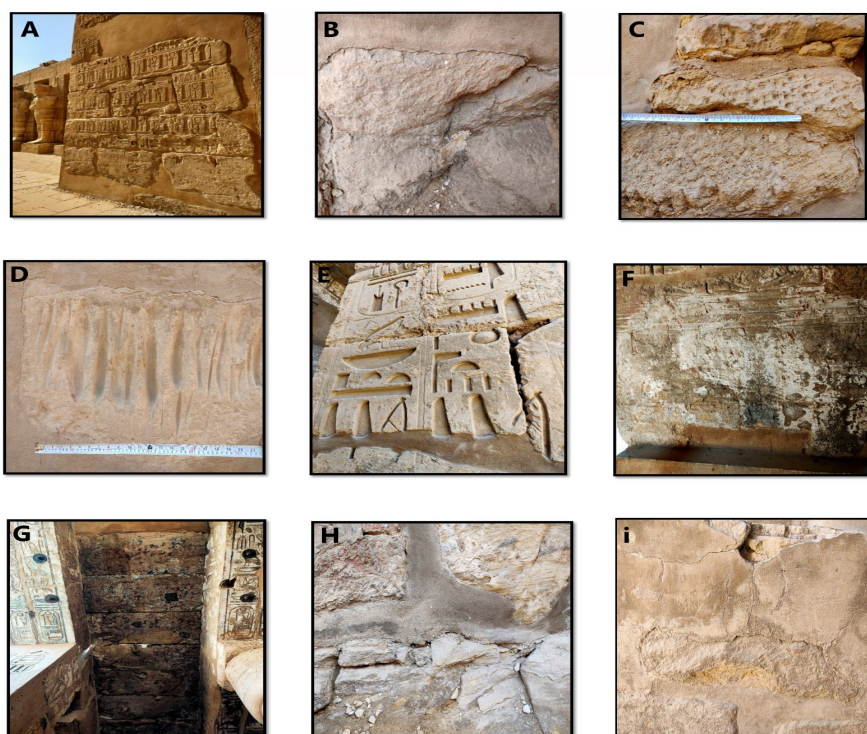
**Figure 3.** Different deterioration symptoms of Ramesses III temple (A) macro-cracks spread on the surfaces. (B) Black weathering due to Loss of scales. (C) alveolar weathering due to lose of stone material. (D) Relief. (E) Break out due to natural cause. (F) Efflorescences to light-colored crust changing the surface. (G) Microbiological colonization to dark-colored crust tracing the surface. (H) Granular disintegration into powder. (i) weathering out dependent on stone structure.

Ramesses III temple walls exhibit pronounced deterioration, particularly in lower sections, due to fluctuating temperature and relative humidity. Repeated expansion and contraction of mineral granules induce internal stresses, leading to cracking [16]. The Temple of Ramses III's proximity to the Nile River, coupled with its elevated position (2 m above surrounding land), exposes sandstone structures to heightened moisture levels from subsurface water, exacerbating deterioration. Groundwater infiltration into the Temple of Ramses III's foundations, facilitated by capillary action, introduces salts detrimental to stone blocks. Temperature and humidity fluctuations exacerbate sandstone degradation through mineral grain disintegration [17]. The Temple of Ramses III's sandstone surfaces undergo physical, chemical, and mechanical deterioration due to plant root growth, bird droppings, and bacterial activity. Soluble salts in avian excrement exacerbate degradation (**Figure 3**) [18].

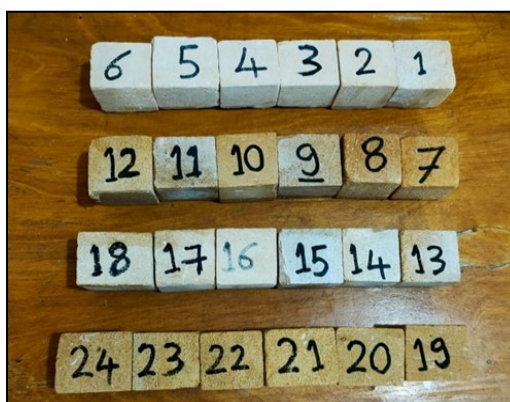
**Figure 5.** The sandstone samples after consolidation.

Treatment materials' suitability for consolidation of sandstone were assessed through immersion testing to ensure safe and effective application, Sandstone samples underwent 21-day consolidation treatment via immersion in respective materials, allowing complete polymerization, as shown **Figure 5**.

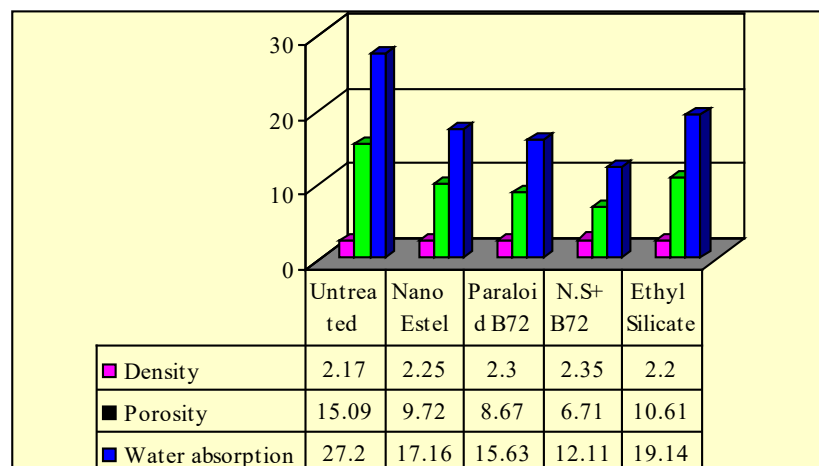
**Figure 10.** The mean values of physical properties after treatments.

The Paraloid B72/Nano Estel mixture yielded a porosity rate of 6.71%, representing a 55.53% reduction compared to the untreated sample (15.09%); Paraloid B-72 treatment yielded a porosity rate of 8.67%, representing a 42.54% reduction from the untreated sample (15.09%); Nano Estel-treated samples exhibited a porosity rate of 9.72%, showing a 35.58% reduction. Ethyl Silicate-treated samples ranked lowest, Ethyl Silicate-treated samples exhibited the highest porosity rate (10.72%), representing a 29.68% reduction from the untreated sample (15.09%) (Table 3, Figure 10).

The Nano Estel + Paraloid B-72 mixture exhibited the lowest water absorption rate (12.11%), representing a 55.47% reduction compared to the untreated sample

(27.2%), Paraloid B-72-treated samples exhibited an average water absorption rate of 15.63%, representing a 43.53% reduction compared to the standard sample, Nano Estel-treated samples showed 17.16% water absorption, a 36.91% reduction. Ethyl silicate-treated samples exhibited 19.14% absorption, a 29.63% decrease (Table 3, Figure 10).

Density measurements were conducted to assess the efficacy of various consolidating materials. The results indicated a significant increase in density values for treated samples, with Paraloid B72/Nano Estel-treated samples achieving an average density of 2.35 g/cm<sup>3</sup>, representing an 82.94% increase compared to untreated samples, which recorded 2.17 g/cm<sup>3</sup>. Subsequently, Paraloid B-72-treated samples exhibited a mean density of 2.30 g/cm<sup>3</sup>, representing an 59.90% increase compared to untreated samples. Nano Estel-treated samples exhibited a mean density of 2.25 g/cm<sup>3</sup>, representing a 36.86% increase. The average density of ethyl silicate-treated samples was 2.20 g/cm<sup>3</sup>, with an 18.43% enhancement (Table 3, Figure 10).

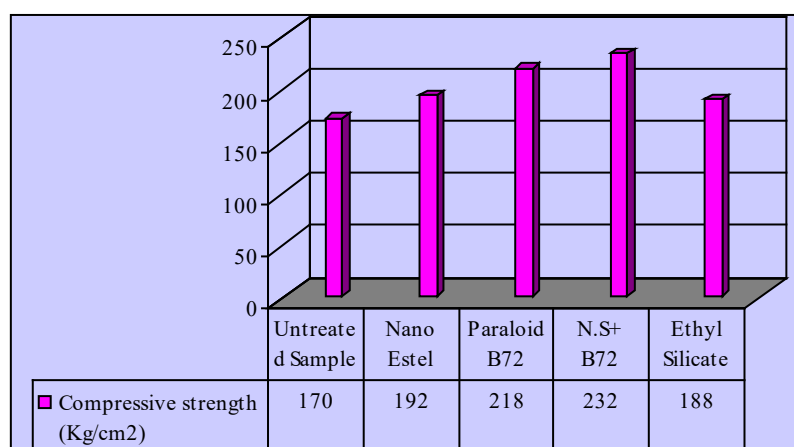
**Figure 11.** The mean values compressive strength of the treated samples.

The Paraloid B-72/Nano Estel-treated samples achieved the highest compressive strength value of 232 kg/cm<sup>2</sup>, compared to 170 kg/cm<sup>2</sup> for the untreated sample. The compressive strength of Paraloid B-72-treated samples reached 218 kg/cm<sup>2</sup>, exceeding the untreated sample. The compressive strength of Nano Estel-treated samples reached 192 kg/cm<sup>2</sup>. Finally, samples treated with ethyl silicate showed a compressive strength of 188 kg/cm<sup>2</sup> (Table 4) (see Figure 11).
