# Dielectric Assessment of 11 kV Three-Core XLPE Power Cable during New Substation Commissioning

**How to cite this paper:** Noh, M.A.M., Khiar, M.S.B.A., Ab Ghani, S. and Chairul, I.S. (2025) Dielectric Assessment of 11 kV Three-Core XLPE Power Cable during New Substation Commissioning. *Journal of Power and Energy Engineering*, 13, 148-159.

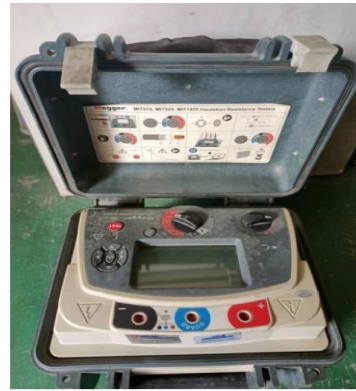
**Figure 1.** Insulation resistance tester.

The insulation resistance tester, shown in **Figure 1**, could measure up to 10 T $\Omega$  and had a selectable test voltage range between 250 V and 5 kV. It was used to perform the IR test, DAR test, and Continuity test. **Figure 2** shows a discharge rod that was used to discharge cables or other electrical objects. The discharge rod was essential to ensure that the test subject did not retain any charge. It could withstand up to 40 kV DC, ensuring the tester's safety during testing.

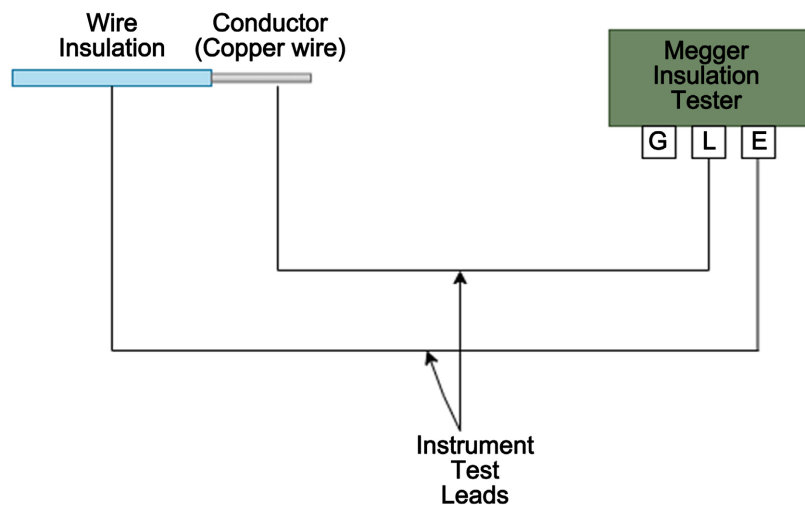
**Figure 3.** Wiring diagram for the IR test setup.

The wiring diagram for the IR test is illustrated in **Figure 3**. An applied voltage of 5 kV was used, appropriate for the power cable's 11 kV rating. Testing was performed on all phase-to-phase connections (R-Y, Y-B, and B-R) as well as on each phase-to-earth connection (R-E, Y-E, and B-E). Each cable segment was tested individually before jointing to ensure the absence of faults. Any cable showing a fault was repaired prior to jointing with other sections. The test was deemed successful if the insulation resistance exceeded 0.1 G $\Omega$ .

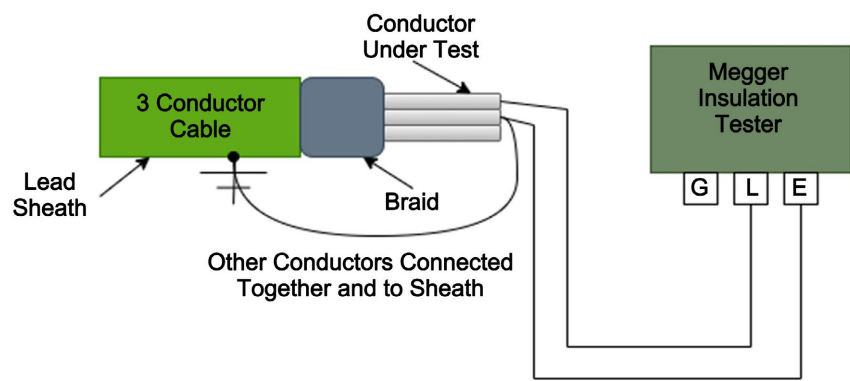
**Figure 4.** Wiring diagram for the continuity test setup.

**Figure 4** illustrates the wiring diagram for the continuity test. Although the power cable is rated at 11 kV, the insulation resistance tester was set to 5 kV for this test. Continuity was checked across all phase-to-phase connections (R-Y, Y-B, and B-R). The continuity test was conducted on each cable segment prior to jointing to identify any faults. Only cables passing this test were permitted to be jointed. The test was considered successful if the measured resistance was below 5  $\Omega$ .
