Evaluation of Driver Behavior in Response to Stop Sign Beacons

Abstract

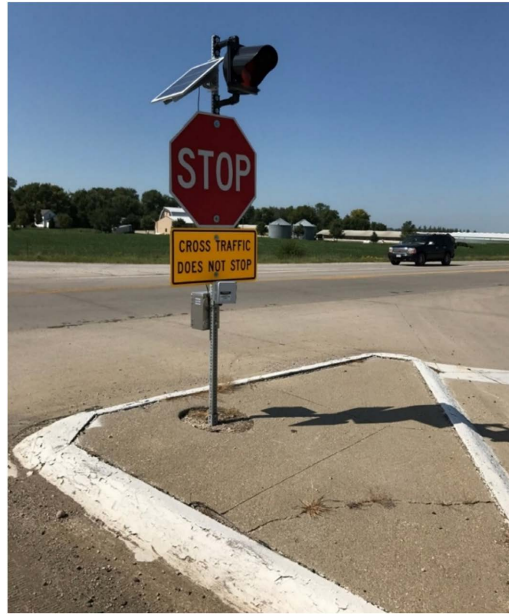
Figure 1. Flashing beacon installation.

The main objective of this study was to evaluate the effectiveness of stop sign beacons. The study in particular focused on stop sign beacons which were set to activate only when a driver was traveling over a set speed threshold and was unlikely to stop as shown in **Figure 1**.

An example of a sign installation is shown in **Figure 1** above. The radar detected speeds approximately 350 to 400 feet before the stop sign. When a vehicle's speed was greater than 40 miles per hour from an approaching distance of 350 feet, the beacon was set to activate. When activated, the beacon flashed at a standard flashing rate for 9 seconds, allowing the driver to register and respond to the intersection ahead. The threshold of 40 mph was used based on calculations of normal stopping distance.

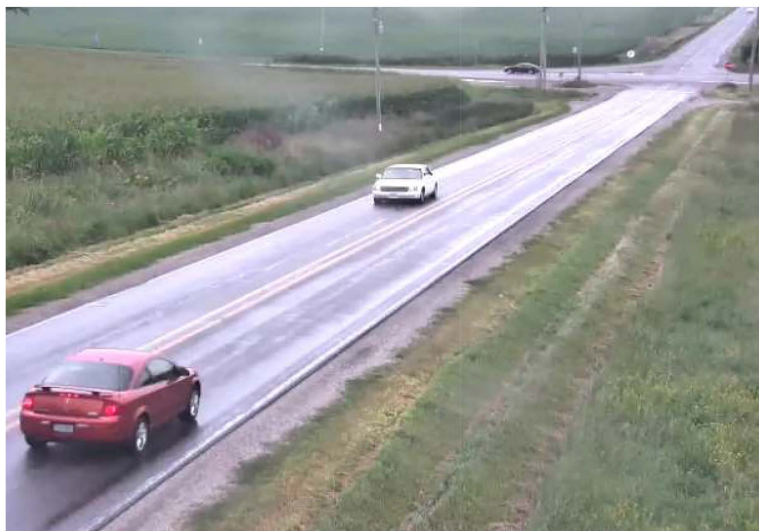
Figure 2. Video view of intersection.

Portable data collection trailers with speed sensors and cameras were used for data collection. A trailer array was set up at each approach where beacons were installed, as shown in **Figure 2**. This ensured coverage of some portion of the upstream approach as well as the intersection. Video data were collected approximately one month before installation at all approaches where the flashing beacons were to be installed. Data were also collected at all 10 approaches around one month after installation of the stop sign beacons.

Once the video data collection trailers were placed in the field, data were collected continuously for around one week during each period. To accurately record the distance from each vehicle to the flashing beacon, white lines were painted on the pavement at 100 ft increments upstream of the intersection.

These markings were placed for a distance of 500 ft upstream of the intersection stop bar. These markings were used as a reference in the video to approximate the point at which drivers began applying their brakes. The lines were then

located in the video frame and marked so that they were clearly visible to the data reductionists.
