# Debris Fan Produced by Failure of Canyon-Blocking Pyroclastic Flows

Michael L. Cummings

Department of Geology, Portland State University, Portland, Oregon, USA

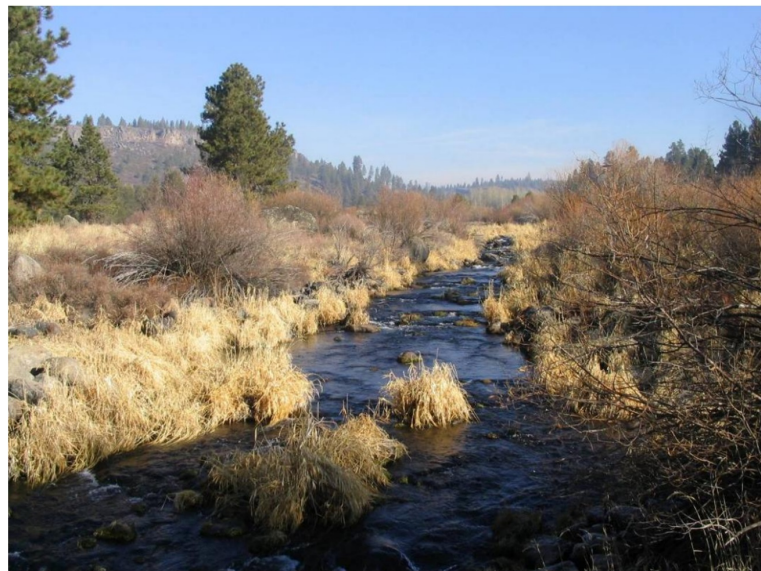
**Figure 4.** Williamson River where it crosses the boulder core upstream from the bridge on FSCR 9730 (Figure 2). The cliff (upper left) is a basaltic andesite intracanyon flow that overlies an eroded surface cut into hydrovolcanic tuff (photo by S. Mattenberger).

Williamson River established its channel across the boulder core (Figure 4) and eroded into hydrovolcanic tuff and volcanoclastic sedimentary rocks south of the debris fan. The following sections describe the composition, estimated density, grain size, statistical parameters of grain size, and stratigraphic relations of the debris fan.

the core (**Figure 4**). Two auger holes, 4600/3975 and 4158/4279, were 536 m apart on opposite sides of the boulder core. In auger hole 4600/3975, 85 cm of moderately ( $\sigma_1 = 0.68$ ) to marginally poorly sorted ( $\sigma_1 = 1.02\Phi$ ), coarse-grained ( $M_z = +0.90\Phi$ ) sand overlies hydrovolcanic tuff bedrock. Here, deposition occurred in an overbank setting. The bank of the pre-eruption river is inferred to be 40 to 50 m away where a modern ravine bounds the east edge of the boulder core. In auger hole 4545/4014, 56 cm of poorly sorted ( $\sigma_1 = 1.65\Phi$ ), basalt pebble-bearing, coarse-grained sand ( $M_z = +0.21\Phi$ ) overlies the boulder core. Auger hole 4158/4279 located on the opposite side of the boulder core penetrated 70 cm of poorly sorted ( $\sigma_1 = 1.47\Phi$ ), strongly fine skewed ( $Sk_1 = 0.31$ ), medium-grained ( $M_z = +1.55\Phi$ ) sand before it entered pyroclastic flows from 70 cm to 150 cm (E.O.H.) (samples 81 - 84 cm and 146 - 150 cm). Two explanations account for pyroclastic flows at the 4158/4279 site. 1) During the eruption, pyroclastic flows passed through the canyon and came to rest there, or 2) blocks of pyroclastic flows dislodged from within the canyon were transported to that location.

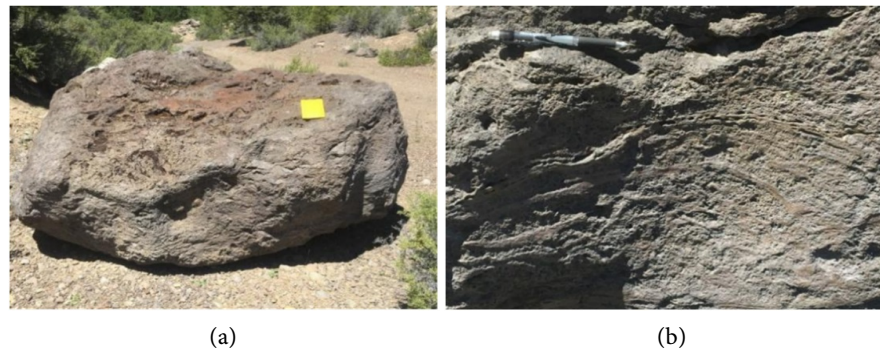
**Figure 5.** a) Boulder of banded olivine basalt in the quarry near the canyon exit (~14 cm × 20 cm field notebook for scale). The nearest outcrops of this lithology relative to the quarry is 6 km. b) Close-up of vesiculation and banding patterns in the olivine basalt (14.5 cm long mechanical pencil in upper left corner for scale).

2) Thin (2 to 3 m thick) flows of olivine basalt crop out along the eastern wall of the Williamson River canyon approximately 6 km upstream from the canyon exit [14]. Boulders in the quarry and slash-burn piles were not weathered and, in the quarry, were up to 3.40 m (d<sub>i</sub>) [12] (Figure 5(a)). Boulders were present at least 1.9 km from the canyon exit. This lithology was distinctly textured with wavy, 2 to 5 cm thick, variably vesiculated bands (Figure 5(b)).

Bedrock boulders were sourced at least as far up canyon as outcrops of the texturally distinct olivine basalt (near RR in **Figure 2**), approximately 4 km. These texturally distinct boulders (**Figure 5(a)**, **Figure 5(b)**) are present on slash-burn piles at least 1.9 km from the canyon exit. Outcrops of hydrovolcanic tuff in the lower 2.6 km of the canyon (starting near the distinct bend in the middle canyon, **Figure 2**) were the sources of hydrovolcanic tuff boulders (**Figure 6**) that were also deposited at least 1.9 km (slash-burn piles) from the canyon exit. Basalt flows were too widely distributed to yield information on source or distance of transport. Near 1.1 km the eastern edge of the deposit was controlled by pre-eruption topography (**Figure 16**). At 1.3 km the boulder core is 420 m wide, 4 to 6 m thick, and its edges are relatively abrupt. The boulders are inferred to be embedded in lithic-rich sand and gravel similar to the sandy pumice gravel ( $\pm$ basalt/hydrovolcanic tuff) unit. The size and abundance of bedrock boulders decrease with distance from the canyon exit. Refusal against isolated boulders embedded within the sandy pumice gravel ( $\pm$ basalt/hydrovolcanic tuff) unit extends at least 2.50 km.

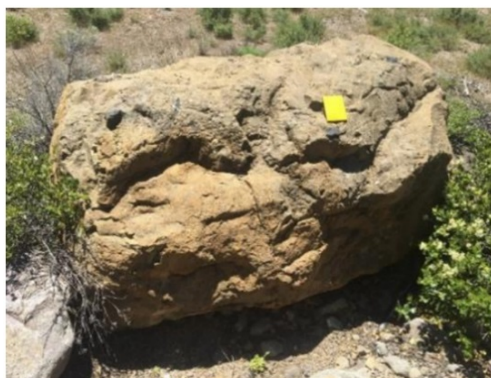
**Figure 6.** Palagonitized hydrovolcanic tuff boulder. The dimensions of this boulder are  $d_1 = 3.40$  m,  $d_2 = 2.75$  m [12]. Field notebook for scale ( $\sim 14$  cm  $\times$  20 cm). Cliffs formed of this lithology are present within 0.3 km of this boulder exposed in the quarry.

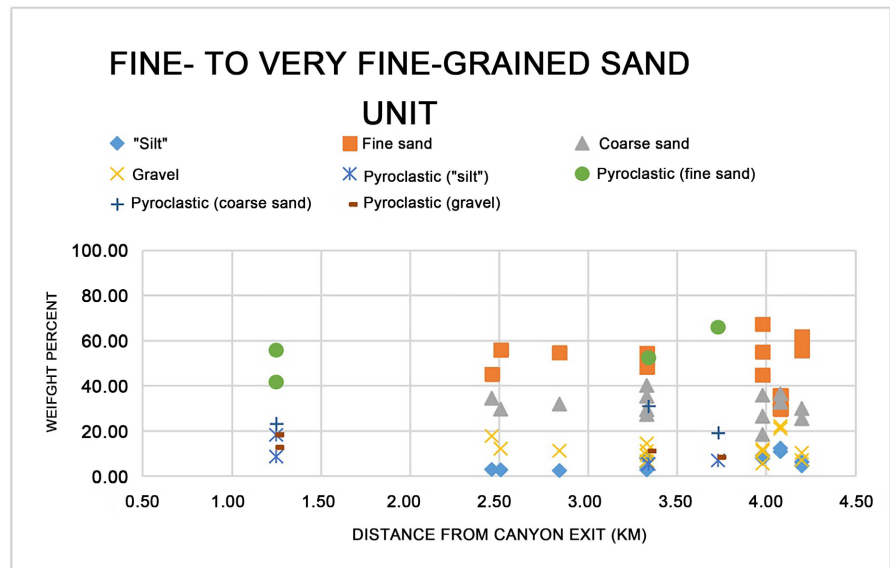
**Figure 8.** Weight percentages with respect to distance from the canyon exit for the fine-grained sand unit and pyroclastic flows. “Silt” = <0.07 mm; fine sand =  $\geq 0.07$  mm <0.42 mm; coarse sand =  $\geq 0.42$  mm <2.00 mm); gravel  $\geq 2.00$  mm. Average weight percent: “silt” = 6.3%, std. dev. = 3.2; fine sand = 50.7%, std. dev. = 9.7; coarse sand = 30.8%, std. dev. = 5.6; gravel = 12.1%, std. dev. = 5.0.

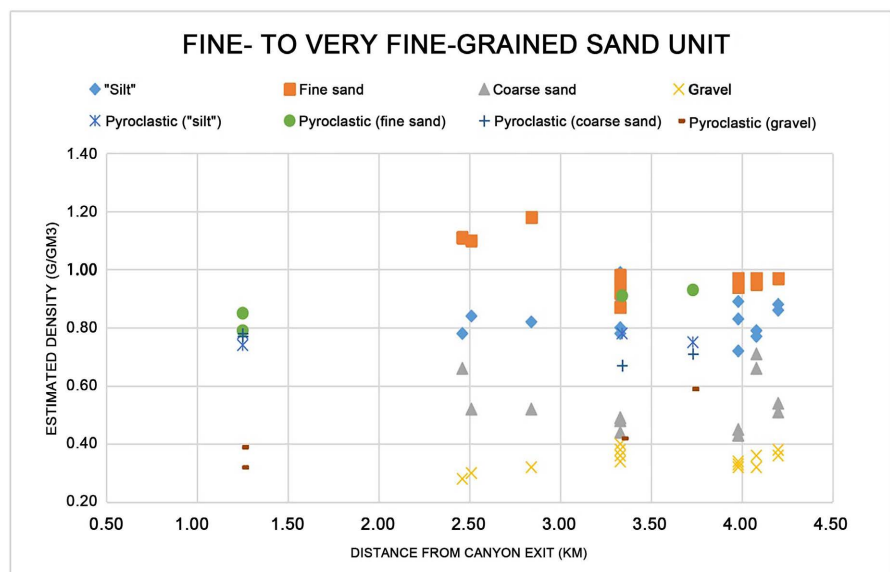
**Figure 9.** Estimated densities with respect to distance from the canyon exit for the fine-grained sand unit and pyroclastic flows. “Silt” = <0.07 mm; fine sand =  $\geq 0.07$  mm <0.42 mm; coarse sand =  $\geq 0.42$  mm <2.00 mm; gravel  $\geq 2.00$  mm. Average estimated density: “silt” = 0.8 g/cm<sup>3</sup>, std. dev. = 0.1; fine sand = 1.0 g/cm<sup>3</sup>, std. dev. = 0.1; coarse sand = 0.5 g/cm<sup>3</sup>, std. dev. = 0.1; gravel = 0.3 g/cm<sup>3</sup>, std. dev. 0.03.

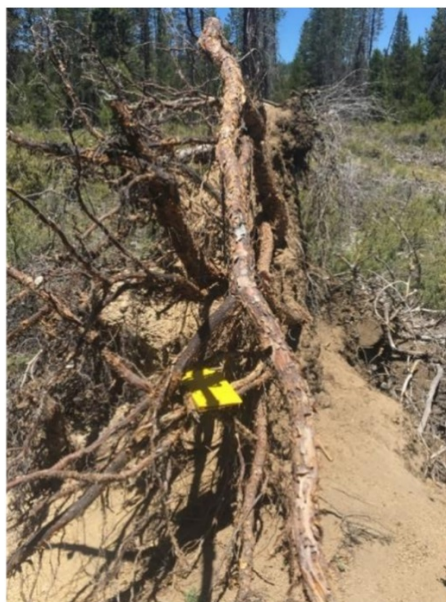
**Figure 10.** Root ball of a ponderosa pine tree (2434/2789) where pumice gravel (left of the yellow notebook) overlies pyroclastic flows (up direction to the left). The site was located upslope from a small ephemeral stream near the crest of the ridge and 3.5 km from the canyon exit.

estimated density, statistical parameters of grain size [32], and stratigraphic position. The Williamson River eroded the upper part of this unit within 2.0 km of the canyon exit. The pumice pebble-rich upper part of the unit overlies pyroclastic flows at 3.5 km and 3.7 km. **Figure 10** shows the root ball of a ponderosa pine

tree where the contact between pyroclastic flows and the upper pumice pebble-rich part of the unit (3.5 km) is exposed. Pyroclastic flows exposed in a lodgepole pine root ball in an ephemeral stream valley underlies the pumice pebble-rich upper part of the unit at 3.7 km. Unit characteristics are summarized in **Table 1** (<2.0 km, 2.0 km to 3.5 km, >3.7 km).

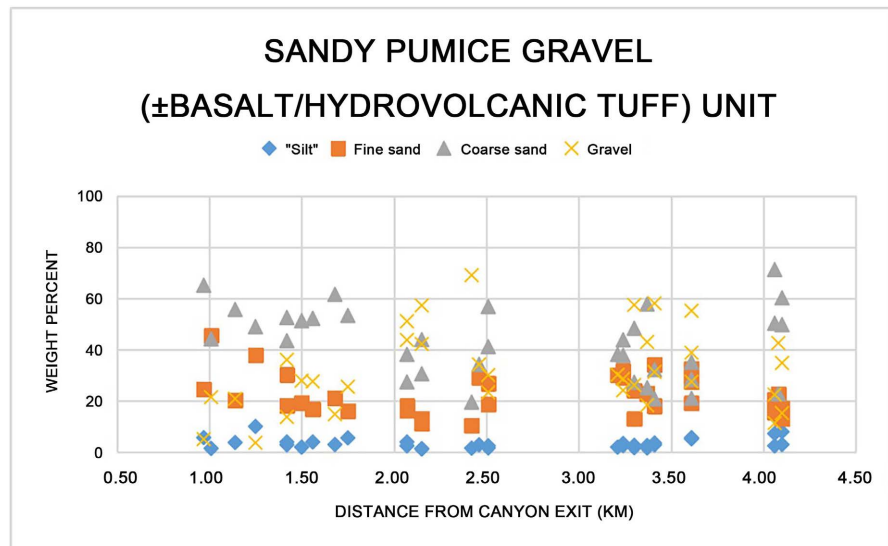
**Figure 12.** Weight percentages with respect to distance (km) from the canyon exit for the sandy pumice gravel ( $\pm$ basalt/hydrovolcanic tuff) unit. "Silt" =  $<0.07$  mm; fine sand =  $\geq 0.07$  mm  $<0.42$  mm; coarse sand =  $\geq 0.42$  mm  $<2.00$  mm; gravel  $\geq 2.00$  mm. Average weight percent: "silt" = 3.6%, std. dev. = 2.5; fine sand = 22.4%, std. dev. = 8.0; coarse sand = 42.5%, std. dev. = 13.8; gravel = 31.7%, std. dev. = 15.8.

Weight percentages and estimated densities for the sandy pumice gravel ( $\pm$ basalt/hydrovolcanic tuff) unit with respect to distance from the canyon exit are presented in **Figure 12** and **Figure 13**. Weight percentages reflect the abundance

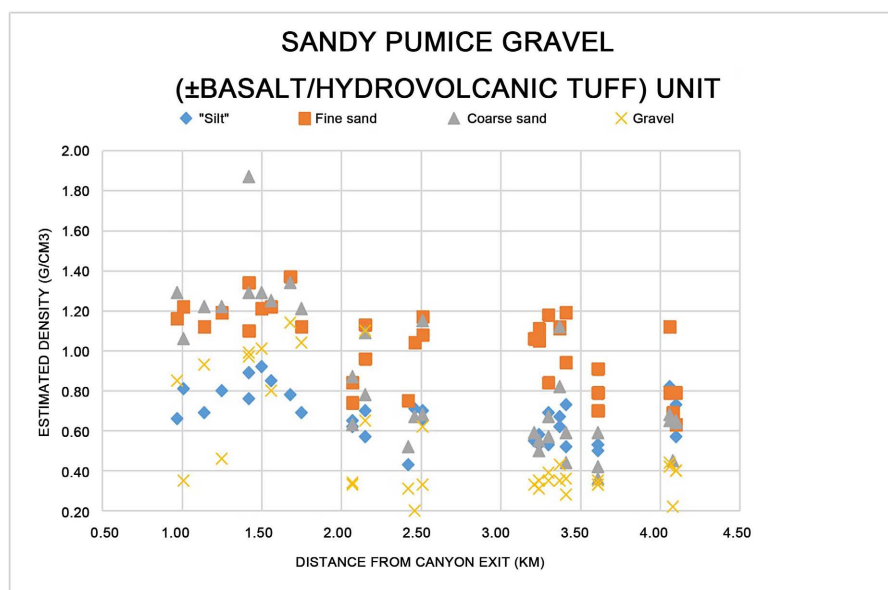
**Figure 13.** Estimated densities ( $\text{g}/\text{cm}^3$ ) with respect to distance (km) from the canyon exit for samples of the sandy pumice gravel ( $\pm$ basalt/hydrovolcanic tuff) unit. "Silt" =  $<0.07$  mm; fine sand =  $\geq 0.07$  mm  $<0.42$  mm; coarse sand =  $\geq 0.42$  mm  $<2.00$  mm; gravel  $\geq 2.00$  mm. Average estimated density: "silt" =  $0.7 \text{ g}/\text{cm}^3$ , std. dev. = 0.1; fine sand =  $1.0 \text{ g}/\text{cm}^3$ , std. dev. = 0.2; coarse sand =  $0.8 \text{ g}/\text{cm}^3$ , std. dev. = 0.4; gravel =  $0.5 \text{ g}/\text{cm}^3$ , std. dev. = 0.3.

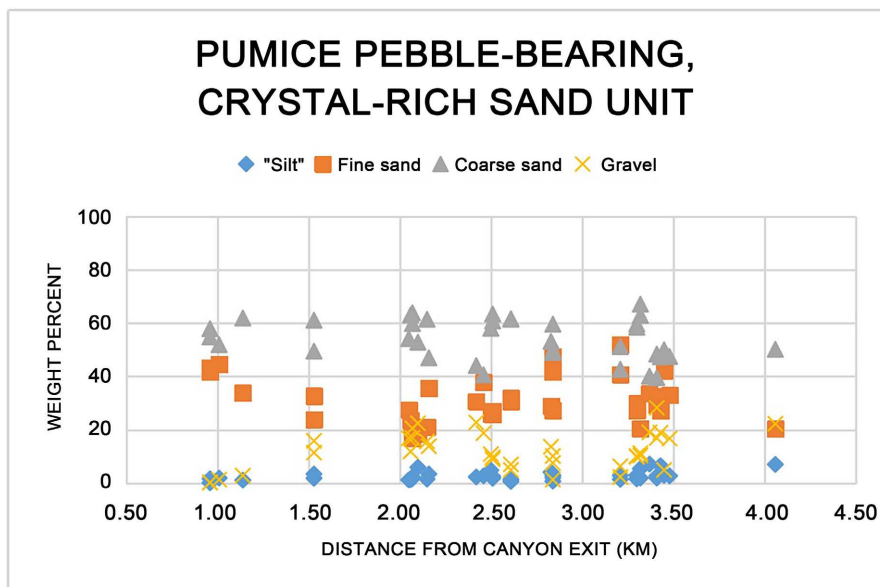
**Figure 14.** Weight percentages with respect to distance (km) from the canyon exit for the pumice pebble-bearing, crystal-rich sand unit. “Silt” = <0.07 mm; fine sand = ≥0.07 mm <0.42 mm; coarse sand = ≥0.42 mm <2.00 mm; gravel ≥2.00 mm. Average weight percent: “silt”: 2.8 wt. %, std. dev. = 1.8; fine sand: 31.0 wt. %, std. dev. = 8.8; coarse sand: 59.2 wt. %, std. dev. = 7.6; gravel: 12.0 wt. %, std. dev. = 7.1.

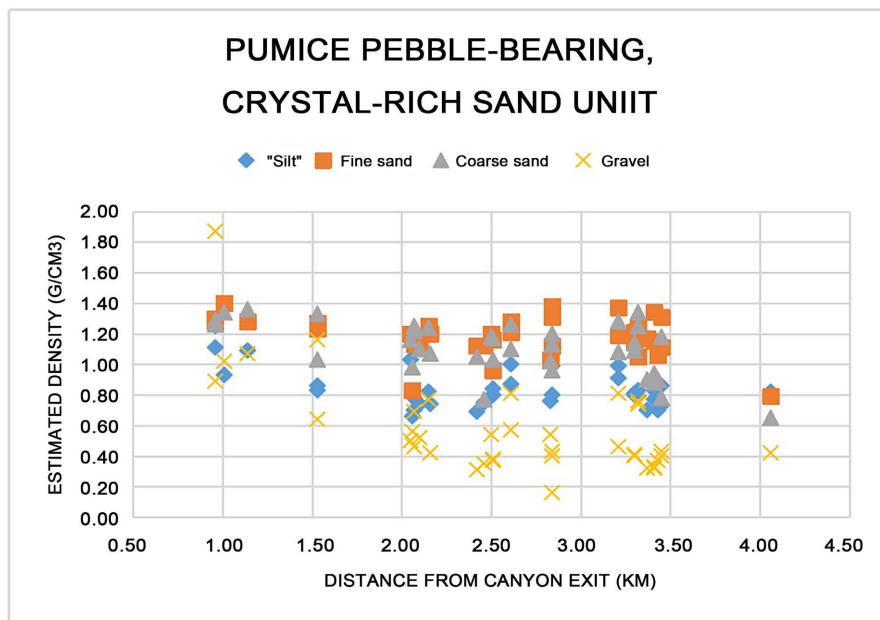
**Figure 15.** Estimated densities (g/cm<sup>3</sup>) with respect to distance (km) from the canyon exit for samples of the pumice pebble-bearing, crystal-rich sand unit. “Silt” = <0.07 mm; fine sand = ≥0.07 mm <0.42 mm; coarse sand = ≥0.42 mm <2.00 mm; gravel ≥2.00 mm. Average estimated density: “silt” = 0.8 g/cm<sup>3</sup>, std. dev. = 0.1; fine sand = 1.2 g/cm<sup>3</sup>, std. dev. = 0.1; coarse sand = 1.1 g/cm<sup>3</sup>, std. dev. = 0.2; gravel = 0.6 g/cm<sup>3</sup>, std. dev. = 0.3.

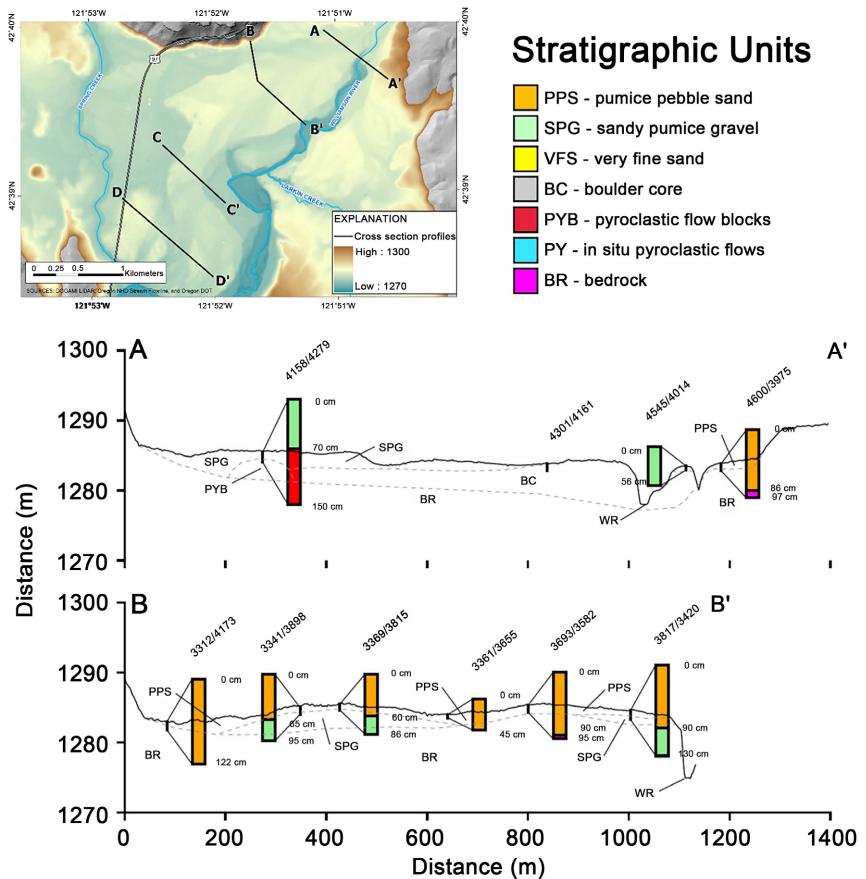
Figure 16. Location map and key for cross sections A-A' and B-B'. The location map and key also apply to cross sections shown in Figure 17 (C-C' and D-D').

Four cross sections constructed at 1.3 km (A-A'), 2.1 km (B-B') (**Figure 16**), 3.4 km (C-C') and 4.1 km (D-D') (**Figure 17**) summarize inferred stratigraphic relations.

Cross section A-A' (Figure 16) is located approximately 1.3 km into the boulder core. Here, boulders are exposed where the Williamson River channel crosses

Cross section B-B' (**Figure 16**) was constructed 250 m down valley from the last boulder-bearing slash-burn pile and 2.1 km from the canyon exit. The cross section extends from near the base of slope that rises to US Highway 97 on the north end (B in **Figure 16**) to the modern incised channel of the Williamson River (B' in **Figure 16**) on the south, a distance of 1000+ m.
