Experimental Assessment of the Flame Resistance Properties of Firefighter Protective Ensembles, including the SPF1 Helmet

Abstract

Firefighters rely on their protective gear for thermal insulation during fires. This study evaluated the flame resistance of firefighter PPE, including helmets, turnout gear, and gloves, under extreme conditions. Results showed excellent performance of the F1 helmet but identified areas for improvement in gloves and turnout gear. The study provides insights into the heat transfer properties of different PPE components and offers recommendations for enhancing firefighter safety.

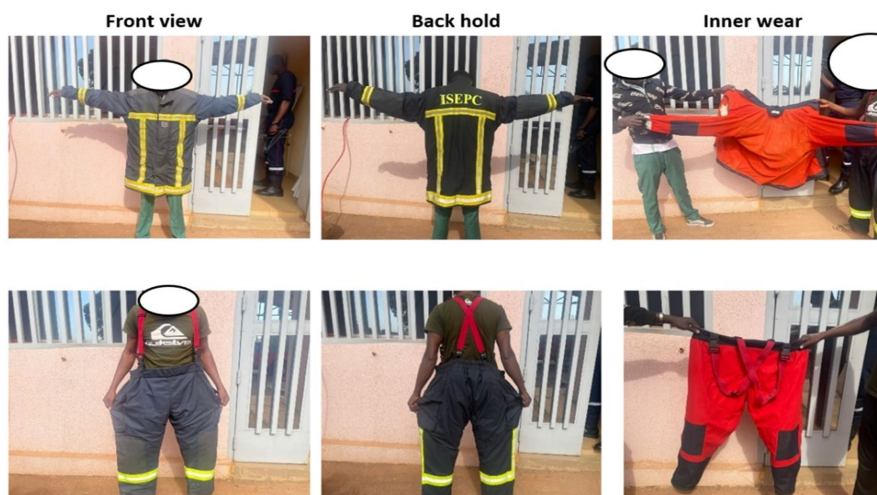
Figure 1. Photographs of the intervention jacket and trousers.

The firefighting suit is composed of 93% Nomex (meta-aramid), 5% Kevlar (para-aramid), and 2% antistatic carbon fibers. This combination ensures fire resistance and antistatic properties [2]. It is designed with three layers of different materials separated by air gaps. The tested firefighting suits (**Figure 1**) were utilized for varying durations, as detailed in **Table 1**. **Table 2** provides a comprehensive summary of their performance characteristics.

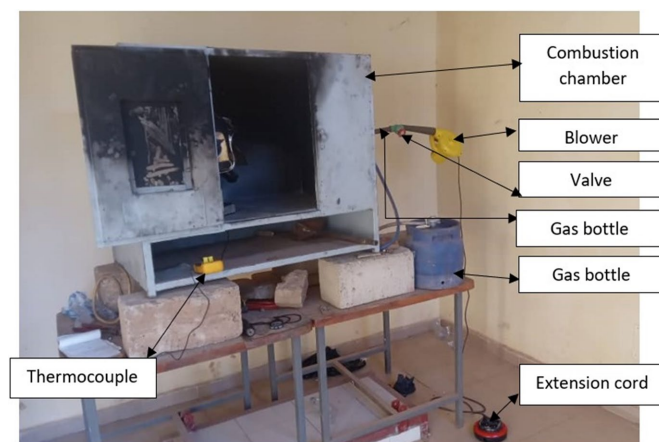
Figure 2. Complete equipment and setup for the FPP test.

The test bench consists of an oven with dimensions $1\text{ m} \times 0.7\text{ m} \times 0.7\text{ m}$, insulated with 2 cm thick layers of clay on all sides. It includes a 6 kg butane gas cylinder supplied by the SODIGAZ company, an air blower with a rotation speed of 13,000 rpm and an airflow rate of $2.3\text{ m}^3/\text{min}$, and a forced-air burner made from a steel tube measuring 40 cm in length and 25 mm in external diameter.

The system is equipped with an electrical extension for power supply, an air flow regulation valve, and a K-type thermocouple. The thermocouple probes are strategically placed inside the chamber and within the equipment being tested. Flexible tubes are used to transport the gas and air. The test bench is adjustable and can be calibrated to deliver the desired heat flux based on testing requirements (Figure 2).

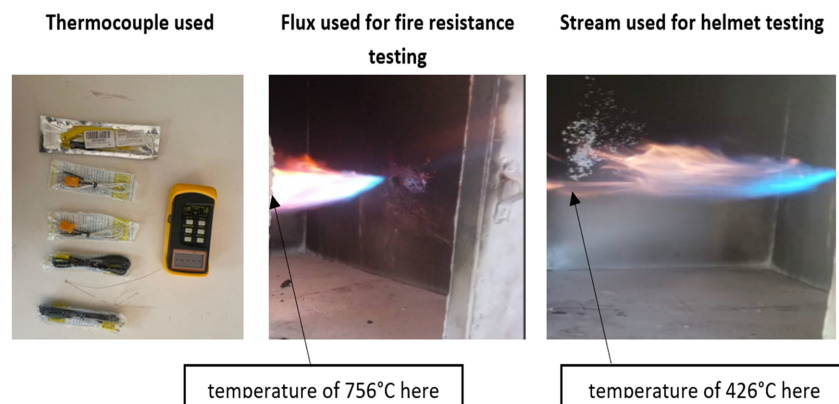
Figure 3. Thermocouples, probes, and heat flux for the turnout gear and helmet.

Figure 3 shows the thermocouples, probes, and heat flux for the turnout gear and helmet.

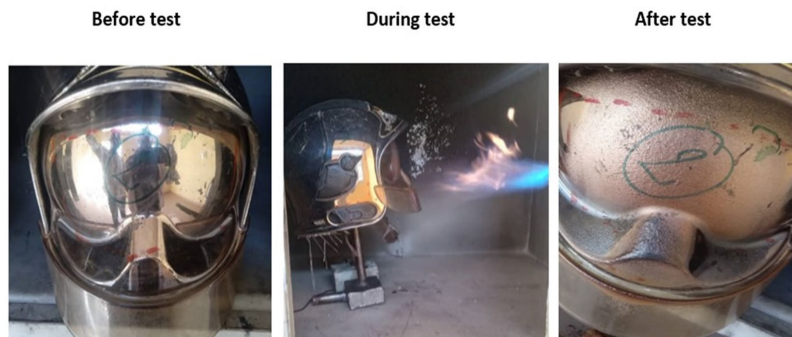
Figure 4. Images of the front visor at different stages of the test.

Figure 4 shows the different phases of our tests: before, during, and after the helmet visor test.

The deposit of stains (a form of carbonization) observed on the visor, which is not specified by the standard, should be given significant attention as it could hinder the firefighter wearing the helmet from having a clear view to escape or continue the mission. This carbonization is caused by incomplete combustion, releasing smoke that settles on the helmet visor. Implementing an anti-smoke deposit treatment on the helmet visor during its design could therefore enhance firefighter safety. This observation, which is not clearly addressed by the EN 443 standard, is considered a weakness of the latter. However, it is recommended that firefighters avoid exposing the helmet visor to a high heat source of approximately 426°C or more during interventions.

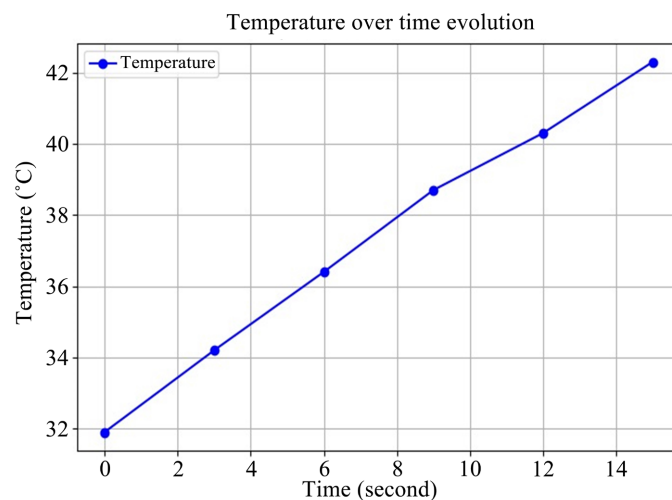
Figure 5. Evolution of the internal temperature of the visor.

The initial temperature of the test chamber was 31.9°C and was then taken at a time interval of three seconds. **Figure 5** shows the evolution of the temperature inside the helmet during the first 15 seconds of the test.

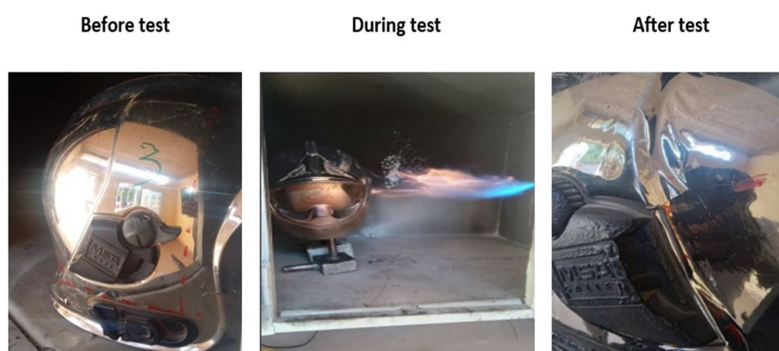
Figure 6. Lateral side of the helmet before, during, and after the test.

Figure 6 shows photographs of the lateral side before, during, and after the flame test.

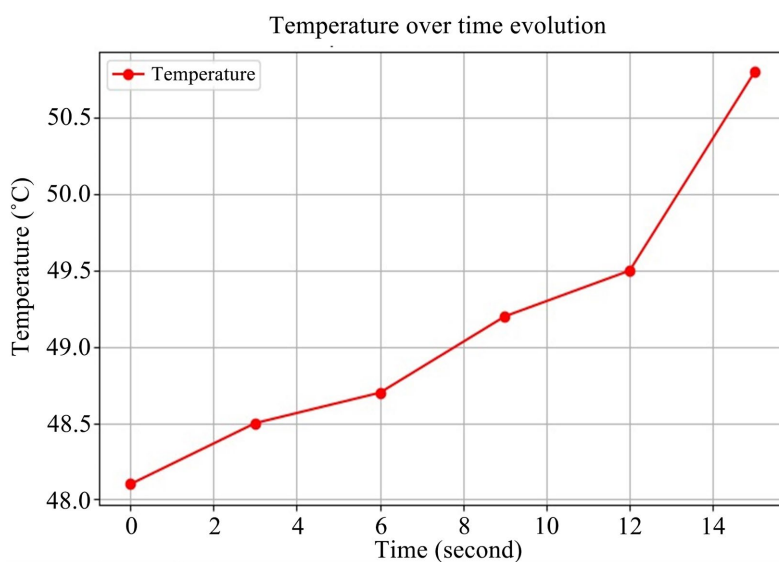
Figure 7. Temperature evolution curve of the lateral side.

During the test, we recorded the temperature changes inside the helmet at three-second intervals, as shown in **Figure 7**.

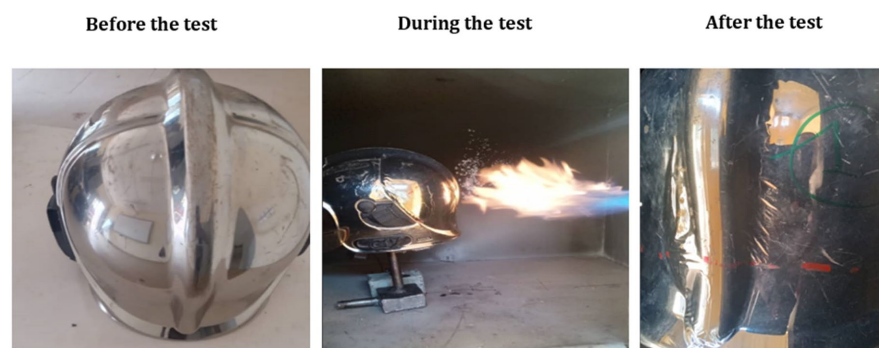
Figure 8. Back face of the helmet before, during, and after the test.

Figure 8 illustrates the back face of the helmet before, during, and after the test.

Starting from the initial temperature of 37.1°C, the temperature evolution inside the helmet after the flame test conducted on the rear of the helmet is shown in **Figure 8**. The final temperature recorded inside the helmet was 47.5°C, representing an increase of 10.4°C.

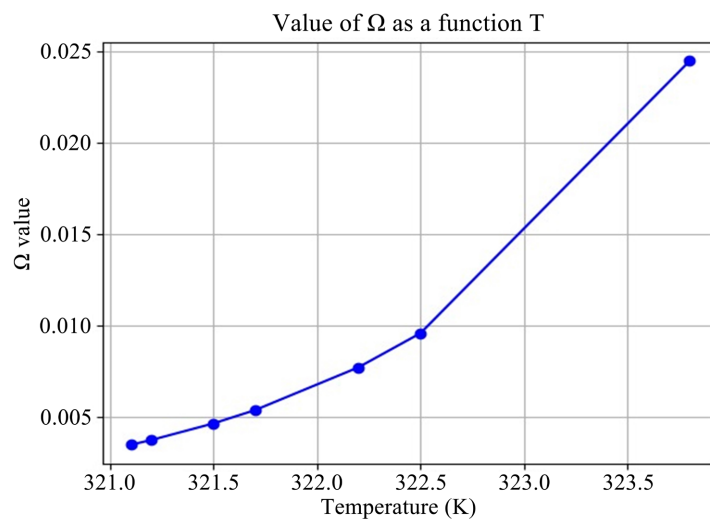
Figure 10. Curve of cellular degradation rate evolution as a function of temperature.

The evolution of the cellular degradation rate as a function of temperature is shown in **Figure 9** and **Figure 10**.

Using relation (2), we obtained **Figure 10**, which shows the evolution of the degradation parameter Ω over time. **Figure 10** reveals a maximum degradation rate of 0.025, which is well below 1. Therefore, the temperatures observed during the test cannot cause total cellular degradation. However, minor burns may be felt, as Ω is not zero.

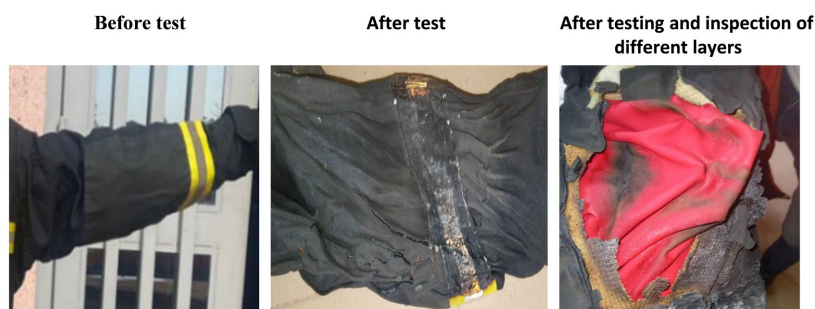
Figure 11. Photograph of the forearm of the protective suit before and after the test.

The results of the FPP test are shown in **Figure 11**, which provides a photograph of the forearm section of the protective suit before and after the test.

Figure 11 indicates that the first and second layers of the turnout gear failed the FPP test, whereas the last layer showed only minor degradation. The internal temperature evolution during the test is illustrated in **Figure 12**.

The test conducted on the forearm section of the turnout gear achieved a performance level of A2, meaning that the samples generally resisted the FPP test. However, the destruction of the first (C1) and second (C2) layers can be attributed to prolonged exposure to ambient conditions, improper washing practices (disregard of washing instructions), and the gear's age (as detailed in **Table 1**).

A discussion with a firefighter from the Ouagadougou brigade revealed that these turnout gears were washed by laundries unfamiliar with technical garments. Additionally, the washing temperature was unknown, a significant contributor to fabric degradation. According to the NFPA 1851 (1999) standard, the washing temperature must not exceed 40°C [15].

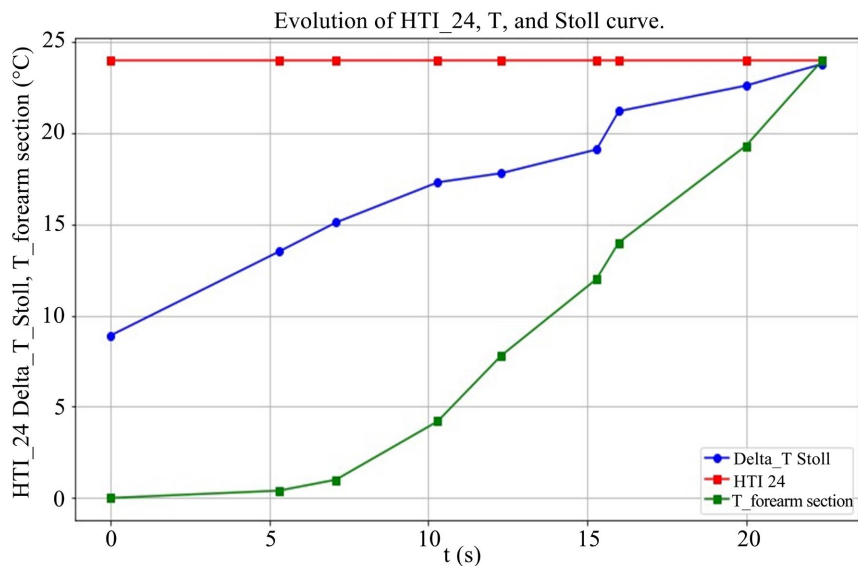
Figure 13. Determination of $t_{2\text{burn}}$ and HTI24 using the forearm section of the firefighter's intervention suit as the test sample for flame protection performance.

certain threshold. The determination of $t_{2\text{burn}}$ and HTI24 parameters, using the forearm section as the test sample, is presented in **Figure 13**.

Samples	t2burn (s)	HTI12 (s)	HTI24 (s)	HTI24-HTI12 (s)	Performance Level	TTI (kJ/m ²)
Forearm	22.41	15.30	22.41	7.11	A2	1792.8
Shoulder	32.44	19.40	32.44	13.04	A2	2595.2

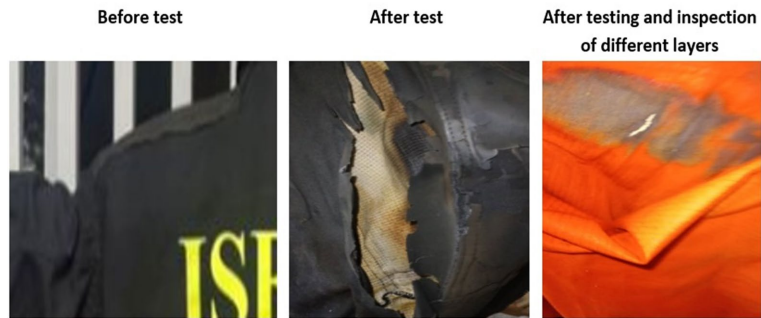
Figure 14. Photograph of the intervention suit, shoulder part before and after FPP test.

The results of the flame resistance performance test, conducted on the shoulder area of the turnout gear, are presented in **Figure 14**.

As shown in **Figure 14**, only the first layer of the turnout gear failed the FPP test, while the other layers exhibited minimal degradation. The evolution of the

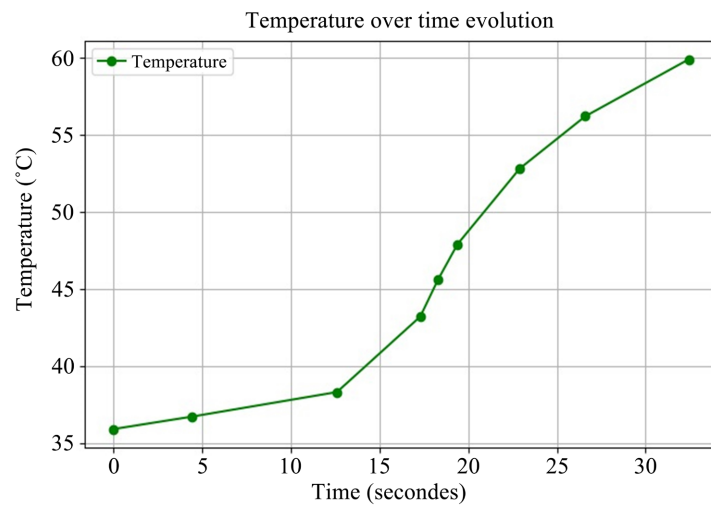
Figure 15. Evolution of the internal temperature of the fire suit, shoulder part, following the FPP test.

internal temperature during the test is illustrated in **Figure 15**, and the parameters t_{2burn} and HTI24 for the shoulder area were determined and are presented in **Figure 16**.

None of the tested samples continued to burn after the flame was removed, confirming the sustained effectiveness of the flame-retardant treatment. The rapid increase in temperature observed after flame removal (as shown in **Figure 15**) is due to heat accumulation within the layers, which accelerates thermal transfer once the materials reach a critical threshold.
