Enhancing Mud Brick Sustainability Using Nanomaterials for Restoration Adobe Enclosure of Dendera Temple, Qena, Egypt

Essam H. Mohamed

Archaeological Conservation Department, Faculty of Archaeology, South Valley University, Qena, Egypt
Email: essam.mohamed@arch.svu.edu.eg

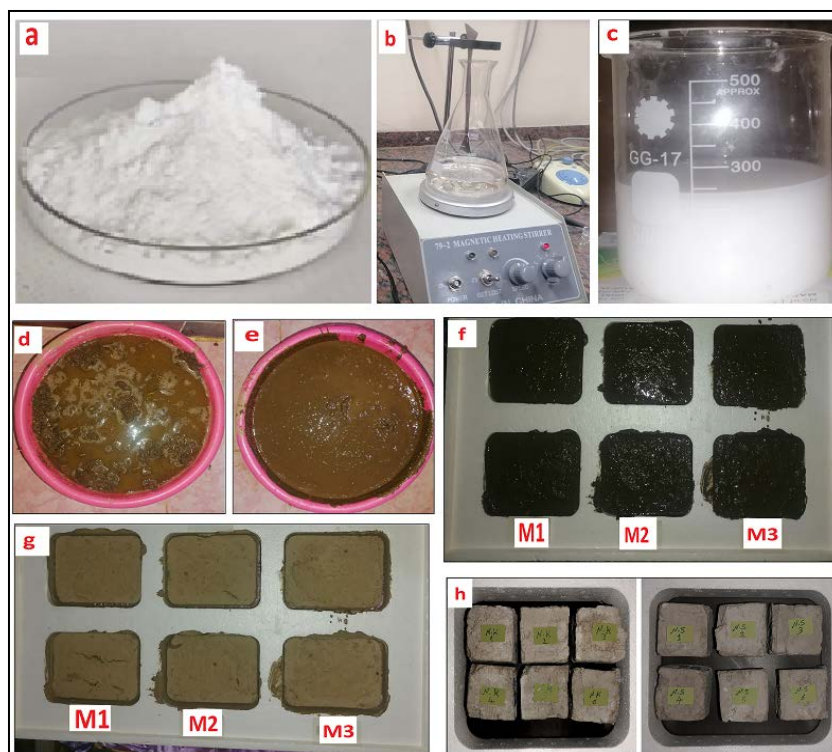
Figure 3. (a) $\text{Ca}(\text{OH})_2$ Nanoparticles. (b) (c) SiO_2 nanoparticles. (d) Clay washing stage (this stage is done several times). (e) Clay fermentation stage (leaving for 28 days). (f) The stage of clay forming into blocks of regular dimensions. (g) The mud brick blocks after drying. (h) The mud brick blocks after cut into cubes with dimensions of ($4 \times 4 \times 4 \text{ cm}^3$).

Three different modules have been prepared to prepare the proposed adobe brick blocks (**Figure 3**).

The first model (M1): Natural components (60% clay – 20% sand – 10% lime – 5% pottery powder – 5% straw) that were traditionally used in adobe brick production were used without adding any improvements.

The second model (M2): Involved the addition of nano calcium hydroxide ($\text{Ca}(\text{OH})_2$) to the soil mixture and other additives, as the following; (45% clay – 20% (1 - 2 mm maximum aggregate dimension of sand) – 10% red bricks powder – 5% straw – 20% nano lime ($\text{Ca}(\text{OH})_2$).

The third model (M3): Involved the addition of nano silica (SiO_2) to the soil mixture and other additives, as the following; (45% clay – 20% (1 - 2 mm maximum aggregate dimension of sand) – 10% red bricks powder – 5% straw – 20% nano silica (SiO_2)).

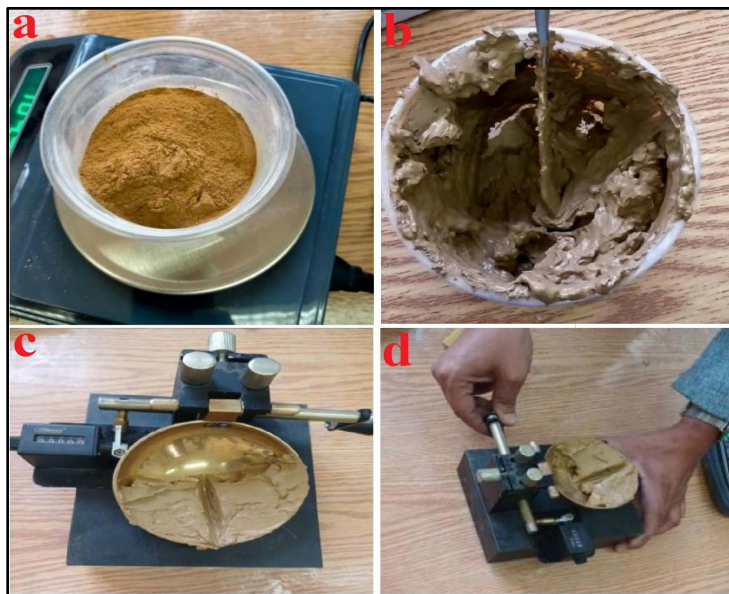
Figure 4. Steps for performing the Atterberg limit test. (a) Weight of the dry soil. (b) The sample is mixed with a suitable amount of water. (c) A portion of the mixture is placed in the front part of the casagrande device. (d) Turn on the device, which operates at a rate of two blows per second.

Determining Liquid Limit (LL) and plastic limit (PL) experiment (ASTM D4318) (Figure 4):

- The sample is ground and passed through a No. 40 sieve to obtain a homogeneous sample.
- The sample is mixed with a suitable amount of water to obtain a soft paste.
- A portion of the mixture is placed in the front part of the Casagrande device.
- The mixture is divided into two parts using a special tool.
- The device is operated, and the number of blows required for the two parts to close over a distance of (13) mm is recorded.
- Turn on the device, which operates at a rate of two blows per second, causing partial flow of the mixture until the two parts are (13) mm apart. The device is then stopped and the number of blows is recorded.
- After the two parts of the paste have closed, the closed portion is taken and weighed wet, then dried in an oven then weighed dry.
- The test is repeated after changing the water content of the paste, and the number of blows is recorded each time.

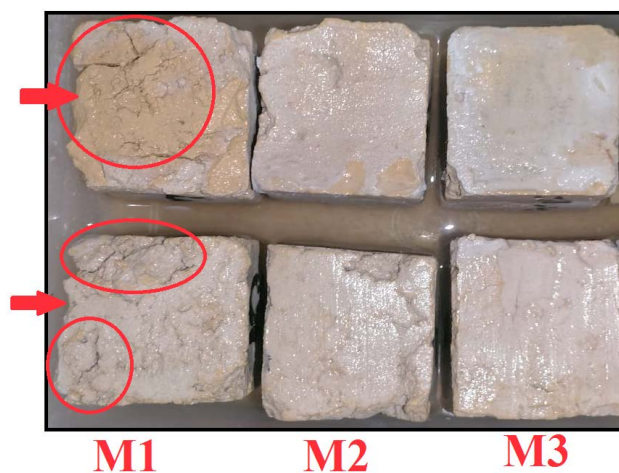
Figure 5. The new mud brick specimens during partial immersion in salt solution, M1 show swelling and cracks in mud brick surface, and M2 and M3 show accumulation of salt on bricks surface.

The specimens were dried in oven at 60°C for 24 hours, allowing the samples to cool to room temperature and their weights were recorded. Then partially immersed in a 25% solution of sodium chloride (NaCl)/sodium sulfate (Na_2SO_4) for 4 hours, the specimens were dried at room temperature for 8 hours. The specimens were dried in oven at 60°C for 4 hours, Then repeat these steps for 15 cycles (Figure 5).

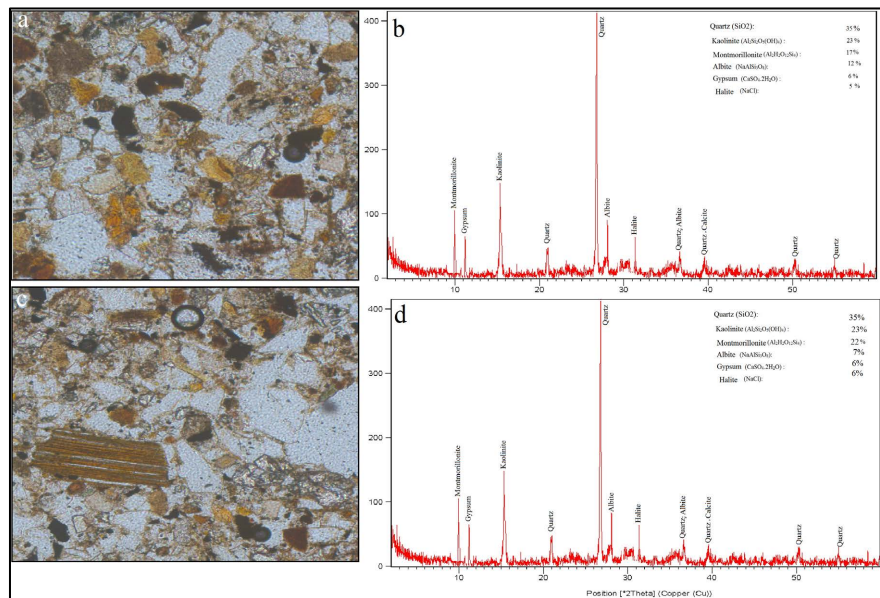
Figure 6. (a) (c) Photomicrograph of thin section of deteriorated mud brick shows quartz grains that are medium to coarse-grained, clay minerals, salts were found. (b) (d) XRD pattern of deteriorated sandstone samples of case study.

Polarized light microscopy (PLM) examination of the mud brick used in the enclosure wall of Dendera Temple revealed a primarily consisting of quartz grains that are medium to coarse-grained, clay minerals including kaolinite, montmorillonite, feldspar minerals comprising albite, gypsum and sodium chloride. Notably, the mud brick exhibited relatively height percentage of clay minerals and salts. clay minerals and salts, as the high percentage of clay minerals caused the swelling phenomenon, which is considered a major cause of damage to adobe blocks.

X-ray diffraction (XRD) analysis of the mud brick samples revealed that they are primarily composed of Quartz (SiO₂) (35%), Kaolinite (Al₂Si₂O₅(OH)₄) (23% - 25%), Montmorillonite ((Na, Ca)0.33(Al, Mg)₂(Si₄O₁₀)(OH)₂·nH₂O) (17% - 22%), Albite (NaAlSi₃O₈) (7% - 12%), Gypsum (CaSO₄·2H₂O) (6%), and Halite (NaCl) (5 - 6), as shown in **Figure 6**.

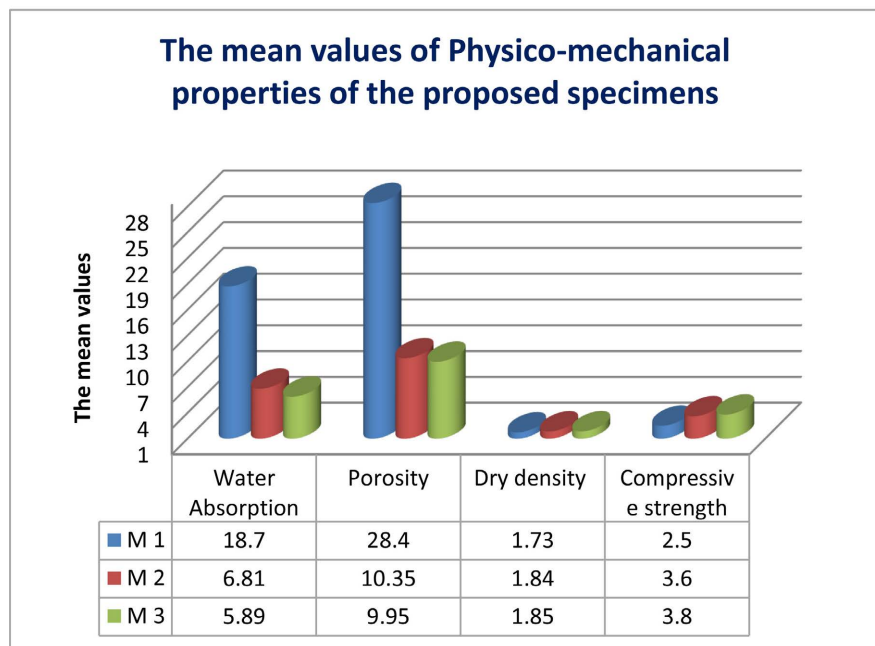
Figure 8. The mean values of the physico-mechanical properties test of the proposed mud brick specimens.

Figure 8 shows the physico-mechanical properties which revealed that the second model (M2) had an average density of 1.84 g/cm³, which was a 6.4% increase compared to the density of the first untreated model (M1), which was 1.73 g/cm³. The third model (M3) achieved an average of 1.85 g/cm³, an increase of 6.5% compared to the first untreated model (M1).

It was found through a water absorption test that the second model (M2) achieved an average of capillarity water absorption of 6.81%, a decrease of 63.6% compared to the first untreated model (M1), which achieved a water absorption of 18.7%. The third model, M3, achieved an average of capillarity water absorption of 5.89%, a decrease of 68.5% compared to the first untreated model (M1).

It was found through a water absorption test that the second model (M2) achieved an average porosity of 10.35%, a decrease of 63.6% compared to the first untreated model (M1), which achieved a porosity of 28.4%, and the third model

(M3) achieved an average porosity of 9.95%, a decrease of 65% compared to the first untreated model (M1).

The mechanical properties of the mud brick specimens revealed that the second model (M2) had an average compressive strengths (3.6) MPa which achieved a 44% increase compared to the first untreated model (M1), which was (2.5) MPa. The third model (M3) achieved an average of (3.8) MPa an increase of 52% compared to the first untreated model (M1).

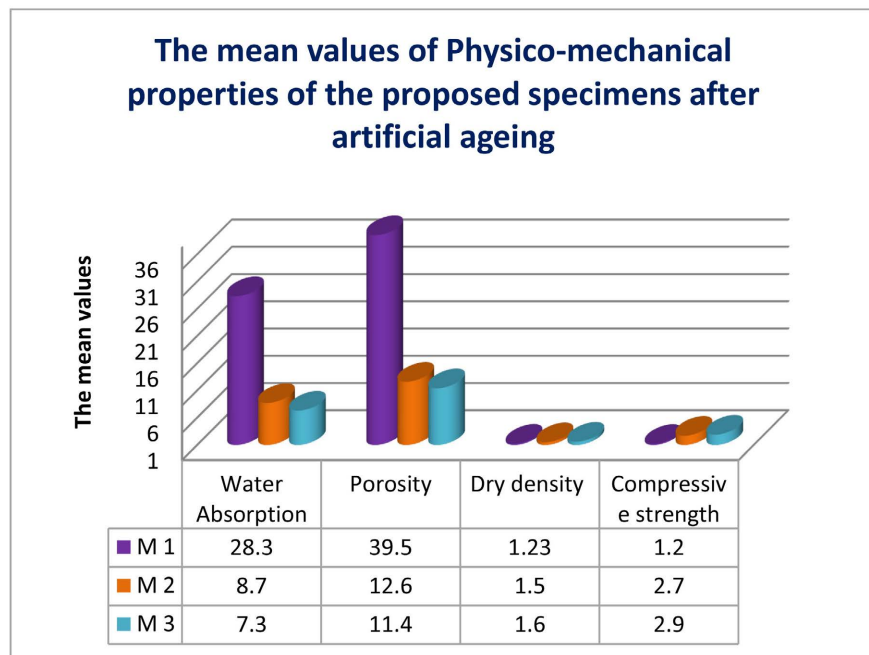
Figure 9. The mean values of the physico-mechanical properties test of the proposed mud brick specimens after artificial ageing cycles.

Figure 9 shows the physico-mechanical properties after artificial ageing by sodium chloride (NaCl)/sodium sulfate (Na_2SO_4). When the mud brick specimens were exposed to salt weathering cycles, it was found that the density of the untreated specimens (M1) decreased by 28.1%, the density of the treated specimens (M2) with nano calcium hydroxide decreased by 18.47%, and the density of the treated specimens (M3) with nano silica decreased by 13.51%.

The results of study revealed that the porosity of the mud brick specimens after subjecting them to salt weathering cycles that the porosity of the untreated specimens (M1) increased by 28.1%, the treated specimens with nano calcium hydroxide (M2) increased by 17.9%, and the porosity of the treated specimens with nano silica (M3) increased by 12.71%.

It was found through a water absorption test that the untreated specimens (M1) increased by 33.9%, the treated specimens with nano calcium hydroxide (M2) increased by 21.7%, and the treated samples with nano silica (M3) increased by 19.31%.

The mechanical properties of the mud brick specimens after artificial ageing

cycles revealed that untreated specimens (M1) had a decrease in compressive strength of 52%, the treated specimens with nano calcium hydroxide (M2) decrease by 25% and the treated samples with nano silica (M3) decrease by 23.7%.
