Hydrological Study (2021-2024) and Physico-Chemical and Microbiological Analysis of the Djoliba River Water in Kouroussa (May-December 2024)

How to cite this paper: Sagno, S., Sakho, A.M., Paul, P.N.T. and Kanté, C. (2025) Hydrological Study (2021-2024) and Physico-Chemical and Microbiological Analysis of the Djoliba River Water in Kouroussa (May-December 2024). *Natural Resources*, **16**, 285-297.

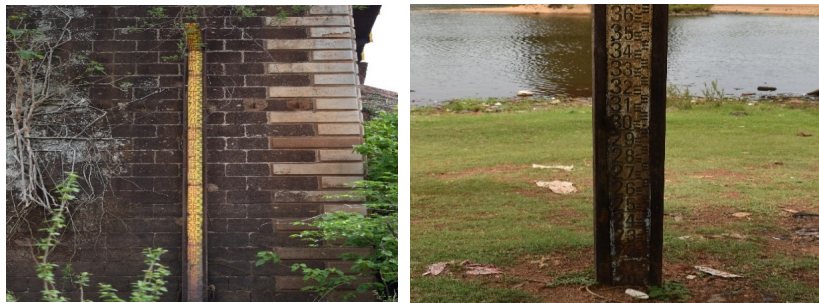
Figure 1. Enamelled steel sheet water level gauge installed at the foot of the historic bridge and in the riverbed in the urban commune of Kouroussa.

The hydrological study technique for the Djoliba River used in this work is based on the monthly determination of water levels over a 4 year period between 2021-2024, of observations using a graduated limnimetric scale, 2 m long and 13 cm wide, installed at the foot of the historic bridge (Niger, Djoliba) in the urban commune of Kouroussa and in the riverbed (**Figure 1**). To take the measurement, stand next to the limnimetric scale and fix your eyes at the water level on the scale closest to the water surface. Read the value found, which will be taken as the height of the water. These measurements were carried out twice a day (7 a.m. and 6 p.m.) for 4 years. Average values for each month and year were obtained by adding the daily values measured at 7 a.m. to each other and those measured at 6 p.m. to each other, divided by 2 respectively, to find the average value for each month (averages h1 and h2).

the volume of water in a river can take from several months to several years. As one of the key steps in the hydrological study of a river, we opted to measure and collect data on water levels during the 2021-2024 period, twice a day (7 a.m. and 6 p.m.), using the limnometric scale installed at the foot of the bridge and in the riverbed (**Figure 1**). Thus, based on the results found, sustainable solutions can be proposed to mitigate risks and improve the water management method. The results are shown in tables. All averages have been rounded to 2 decimal places for greater readability. At the time the water samples were taken for analysis, a number of dead arms were observed in certain areas of the river. Average monthly values of the water level observed on the limnometric scale (year 2021 to 2024) of the Djoliba River in the urban commune of Kouroussa are in **Tables 6-9**.

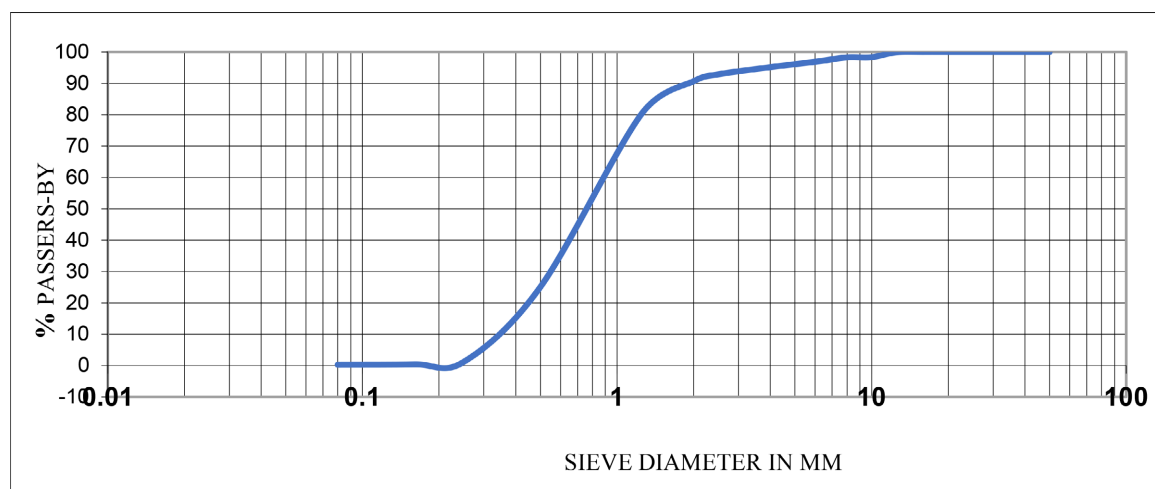
Figure 2. Granulometric curve of the sand sample from the Djoliba River (Kouroussa).

Sand is generally formed by the degradation under the action of the weather and erosion of rocks. Then, drained into water sources and constantly decomposing along the way, forming particles of various sizes. Ains, with granulometric methods, the different sizes of their particles can be known using sieving techniques after washing and drying sand grains from 3 kg samples using a series of square meshed sieves with standard NF XP 13-901 on CEB (A. F.N.O. R) [15]-[18]. These meshes are superimposed one on top of the other, their diameters successively decreasing downwards [9]. The results are shown in **Table 1** and **Figure 2**.

The extensive silting of the Djoliba River led us to take a number of steps, including a granulometry study, to determine the type and origin of the sand in the Djoliba River at Kouroussa (**Figure 2** and **Table 1**).

According to the results in (Table 1), the number of 100% passes was obtained with 50 to 12.50 mm sieves. However, refusals were obtained with 10.0 to 0.080 mm sieves, which may probably be due to the size of certain aggregates. However, analysis of Figure 2, shows the particle size classification of particles presenting a very narrow β -shape blend. An important element here, but little developed, is the correlation that can exist between the composition of the sand on the bank and the quality of the water. The results of field observations show that the nature of the sand can influence the dynamics and quality of the river water. The sites located upstream (S1 and S2) (Tables 2-4 in order), where the substrate (soil on which the bank rests) is formed of coarse and less compact sand, one of the factors for better infiltration of water thanks to the level porosity of the soil. This granular structure allows water to pass through in depth. It limits the speed of surface runoff and acts as a natural filter, in order to obtain water of relatively better quality.

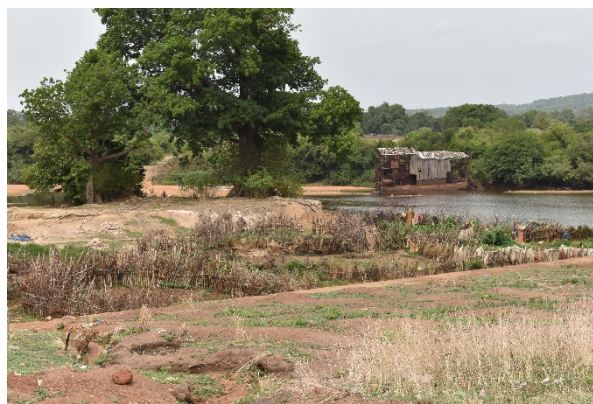
Figure 4. Showing a dead arm fed during high water.
