New Proposal for Seismic Rehabilitation of Hospitals in Cuba

This work presents the seismic evaluation and the rehabilitation proposal of one essential facility, specifically the “Guillermo Luis” hospital of the Moa city in Holguín. The authors intend to apply, for the first time, a non-conventional technique used in Cuba to seismic protection of facilities health. This solution is based on seismic energy dissipation mechanisms, by mean of shear link device. The Shear Link-Bozzo device, allows the “GIRON” precast concrete systems to improve the inadequacies of behavior under earthquake lateral load by avoiding the undesired failure mechanism, such as: weak story and torsion due to great stiffness and mass asymmetries. All the above mentioned aspects drive us to take some alternative measures of seismic retrofit for these typical structures, based on the incorporation of the passive energy dissipation that allows the system to behave in the elastic range of response. By means of this solution it is possible to reduce the interference during the rehabilitation works, and also to reduce the time of break services of the hospital.

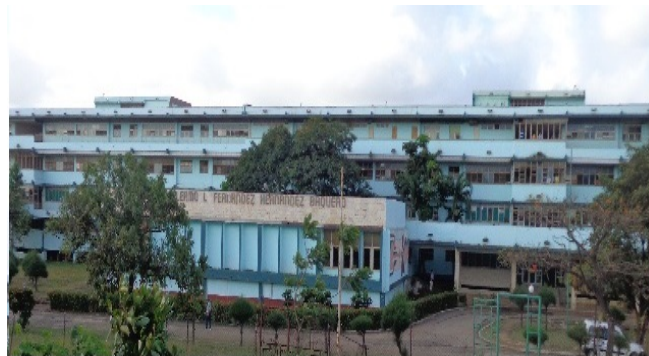
Figure 1. (a) Regional location of the building at the Moa city, Holguin province, Cuba; (b) View of the “Guillermo Luis” hospital, Building of Block 2 area in which hospitalized patients are located.

The building under study is the Clinical-Surgical Hospital "Guillermo Luis" located in Moa. **Figure 1(a)** shows the regional location of the Moa city at the Holguin province of Cuba. Because of its extension the building was fragmented in parts for its study. Taking advantage of the construction joints that divide the two blocks of the main building it was divided into two part or blocks, establishing as priority the assessment and retrofit of the part of the structure corresponding to the building of hospitalized patients, called Block 2, which is shown in **Figure 1(b)**. The information collected for the initial works proved to be essential in the development of the later stages, related with the computations of vertical loads and seismic horizontal actions. More than 600 drawing documentation belonging to the original layout (architectural and structural drawings) of
