Failure Analysis of Transverse Cracks in API 5L X70M Pipes

Abstract

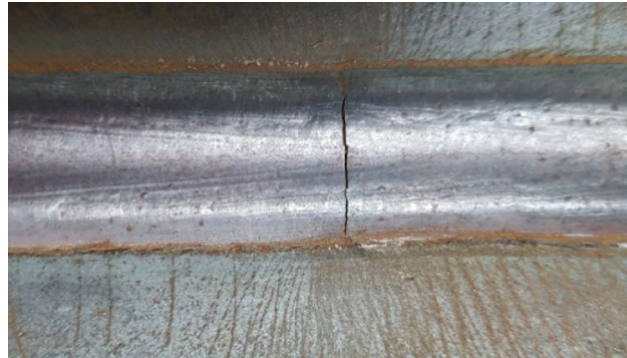
inspected, and segments containing transverse cracks were cut and retrieved (**Figure 1**). These cracks often resulted from fatigue, corrosion, or external mechanical damage. Field samples provide insights into real-world failure mechanisms under varying environmental and operational conditions.

Figure 1. Illustration of a cracked pipeline section retrieved from a field failure.

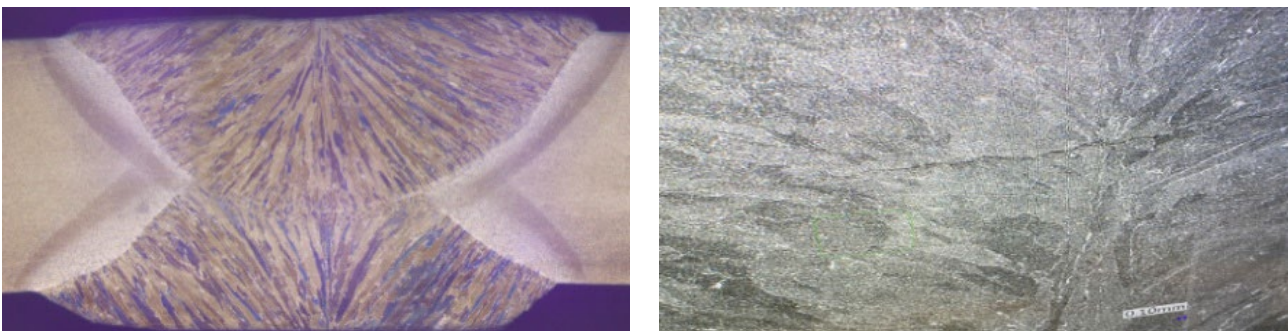
2) **Laboratory Testing:** Controlled experiments were conducted on pristine pipe segments to simulate transverse cracking. Methods such as cyclic loading, thermal stress application, or notch induction were employed to generate cracks under monitored conditions. These laboratory samples help isolate specific variables influencing crack formation and propagation (**Figure 2**).

Figure 2. Macro sample of Transverse crack in pipe.

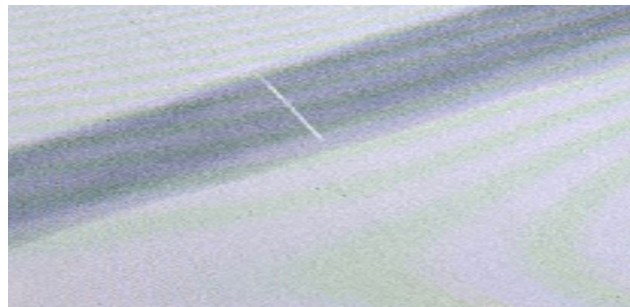
Digital Radiography (DR) is a form of X-ray imaging where digital sensors are used instead of traditional photographic film. It provides instant image viewing, enhanced image processing, and easier storage and sharing of results. **Figure 3** shows a digital image of a transverse crack.

Figure 3. Involves passing X-rays or gamma rays through the pipe and capturing the image on film, Detects internal cracks and voids.

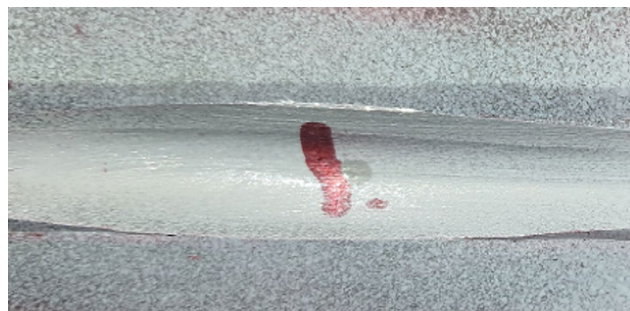
Dye Penetrant Testing (DPT) is a non-destructive testing (NDT) method used to detect surface-breaking defects in non-porous materials. It involves applying a visible or fluorescent dye to the surface, allowing it to seep into cracks, removing excess dye, and then applying a developer to draw out the dye from defects, making them visible under appropriate lighting. **Figure 4** shows the DPT result for this transverse crack.

Figure 4. A colored or fluorescent dye is applied to the surface, penetrating open cracks. Excess dye is removed, and a developer highlights the cracks.

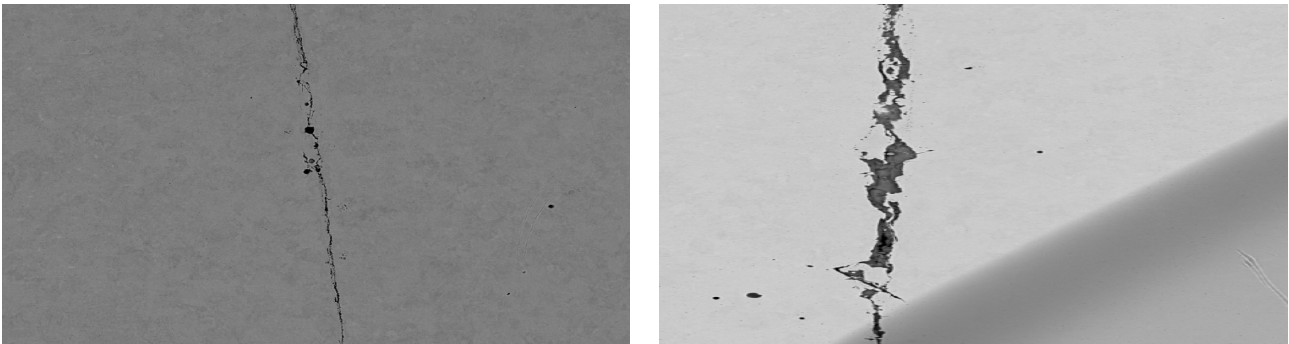
Scanning Electron Microscopy (SEM) is a technique that uses a focused beam of electrons to create high-resolution images of a sample's surface, revealing its texture, composition, and topography at the microscale. **Figure 5** shows the SEM result of the sample.

Figure 5. SEM image of crack @ 350X.

- The analysis showed distinct crack propagation paths influenced by material heterogeneities, such as inclusions and phase boundaries.
- Surface features near the crack edges showed signs of oxidation and material degradation.
- Elevated concentrations of Mn and O were detected along the crack edges.
- Quantitative analysis revealed Mn content ranging from 32.9 wt% and O content ranging from 33.35 wt%, suggesting the presence of manganese oxides.

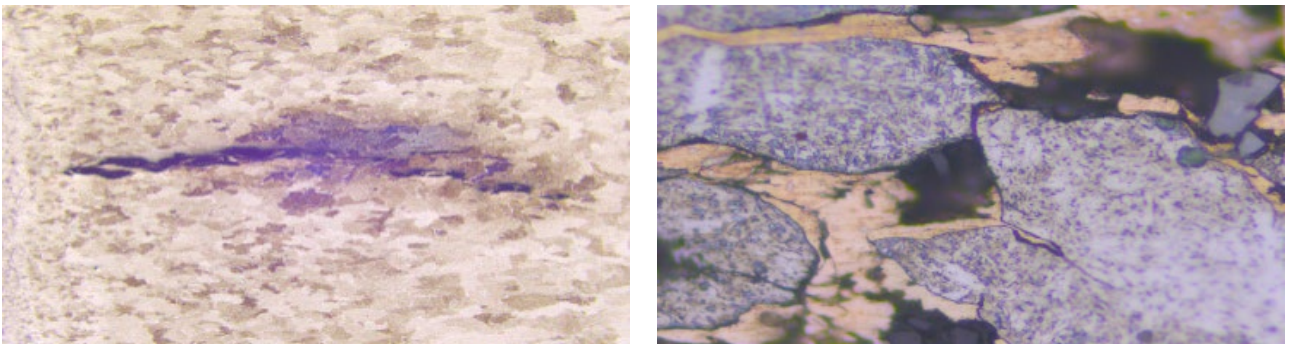
Figure 6 shows the polished and etched cross-sections to examine microstructures, revealing features like grain boundaries, inclusions, and voids for a sample having a transverse crack.

Figure 6. Uses polished and etched cross-sections to examine microstructures, revealing features like grain boundaries, inclusions, and voids.

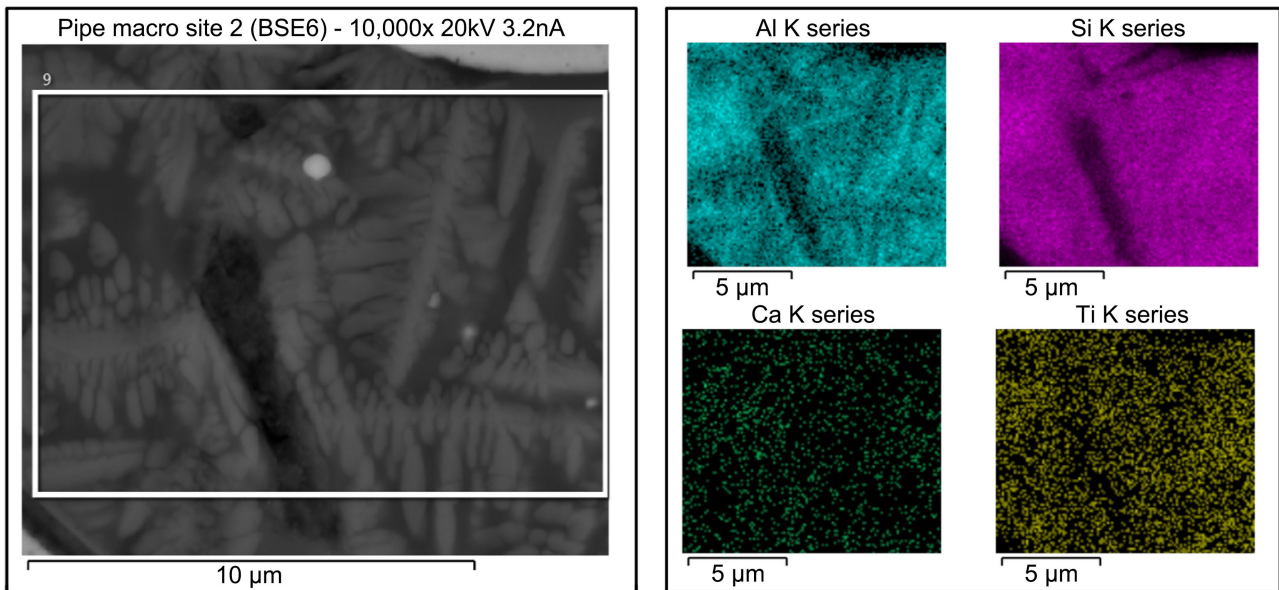
- Elemental mapping confirmed that Mn and O were localized predominantly at the crack tips and along the walls.
- **Figure 7** & **Figure 8** show exogenous material in the weld bead that is high in silicon and oxygen together with aluminum, calcium, titanium, manganese, and iron. The chemical makeup together with the location of the inclusion indicates that it is likely slag, flux, and/or oxides.

Figure 7. EDS images of crack with surface elements distributions.

- The examined regions of the exogenous inclusions all contain concentrations of silicon, oxygen, aluminum, calcium, manganese, and iron. All these elements concentrated together indicate that the inclusions are likely a combination of flux, oxides, and/or slag most likely all three.

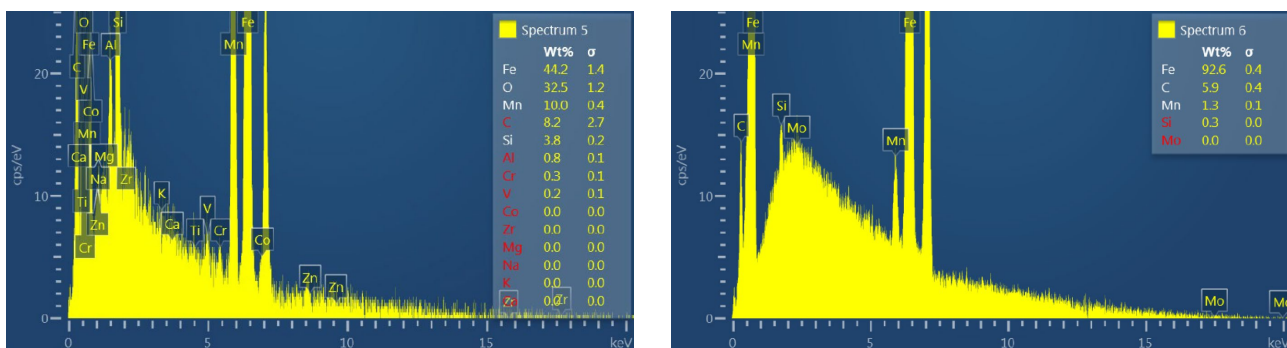
- As welding flux that has gathered metallic oxides (as is intended) the resultant slag was somehow trapped in the weld rather than floating to the surface. Reference back to **Figure 9** shows that this exogenous material is inside the weld bead of the first weld pass on the inside of the pipe. Entrapped slag or oxides are generally due to the technique or operation of the welding machine. The amounts of silicon and oxygen are much too high to have come from the base metal. The location within the weld bead at the parent metal interface reinforces this assertion.

Figure 9. Slag (internal defect) found in crack.
