Pathological and Physical Analysis of Reinforced Concrete Poles of Electrical Distribution Network in Côte d'Ivoire

Abstract

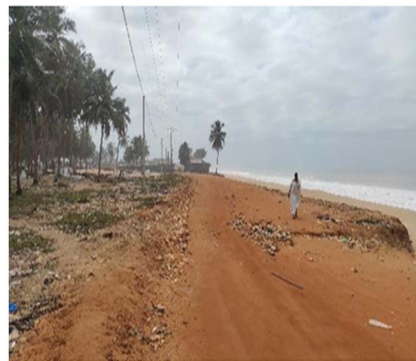
Figure 3. Study zone photography.

The study was conducted in southern Côte d'Ivoire, at the Grand-Bassam site, specifically in the village of Azuretti. Due to its geographic location at the coast of the sea, the electricity poles are affected by sea salt. Grand Bassam is a coastal town in Côte d'Ivoire, located 43 kilometers east of Abidjan. The city has a tropical climate characterized by high temperatures of (21 °C to 35 °C) and dense humidity particularly during the rainy season [7]. Azuretti, a small village nestled between the lagoon and the ocean, is now lined with concrete electricity poles. In fact, many of these poles are less than ten years old, which corresponds to the warranty period for concrete poles against manufacturing defects according to standard NF C 67-200 and its equivalents. Two categories of poles are available in this zone, namely low-voltage (LV) public lighting poles up to 10 m high and medium-voltage electricity distribution poles reaching 14 m high with a voltage of 15 kV. **Figures 1-3** show, respectively, the location of the study area in Côte d'Ivoire, a satellite image of the study zone, and a photograph of the beach under study, illustrating the electricity poles along the coast.

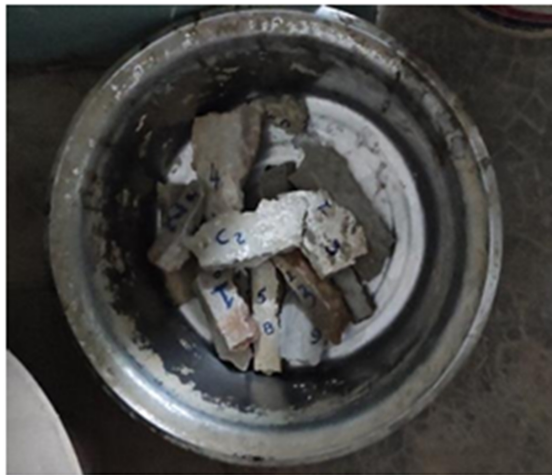
Figure 4. Sample collection.

Hydrostatic weighing is a systematic process used to evaluate the physical properties of samples, including the porosity, density and water absorption of concrete. In this test, samples of poles, as shown in **Figures 4-7**, are subjected to a specific treatment. After collection, the samples are placed in an oven at 105°C for 24 hours to determine their dry mass (DM), which is measured using an electronic balance. After this, the samples are immersed in water for 24 hours to reach water saturation. The samples are then suspended in a basket that is immersed in a water tank, as shown in **Figure 7**, to measure their submerged mass (MH). After being removed from the water and lightly wiped dry, the samples are weighed suspended to determine their saturated mass (MA). This methodical process aims to evaluate various properties of the pile samples poles within the framework of the study [8].

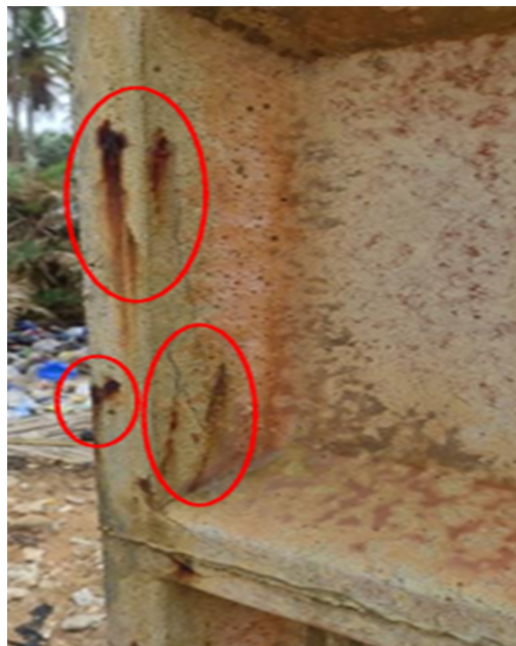
Figure 8. Rust stain.

These stains can be identified by reddish-brown marks (rust), which are caused by the oxidation of pyrite or the presence of other metallic compounds in the stone (**Figure 8**).

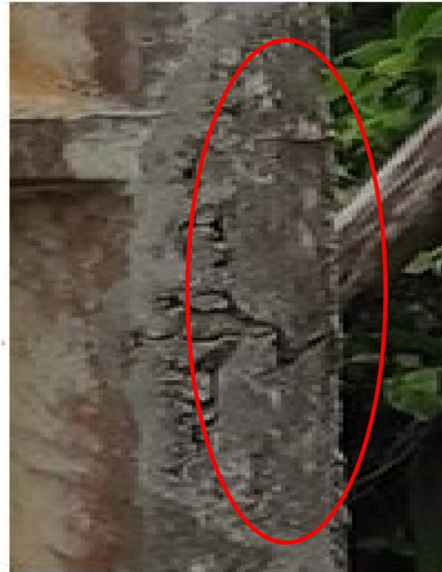
Figure 9. Segregation.

The common signs of segregation are visible in **Figure 9**. Manifestations of concrete segregation include the formation of layers of aggregate and a fine particle of cement on the surface of the concrete, in other words nested stone. It is an aesthetic problem, which creates an opening for aggressive chemical agents. This is caused by an unsuitable concrete mixture and improper application, resulting in poor distribution of its constituents [10]. In addition, segregation is caused by insufficient vibration of the concrete during the pouring of the element, which results in reduced physical and mechanical characteristics of the concrete (high porosity, lower cohesion and strength of the concrete, etc.) [5].

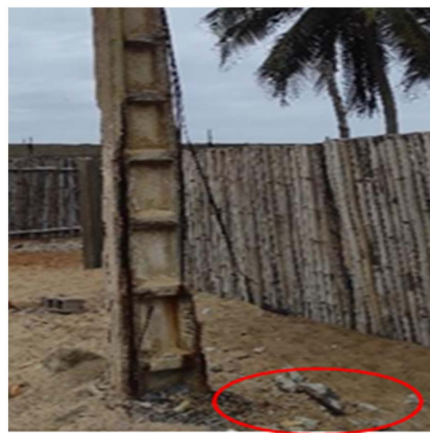
Figure 10. Concrete spalling.

Visible cracks are often the first sign of spalling or bursting (see **Figure 10**). They can be fine or wide, depending on the severity of the problem. They can also be recognized by pieces of concrete that have been detached from the main substrate. This pathology is caused by poor concrete quality, insufficient coating for this type of environment, and the corrosive effect of the sea breeze.

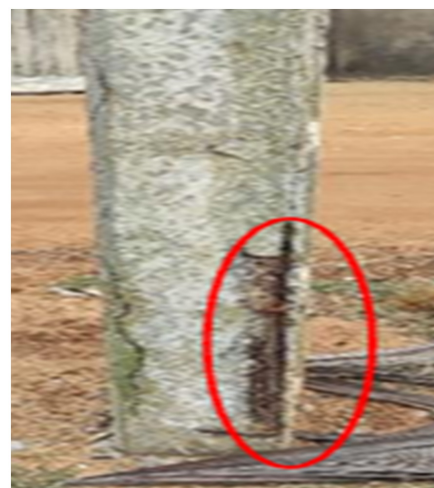
Figure 11. Corrosion.

The steel frames have a reddish-brown color on their surface, as shown in **Fig-**

ure 11. This is the result of an electrochemical process that causes iron to transform into iron oxides. This reaction leads to a loss of steel cross-section, as well as volumetric expansion around the reinforcement bars. This results in the disappearance of the ribbing effect and the appearance of rust stains or discoloration on the concrete surface, as well as cracking of the concrete cover. Corrosion degrades the steel/concrete interface, reducing adhesion between the two materials [11]. Two main phenomena responsible for the corrosion of steel reinforcement are, notably the carbonation of the surrounding concrete through the adsorption of carbon dioxide from the atmosphere and the penetration of ion chloride to the level of the steel frames.

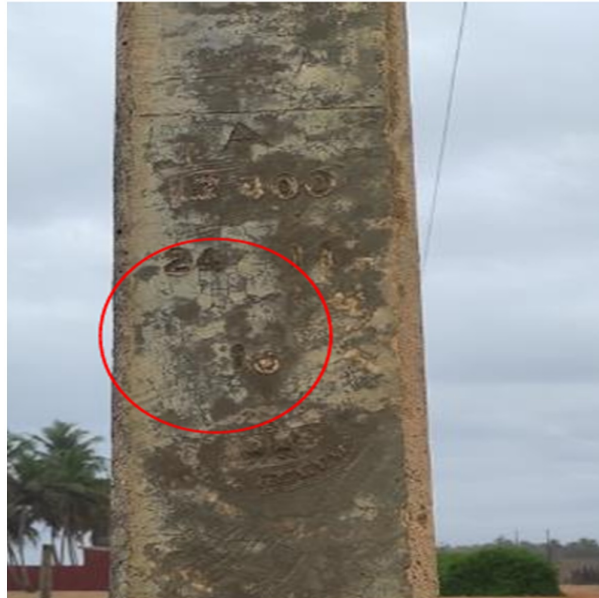
Figure 12. Crazing.

This pathology of the concrete pole shown in **Figure 12** is characterized by fine cracks in the form of spider webs or geometric patterns that generally affect only the top layer of the material without seriously compromising its structural integrity.

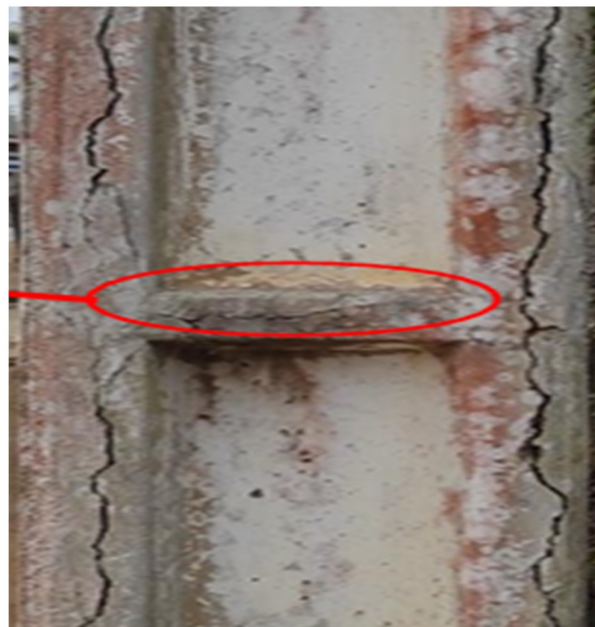
Figure 13. Vertical and horizontal cracks.

Figure 13 shows vertical and horizontal cracks, which are linear openings with a regular pattern and a width of between 0.2 and 2 mm. A crack is a split between two parts of the material that are no longer bound together and are separated. Several types of cracks have been identified, namely vertical and horizontal cracks. These types of cleavage may have diverse causes [1], namely the permanent presence of water, which creates micro-cracks that develop into continuous or discontinuous fissures over time. Cleavage due to swelling is caused by corrosion of the steel frames, while moisture also causes microcracks and manufacturing defects in the concrete (shrinkage, bleeding, etc.).

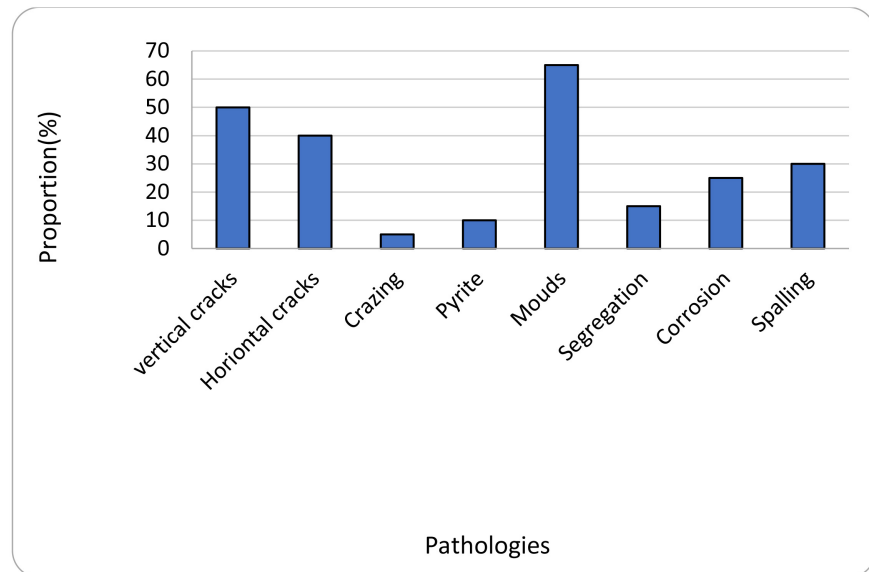
Figure 14. Repair of pathologies of reinforced concrete poles.

The results of this study are presented in **Figure 14**. The most common pathologies are mould (65%), vertical and horizontal cracks (40% and 50% respectively) and spalling (30%). The presence of moulds can indeed be explained by the humid environment and the proximity of the study site to the sea and lagoon. Furthermore, although pathologies such as corrosion and segregation are less common, they can have a detrimental impact on the structure of the building and lead to its collapse. However, pyrite and crazing pathologies are rare.

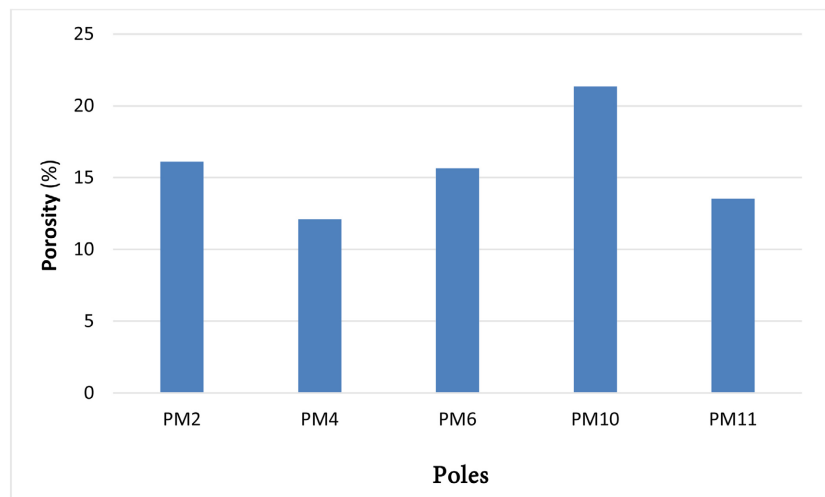
Figure 15. Porosity of concrete samples.

Porosity is the natural consequence of the amount of water added more than that required for hydration and any voids present in the aggregates. **Figure 15** shows the porosity results for the different poles. The concrete resulting from the degraded poles has a porosity ranging from 12.11% to 21.35%. This can be explained by the presence of air bubbles when the concrete is poured and by the rapid evaporation of some of the mixing water, which hinders the crystallization of the cement in the concrete. In porous reinforced concrete, the pores act as pathways through which water or other chemical agents can infiltrate until they reach the reinforcement bars. Contact with these agents leads to the reinforcement bars degrading through oxidation. This causes the bars to swell, resulting in cracking the concrete. Cement-based materials with a porosity greater than 16% have a durability of less than 30 years [12]. Indeed, durability problems are mostly caused by the penetration of aggressive external chemical agents, in solid, liquid or gaseous form, through the pores of the concrete distributed randomly in the hardened cement paste [13]. This implies that pole PM10, which has a porosity of 21.35%, has poor durability of less than 30 years. The structure of pores influences all aspects of durability associated with the transport of active chemical agents and reaction mechanisms. In this context, the density of the microstructure, the quantity of capillary pores, the interconnection and permeability of the pore system, as well as micro-cracks, are among the factors to consider. In cementitious materials, pores form an open and interconnected system [14]. The drawback of this porosity affects both the mechanical strength and durability of reinforced concrete

The data from electricity pole PM10 (**Figures 15-17**) show the lowest density (of

2.05), which translates into the highest porosity (with 21.35%) and water absorption (with 10.43%). This contrasts with the analysis of the physical data from the samples from pole PM4, which show high density (of 2.29) with the lowest porosity (with 12.11%) and water absorption (which is 5.92). When porosity is high, the substrate has a high-water absorption capacity, resulting in low density. Thus, the water, which remains in the substrate for a long time in the presence of humic matter from aggregates (sand, gravel, etc.) or air, causes mineral and biological stains to proliferate. In general, the mechanical strength of cementitious materials depends on their porosity. The more porous they are, the less resistant they become. Also, when the structural elements are very porous, their absorption of water or chemical agents is important, which leads to the corrosion of reinforcements in concrete. This corrosion of the steel frames causes swelling followed by spalling of the parts of the concrete in contact with the corroded part. The origin of this significant porosity is linked to the discontinuity of the size of gravels of the concrete, as well as to high cement shrinkage. Similarly, failure to control the consistency of concrete leads to defects in concrete pouring, which can increase porosity. However, porous concrete has low durability. In addition to these concrete failures, one of the essential elements of concrete columns intended to ensure structural stability, namely the steel frames, is attacked by external agents. Here are the fundamental causes. Indeed, as shown, most of the poles (PM2, PM6 and PM10) have high water absorption of over 6%. This explains the recurring appearance of pathological disorders (see **Figure 13**) such as moulds, *i.e.* microorganisms or fungi, various types of cracks, corrosion and spalling, which over time spread throughout these electricity poles. In the design of electricity poles, very little iron sulphide mineral (pyrite) is present in the aggregates used. When in contact with air (oxygen) and water, pyrite oxidizes, transforms into iron sulphate and swells. The frequency of pathology shows that it is rarely responsible for material deterioration. The same applies to the cracking of reinforced concrete, which is caused by drying too quickly before the application of wet curing. These pathological disorders are very rare or even non-existent on some poles PM4 and poles PM11.

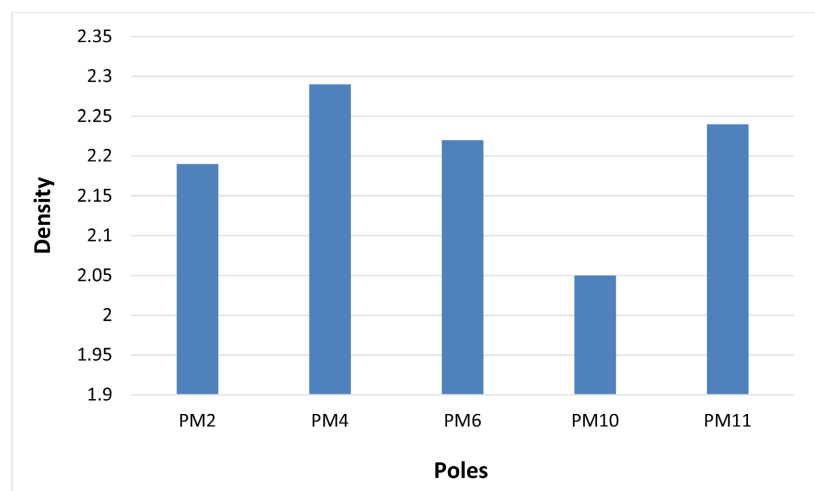
Figure 16. Density of concrete samples.

Figure 16 presents the density results based on the different concrete samples of the poles. According to **Figure 16**, pole PM4 has the highest density followed by pole PM11. However, pole PM10 has the lowest density. The values of the density of the concrete samples show that all the concrete falls within the range from 2.05 to 2.29. According to standard NF EN 206/CN, concrete with a density between 2 and 2.6 belongs to the normal concrete category. Therefore, the various types of concrete used in electricity poles are normal concrete. The density of reinforced concrete affects its durability. Its chemical composition and internal chemical reactions also contribute to its disintegration. Indeed, its density affects porosity and thus the ability of the concrete to resist the intrusion of corrosive chemical substances impacts the degradation of reinforced concrete. High density results in compactness and therefore low porosity.

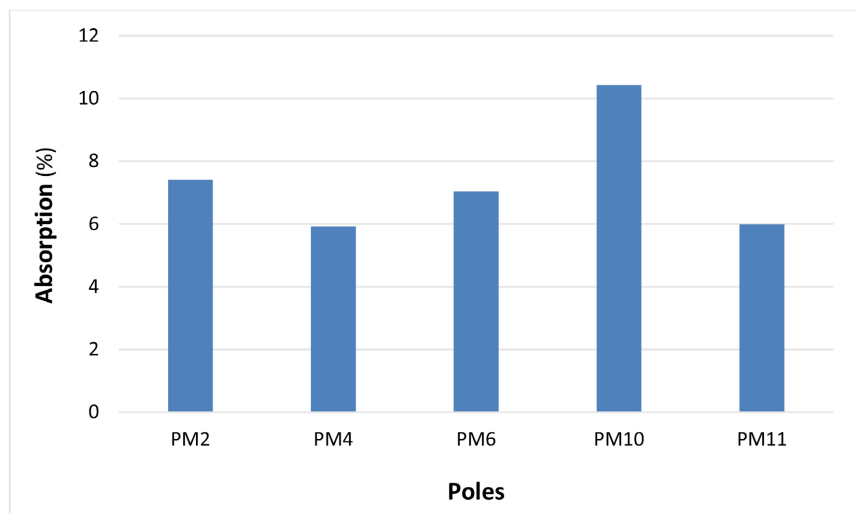
Figure 17. Absorption of concrete samples.

Water absorption is the result of capillary movements in the pores of concrete opening to the exterior environment. The absorption results are shown in **Figure 17**. This figure shows the absorption values obtained on the poles studied, which vary from 5.92% to 10.43%. As shown in **Figure 17**, absorption evolves in a similar way to porosity, as the absorbed water is retained in the pores of the concrete. However, the water absorption coefficient defined by standard NF C 67-250 must not exceed 6%. This indicates that poles PM2, PM6 and PM10 are not certified this standard. Poles PM10 exhibit high absorption.
