# Locating and Projecting Hydrologically Induced Forest Road Vulnerabilities

Nana Agyei Owusu Afriyie<sup>ORCID</sup>, Mark A. Castonguay<sup>ORCID</sup>, Paul A. Arp<sup>ORCID</sup>

Faculty of Forestry and Environment Management, University of New Brunswick, Fredericton, Canada

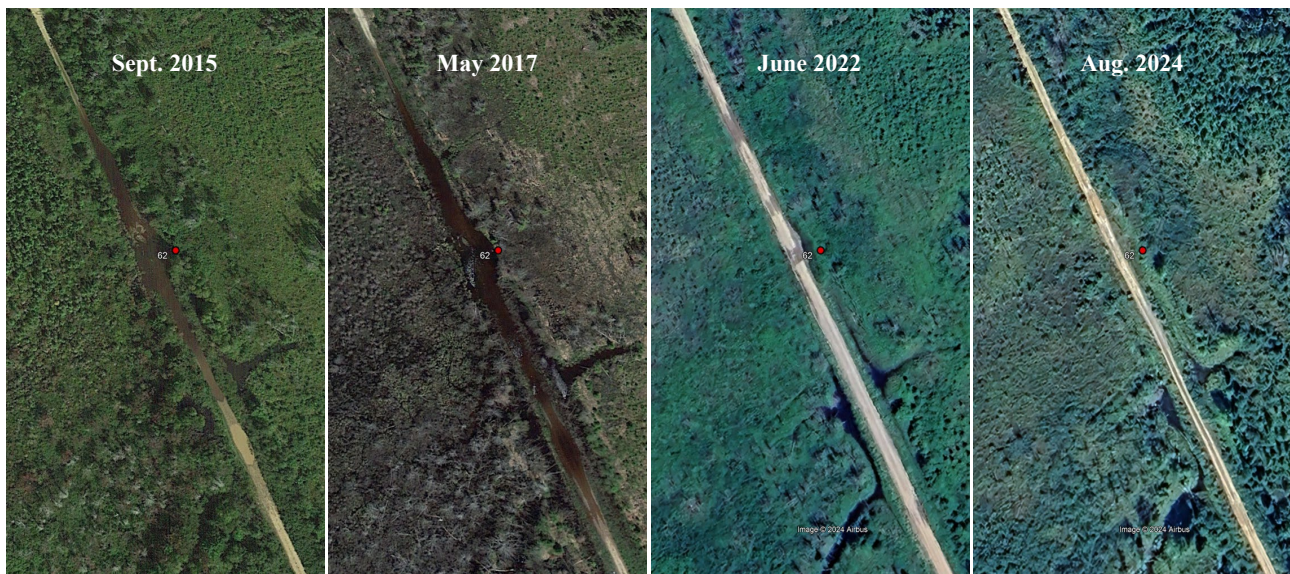
**Figure 2.** Best-focused historical Google Earth images centered on road flooding (Location 62) along the Aboujagane Road before (Sept. 2015, May 2017) and after (June 2022, Aug. 2024) road repair, centered on Location 62.

from June 2015 to August 2024 revealed considerable variations in road segment quality along the Aboujagane Road and elsewhere. The best historical Google Earth Images (**Figure 2**) were used for marking and indexing 67 damaged locations (**Figure 3**) and 27 additional no-damage ridge-top locations along the Aboujagane Road. Doing so produced the road damage index (RDI) as an off-road trafficability indicator, symbolized as no damage 0, rutted 1, braided 2, puddled 3, and flooded 4, and also symbolized as 0, r, b, p, f, respectively, with examples in **Figure 4**. This evaluation was supplemented and confirmed: 1) by on-the-ground roadbed and culvert inspections and 2) AUV imaging in May 2020 (**Figure 3**). The resulting RDI values for the non-upgraded road segments were averaged for further analysis.

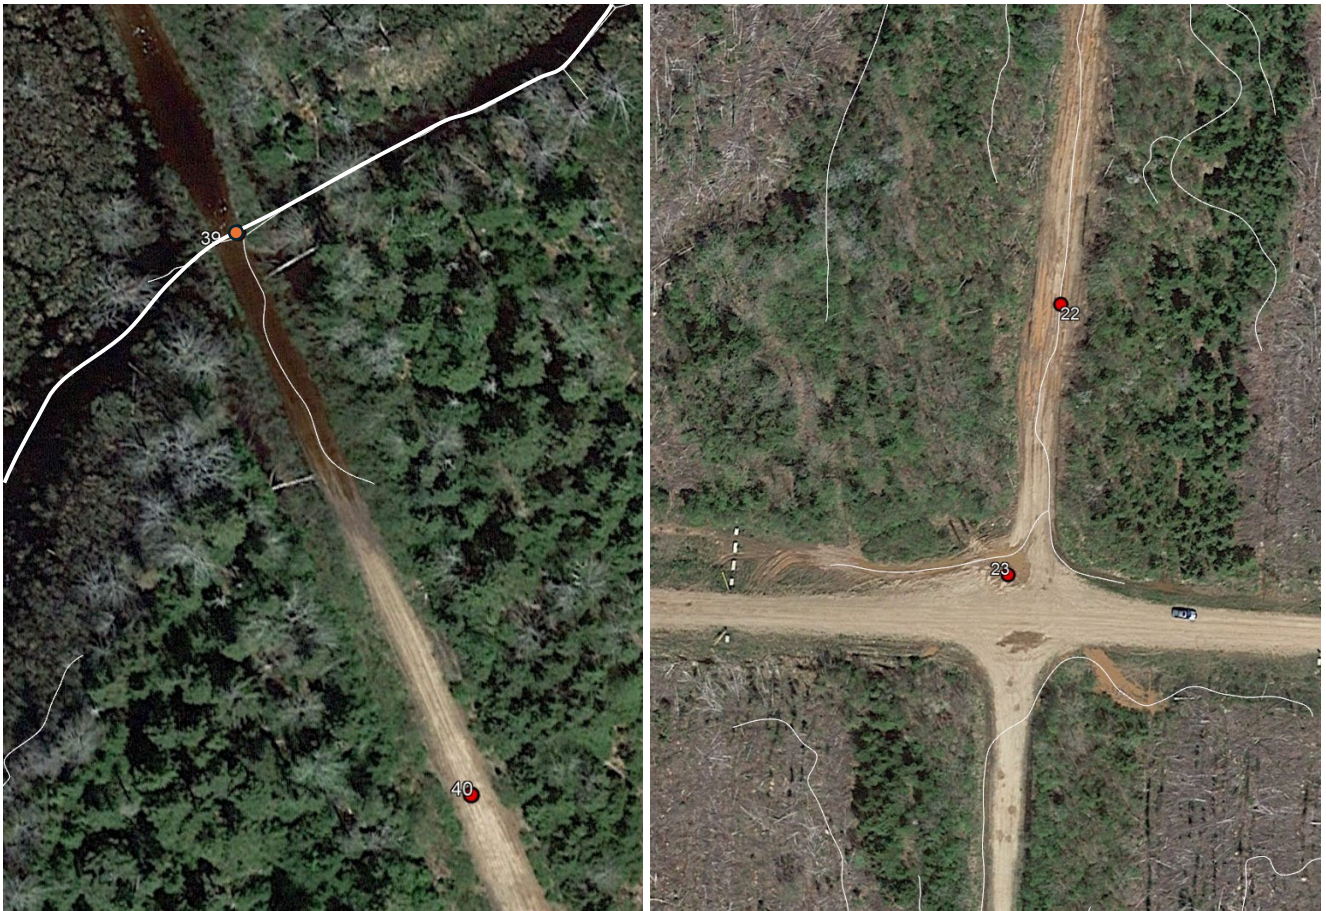
**Figure 4.** Road deterioration examples. Left panel:  $FA > 4$  ha channel-induced flooding (f) at Location 39;  $FA > 0.1$  ha channel-induced rutting (r) at Location 40. Right panel:  $FA > 0.1$  ha channel-induced braiding (b) and puddling (p) at Locations 22 and 23, respectively. Thin and thick white lines: DEM-derived flow channels  $> 0.1$  ha and  $> 4$  ha.

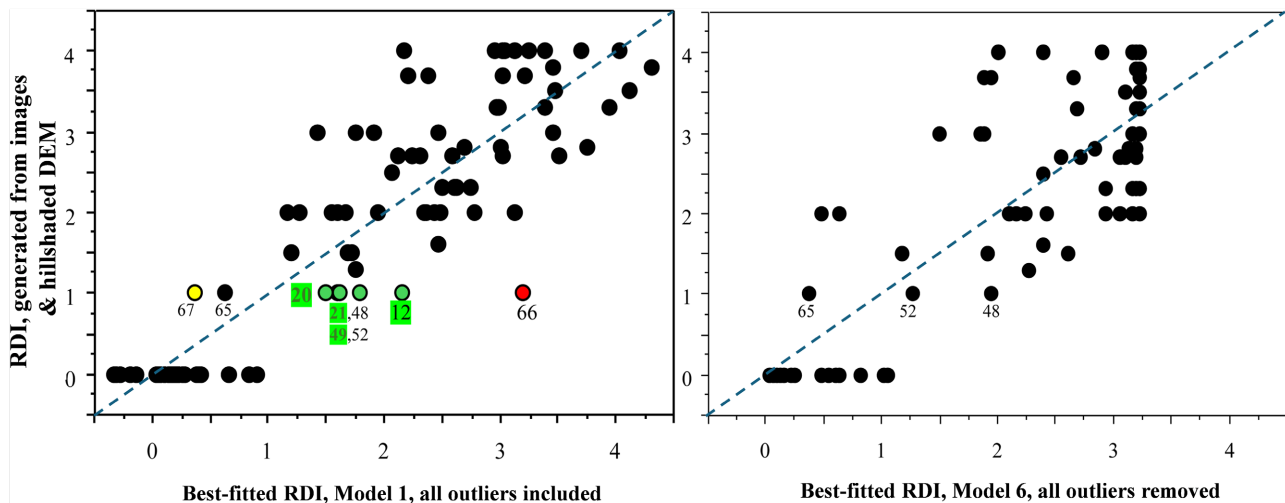
**Figure 7.** Image-determined versus best-fitted RDI scattergrams for Model 1 after removing its Location 66 outlier (red dot, left) and Model 6 (right) after removing its outliers at Location 12, 20, 21, 49, 66, and 67, i.e. dots marked red, yellow and green in the left panel.
