# Middle Mississippi River: A Critical Transportation, Flooding and Ecological Corridor Needs Mitigation and Restoration

Kenneth Ray Olson

Department of Natural Resources and Environmental Sciences, College of Agricultural, Consumer, and Environmental Sciences, University of Illinois, Urbana, USA

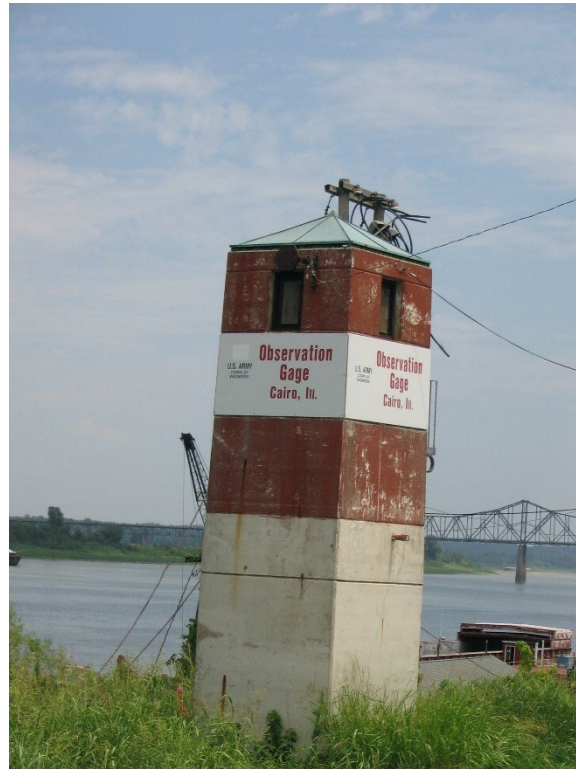
**Figure 3.** The Cairo, Illinois, river gage on the Ohio River is used to determine river height and when it is necessary to open the Birds Point–New Madrid Floodway to relieve downstream river pressure. Photo Credit: Lois Wright Morton. Reprinted with permission from Editor of Journal of Soil and Water Conservation.

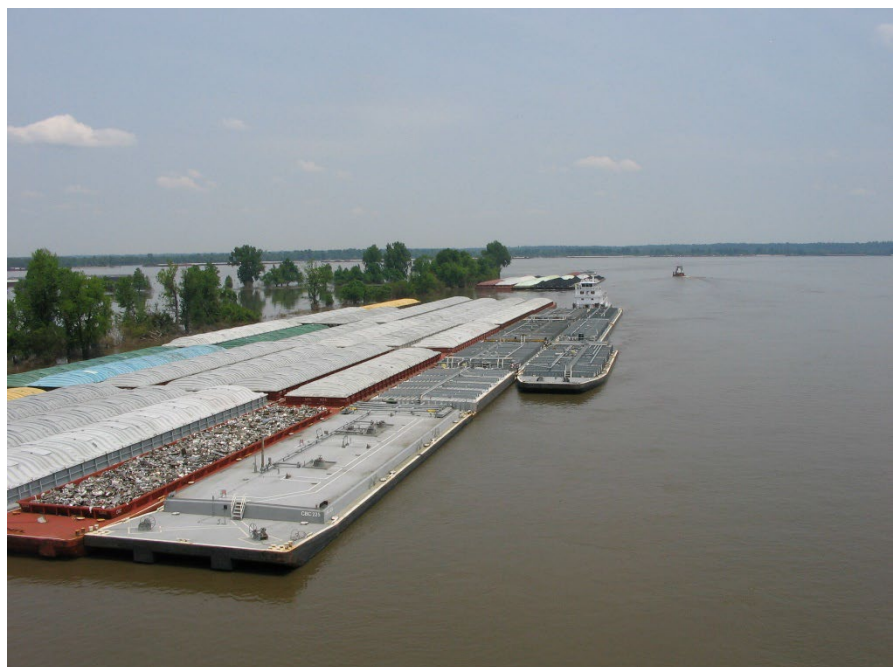
**Figure 4.** During the spring of 2011, barges were anchored on the Mississippi riverbank next to the flooded Fort Defiance State Park. Reprinted with permission from Editor of Journal of Soil and Water Conservation.

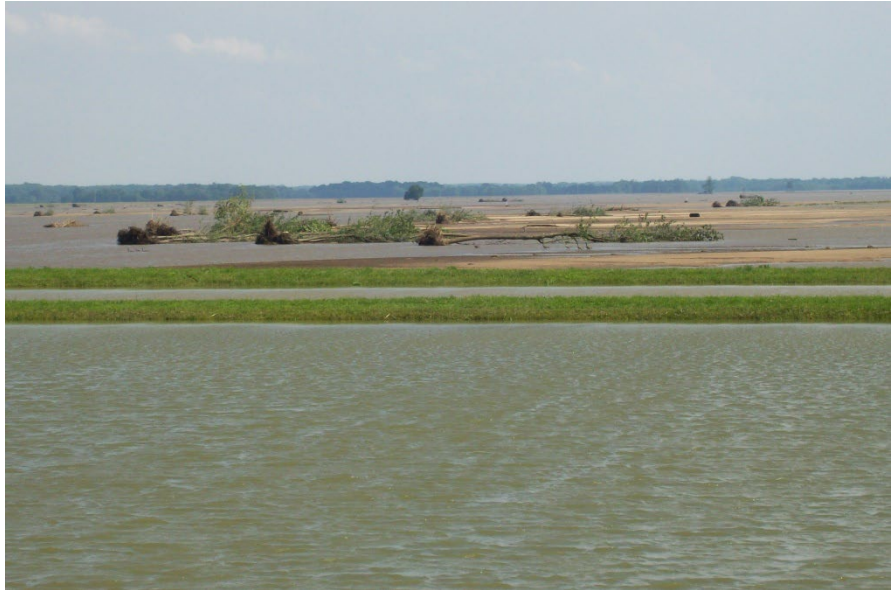
**Figure 5.** Agricultural fields are covered by deltaic sand deposits, water, and trees moved and deposited by rushing water through a levee break on the Embarrass River, Illinois, in June of 2008. Photo credit: Ken Flexter, Jasper County Natural Resources Conservation Service Field Office, Newton, Illinois. Reprinted with permission from Editor of Journal of Soil and Water Conservation.

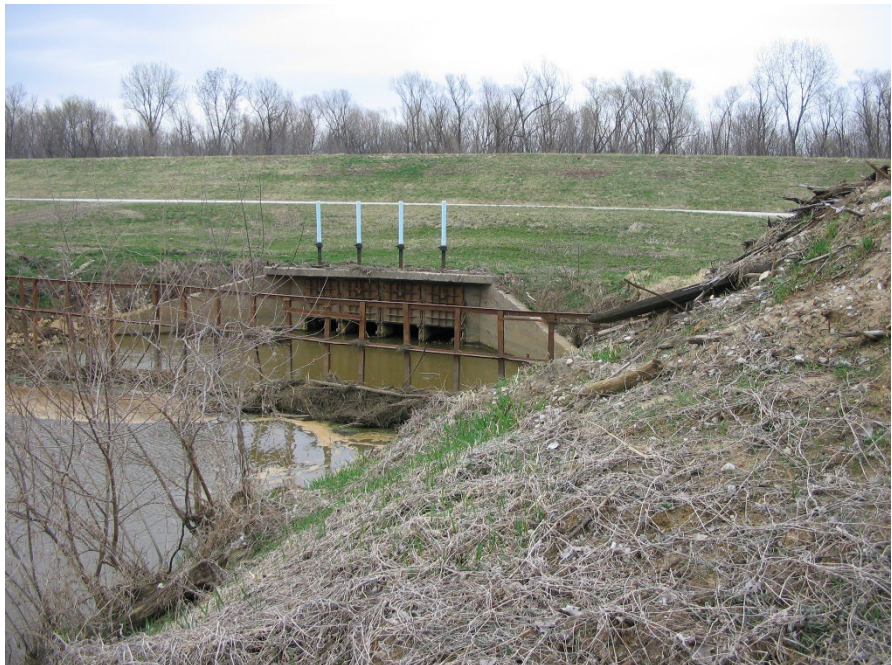
**Figure 6.** The Sny River aqueduct passes under the Kiser Creek Diversion channel. Reprinted with permission from Editor of Journal of Soil and Water Conservation.

that are sources of wealth and risk to those whose lives are intertwined with the rivers. They illustrate levee-protected agriculture and breach management when the river exceeds flood stage (**Figure 5**); dredging in drought to assure a navigable channel; and locks, dams, aqueducts (**Figure 6**), and reservoirs engineered to

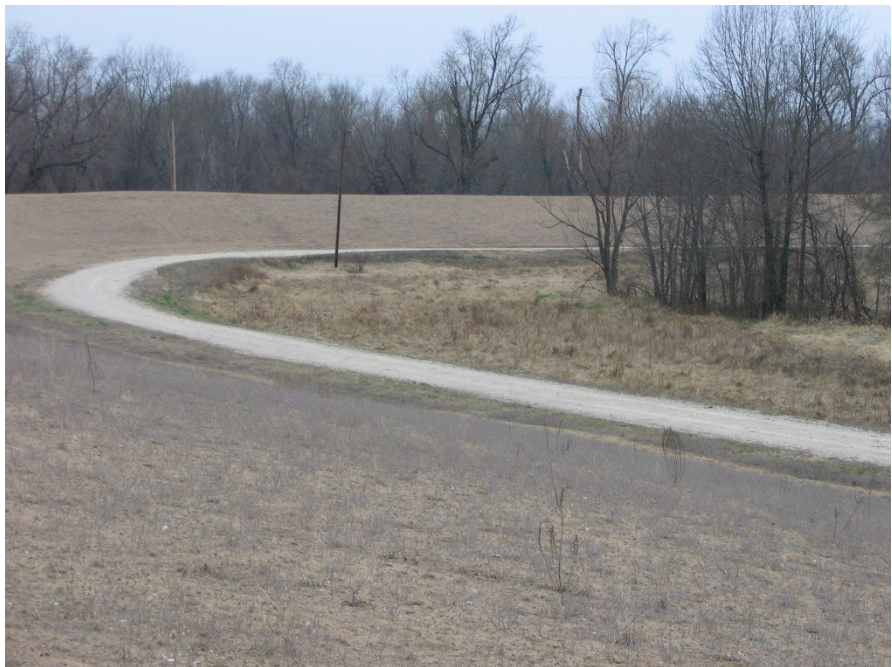
**Figure 8.** The merged Mississippi River and Kiser Creek Diversion levee blocks the Sny River channel flow, and water has to be pumped over the levee to the Mississippi River. Reprinted with permission from the Editor of the Journal of Soil and Water Conservation.

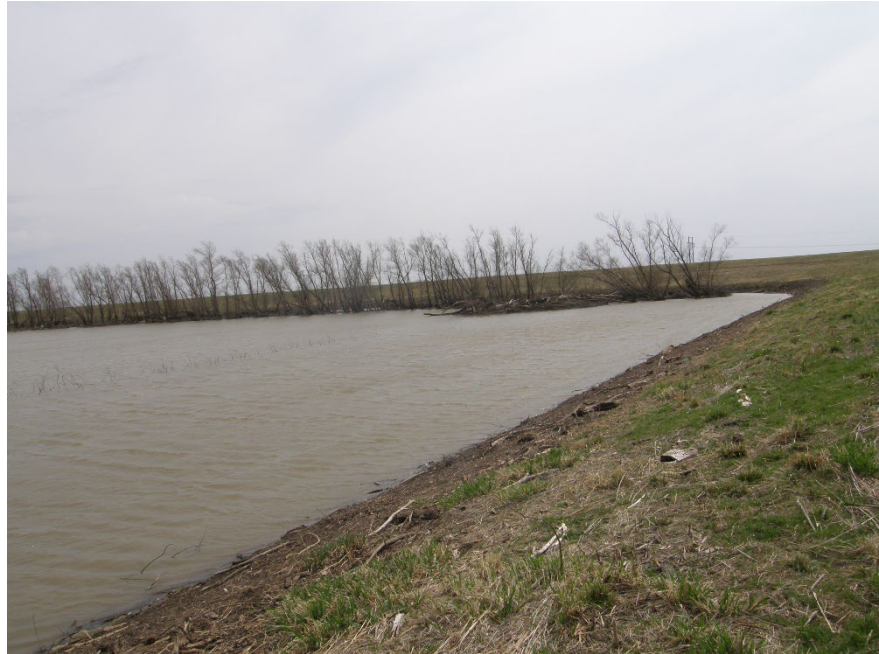
**Figure 9.** The Pigeon Creek settling basin west of Hull, Illinois, is currently active during high runoff and flooding. Reprinted with permission from the Editor of the Journal of Soil and Water Conservation.

The combination of purposefully created wetlands and settling basins (Figure 9) alongside agricultural lands protected by levees provides diverse habitats for wetland species, fishing, and recreational duck and deer hunting. The high cost per hectare of land assessment pushes producers on both bottomlands and uplands to select high-value crops and to farm right to the edge of their internal drainage ditches. Fast-moving, high water in these ditches increased bank erosion where it is not held by vegetation, clogging the drainage system and increasing the need for more frequent ditching and the Sny River channel dredging. Incentives

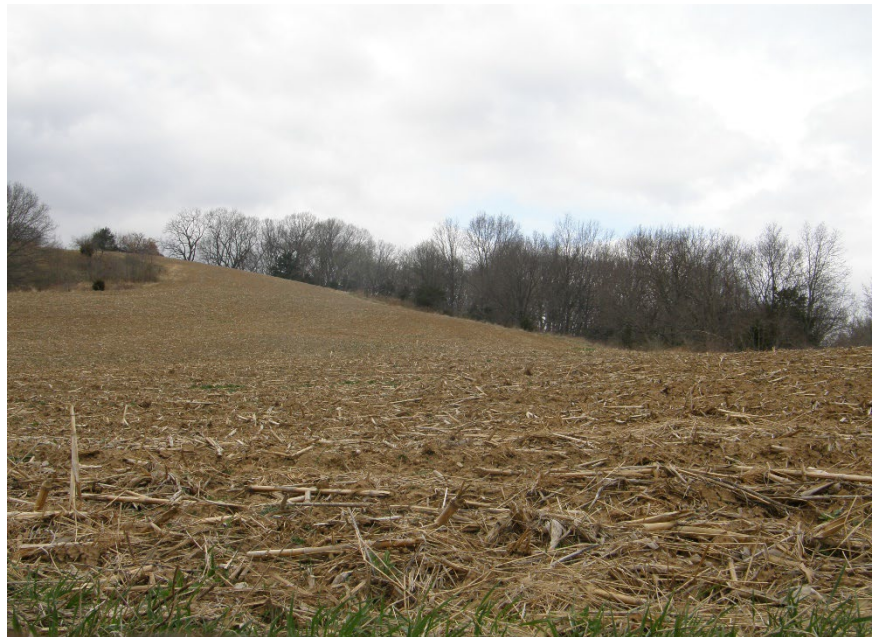
**Figure 10.** Many of the Sny River watershed uplands have no-till corn planted on very steep slopes, which reduces soil erosion into drainage ditches. Reprinted with permission from the Editor of the Journal of Soil and Water Conservation.

to encourage 2 to 3 m vegetative strips along-side these steep ditches are conservation measures that would hold soil in place and reduce the movement of soil from field to water. Much of the upland and bottomland farmland is already in no-till (**Figure 10**), so producers should be encouraged to continue this practice

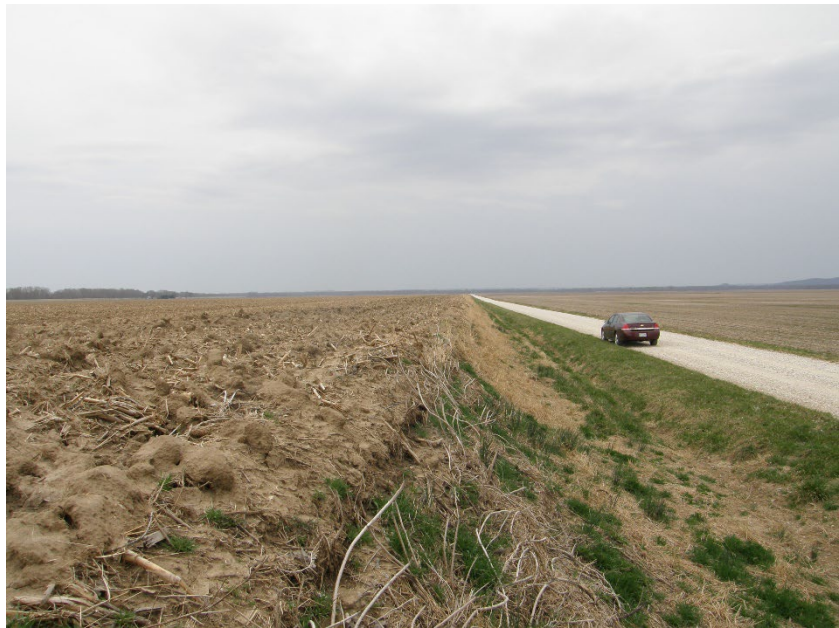
**Figure 11.** A filled Sny River settling basin that is 3 m above the land surface. Reprinted with permission from the Editor of the Journal of Soil and Water Conservation.

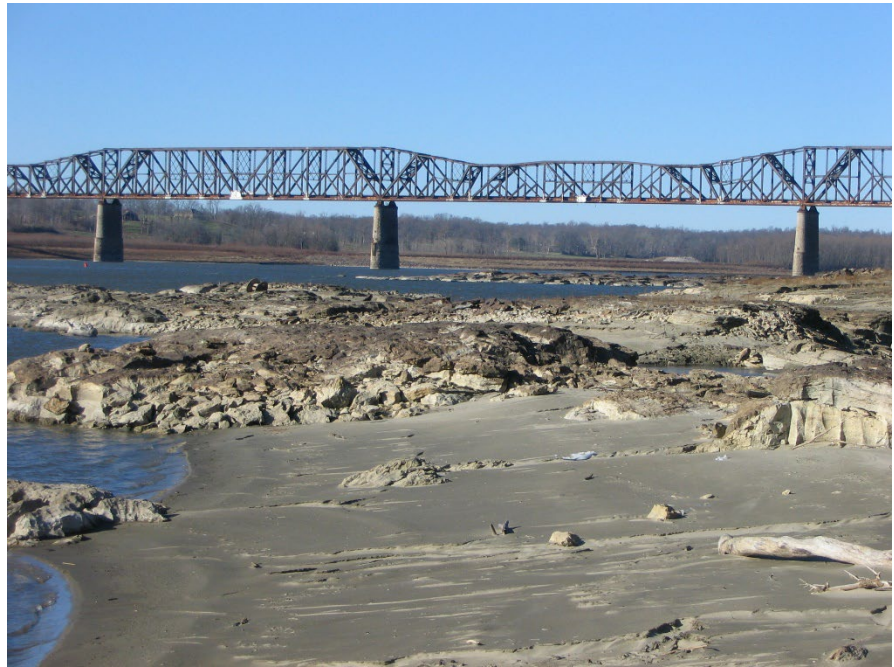
**Figure 13.** Bedrock was exposed and a threat to navigation on the Mississippi River near the Thebes railroad bridge on December 21, 2012, when the river reached a low of 2 meters. Reprinted with permission from the Editor of the Journal of Soil and Water Conservation.

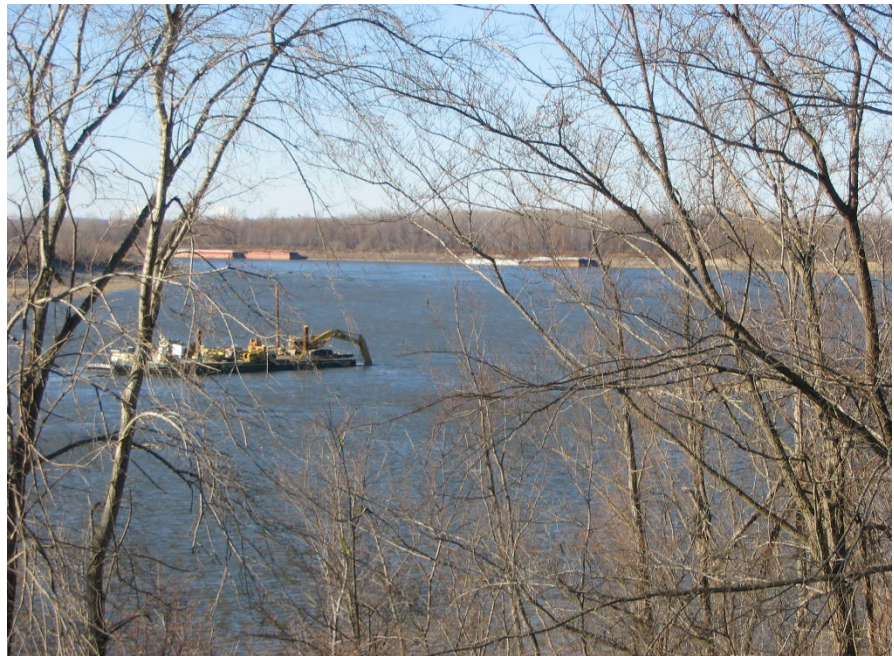
**Figure 14.** River bottom bedrock is dredged using an excavator to increase the navigation depth. Reprinted with permission from the Editor of the Journal of Soil and Water Conservation.

The dredging of the 9.1 km narrow bedrock-lined channel near the town of Thebes, Illinois, required large excavators capable of breaking loose the consolidated river bottom to deepen the channel. The 2.7 m deep and 91 m wide Middle Mississippi River channel was dredged at a time when the excavators (Figure 14) could easily reach the bottom of the shipping lane and were able to restore and maintain the shipping lane for barge traffic as water levels dropped during the drought of 2012 to 2013. Without the dredging work by the USACE, due to low water levels the natural risk to shipping on the Middle Mississippi River was great. All shipping through the Middle Mississippi River corridor would have stopped, possibly for months, which would have been an unacceptable risk to food and national security.

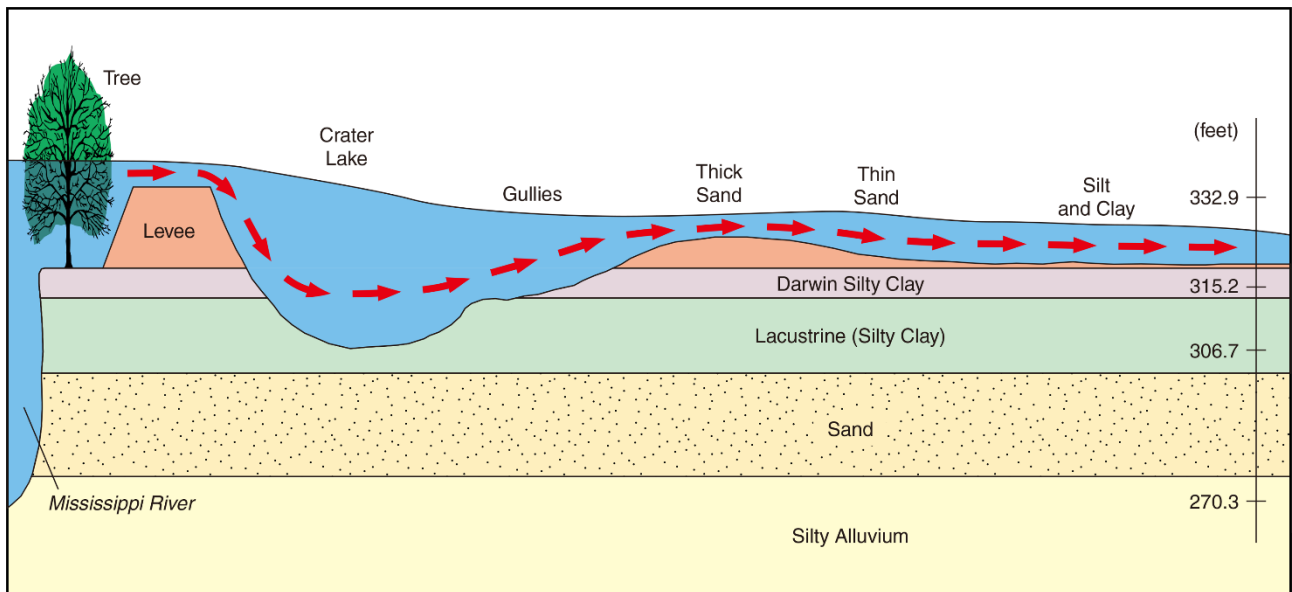
**Figure 16.** Diagram of levee topping by the Mississippi River above flood stage, including a crater lake, gullies, and thick sand deposits. Drawing by Mic Greenberg. Reprinted with permission for Editor of Journal of Soil and Water Conservation.

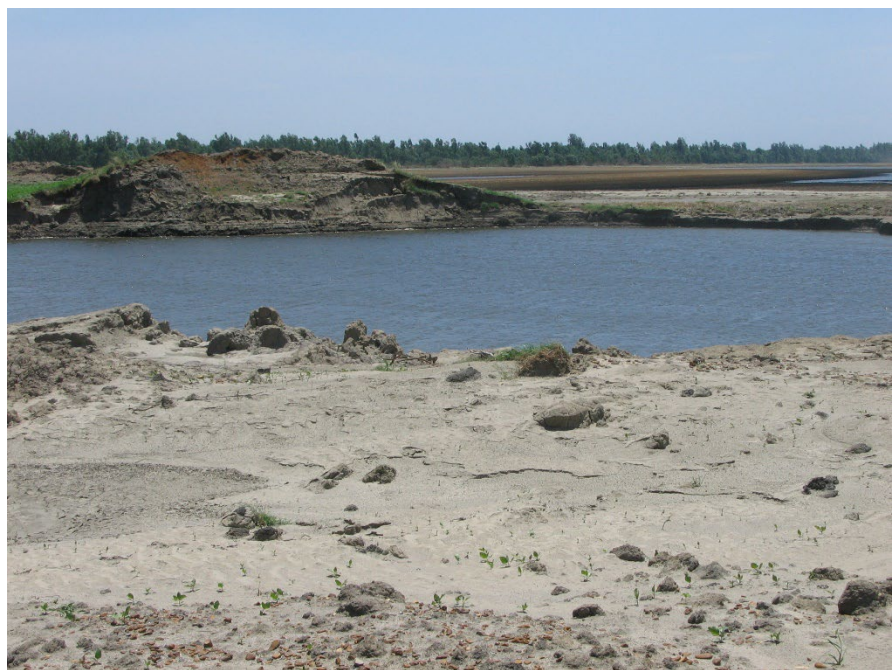
**Figure 17.** The Birds Point levee was the site of the first explosion on May 2, 2011, that opened the New Madrid Floodway and relieved river pressure on the Cairo floodwall. Remnants of the fuse plug levee and the crater lake extend into the adjacent agricultural lands. Photo Credit: Lois Wright Morton. Reprinted with permission from Editor of Journal of Soil and Water Conservation.

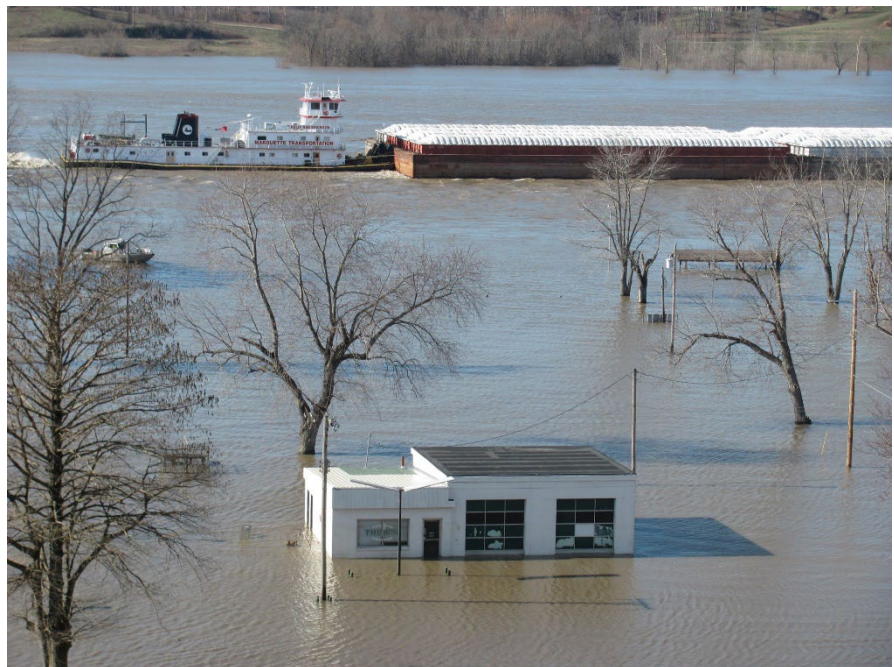
**Figure 19.** Mississippi flooding at Thebes, Illinois, on January 5, 2016. The floodwaters covered the playground and the riverbanks and flooded homes and businesses that were not on stilts. A tugboat is pushing barges upriver in the background. Reprinted with permission from Editor of Journal of Soil and Water Conservation.

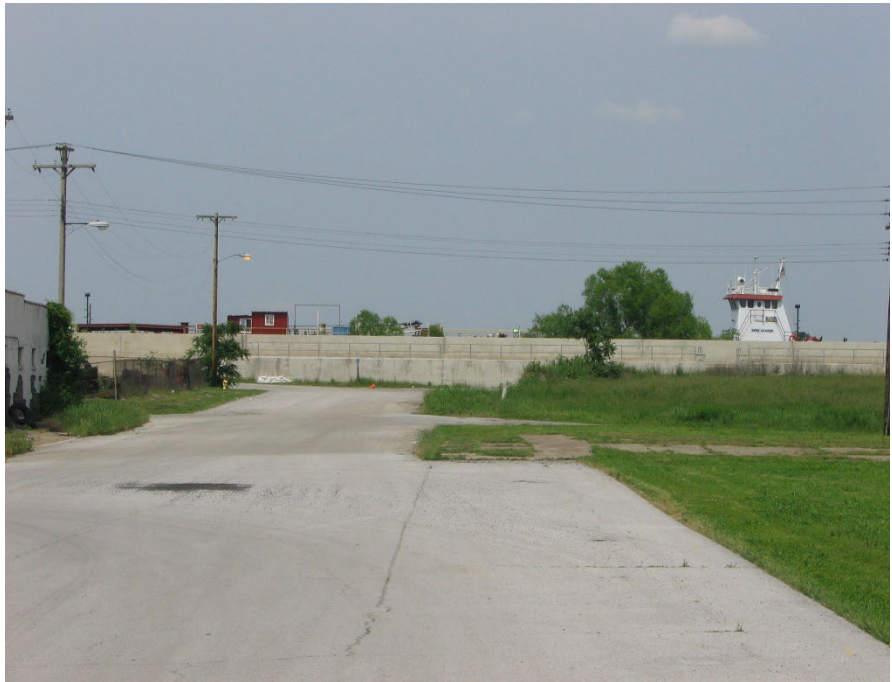
**Figure 20.** The Cairo floodwall is built on the Ohio River side at the bend in the river where an earthen levee would be difficult to maintain. With the river 3 m above flood stage, a tugboat is visible behind the floodwall. Reprinted with permission from Editor of Journal of Soil and Water Conservation.

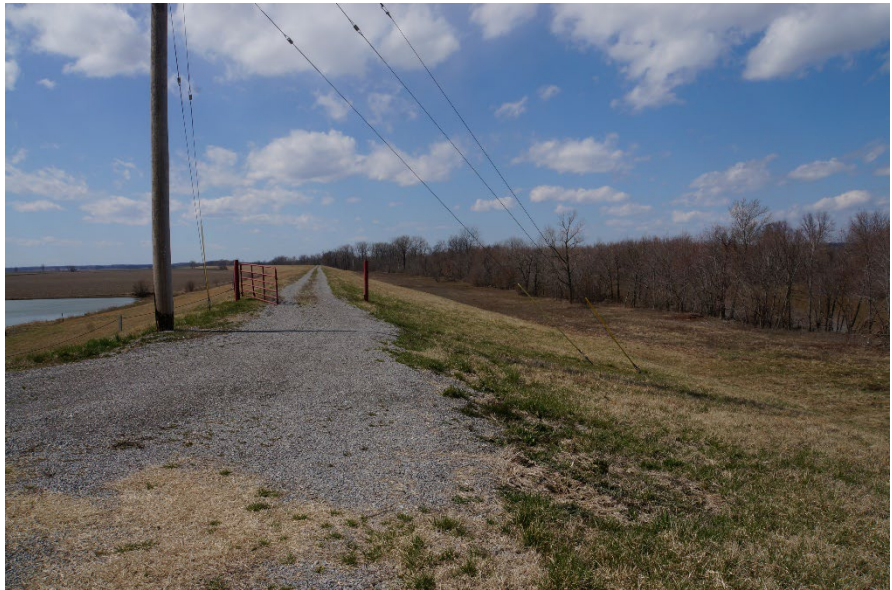
**Figure 21.** The Headwaters Diversion watershed drains Missouri Ozark upland streams southward where they are diverted directly into the Mississippi River south of Cape Girardeau, Missouri, via the diversion channel. Photo Credit: Lois Wright Morton. Reprinted with permission from Editor of Journal of Soil and Water Conservation.

Olson *et al.* [5] found: “*The Headwaters Diversion (Figure 21), a system of impounding basins, channels, and levees, carries the waters of the eastern Missouri Ozark Plateau hill streams eastward to the Middle Mississippi River south of Cape Girardeau. The system consists of three large basins, 78 km of channels, and 69 km of levees designed in 1910s by the Little River Drainage District (LRDD) to divert and temporarily store ordinary and flood waters running off 288,000 ha of the Francois Mountains and Ozark Plateau uplands. Today, the Headwaters Diversion helps drain and protect 480,000 ha of agricultural lands in southeast Missouri from internal seasonal flooding and Mississippi River backflow at flood stage. It was constructed concurrently with an intricate network of 1500 km of ditches (Figure 22), 375 km of levees, and water detention basins draining thousands of alluvial wetland hectares in the ancient Mississippi River floodplain running south from the diversion levee 144 km to the Arkansas border (Figure 23).*”

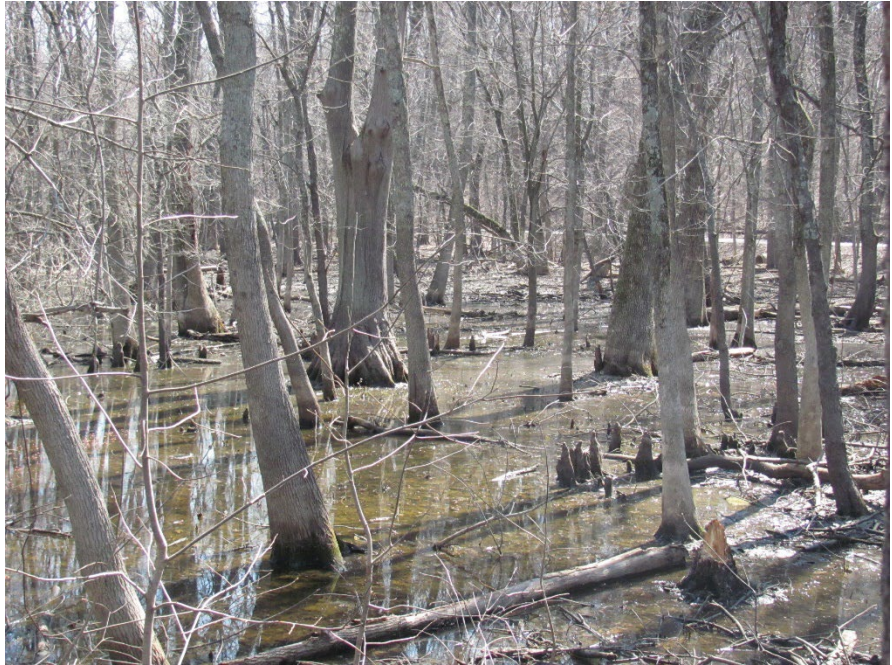
**Figure 25.** The Mingo National Wildlife Refuge, a 8660 hectare bottomland preserve, is a small restored remnant of the original 0.5 million-hectare Missouri Swamp that was transformed into fertile agricultural lands by extensive drainage systems in the early 1900s. Reprinted with permission from Editor of Journal of Soil and Water Conservation.

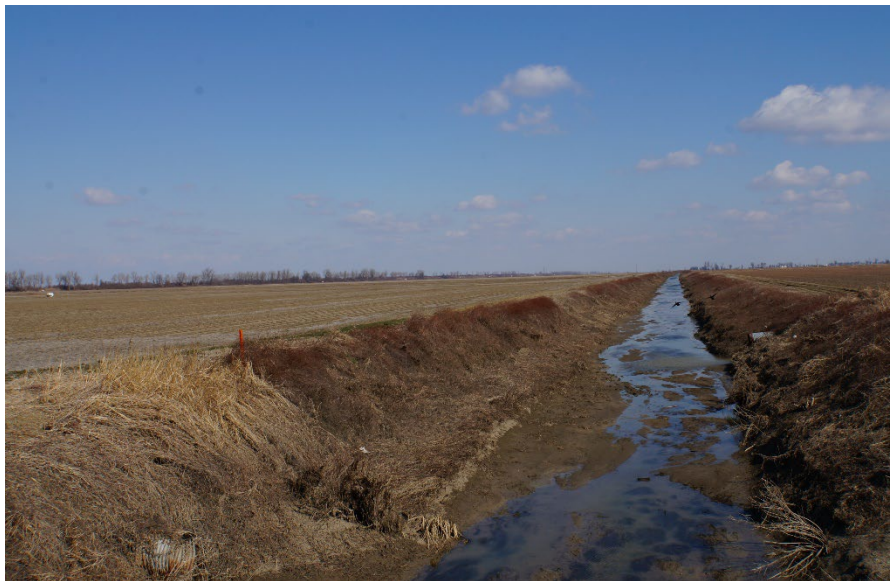
**Figure 26.** Agricultural lands created by draining Big Swamp. Reprinted with permission from Editor of Journal of Soil and Water Conservation.

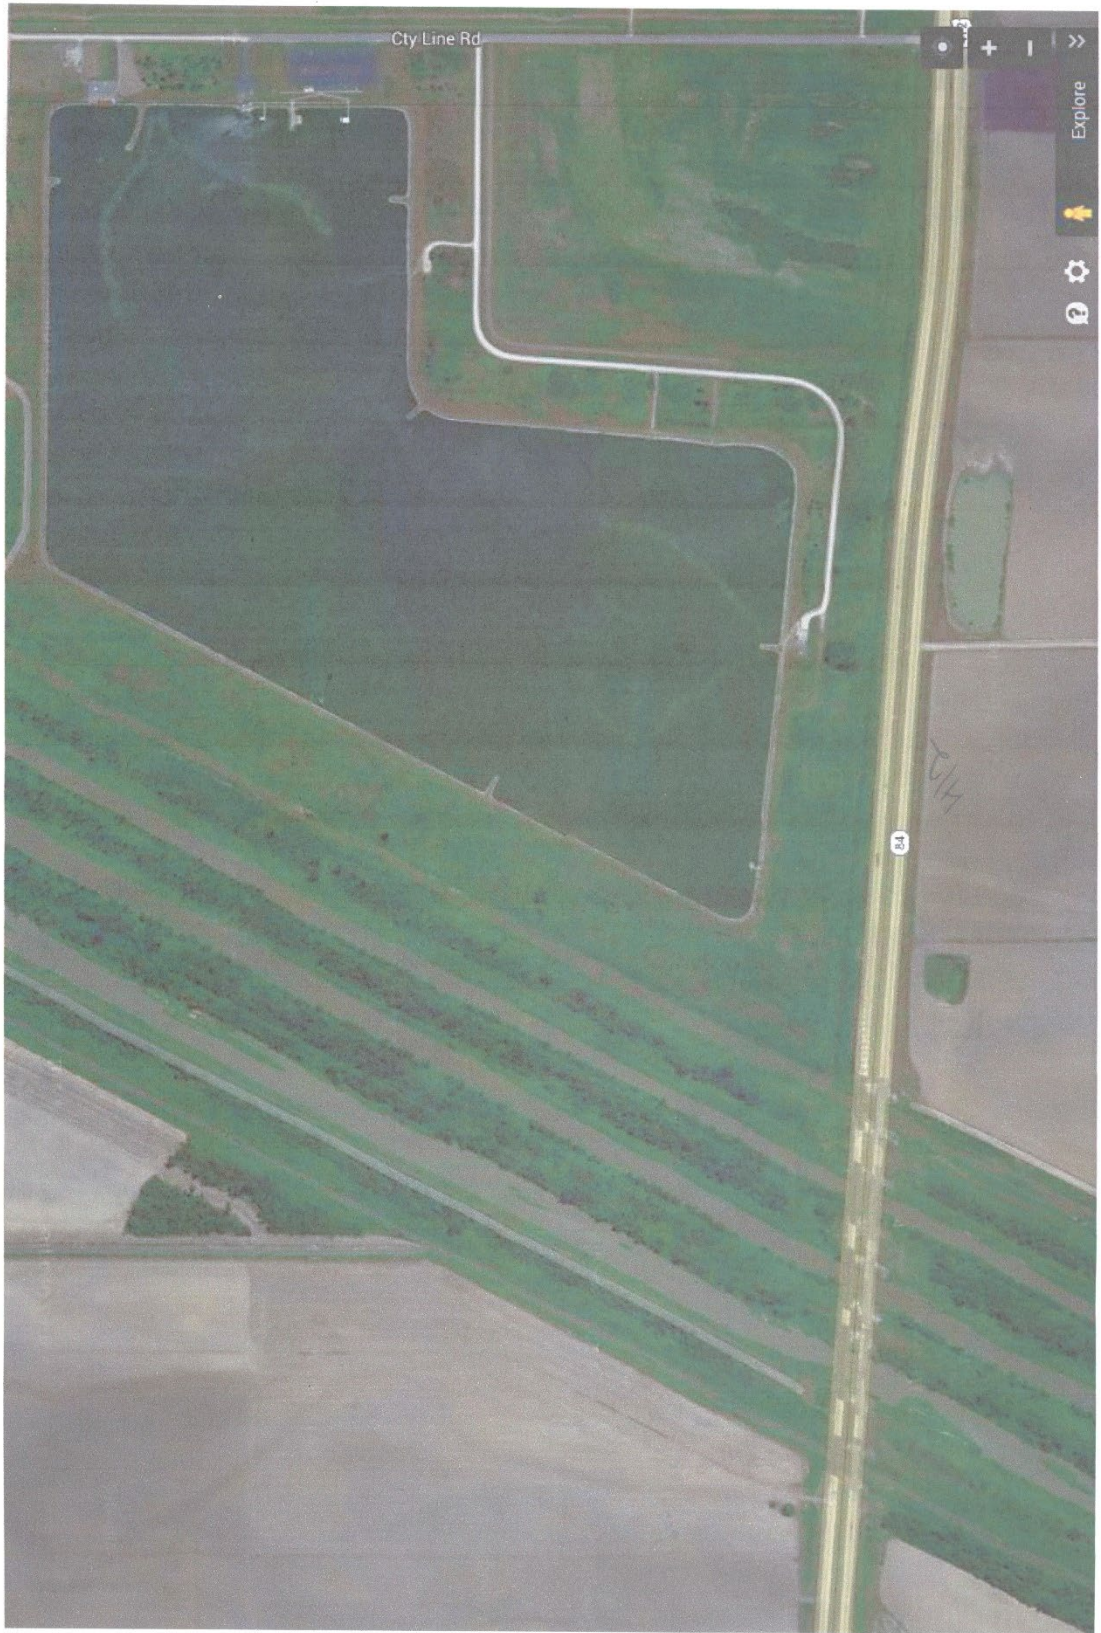
**Figure 28.** Five drainage ditches run parallel in southern Little River Drainage District just north and east of the Arkansas border. Reprinted with permission from Editor of Journal of Soil and Water Conservation.

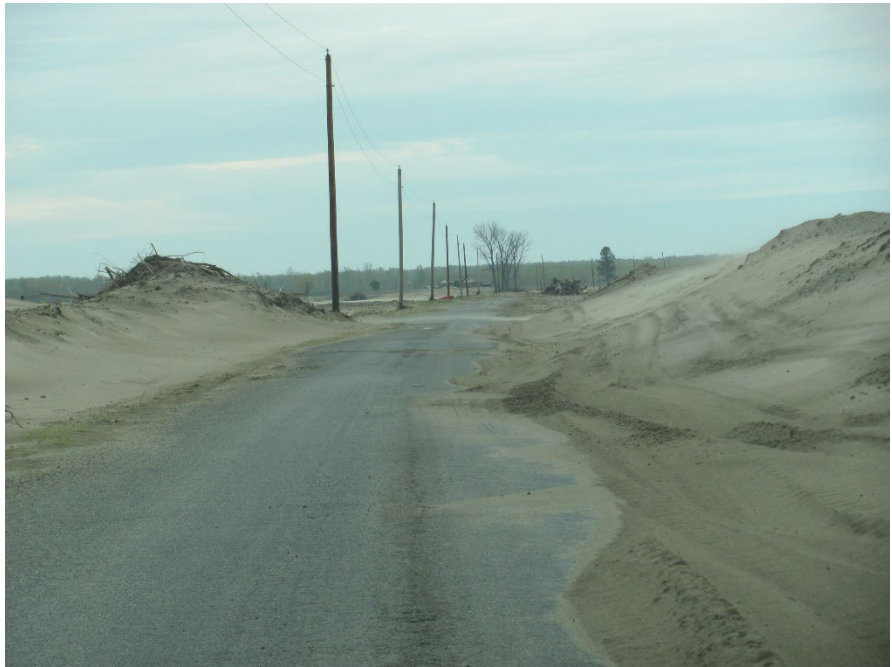
**Figure 29.** Mississippi River floodwaters deposited many tons of sand on farmland and roads in Dogtooth Bend peninsula when the Len Small levee breached in January of 2016. The sand dunes left behind required graders and snowplows to open the road for local traffic. Reprinted with permission from Editor of Journal of Soil and Water Conservation.

Olson and Morton [7] noted: “*The receding floodwaters of the Middle Mississippi River in January of 2016 left behind barren sand dunes on southern Illinois farmland reminiscent of the wind-swept dunes of the movie Lawrence of Arabia (Figure 29). Large sand deposits up to 1.3 m deep covered nearly 800 ha of farmland south of Miller City, Illinois, in the Dogtooth Bend peninsula. Rainfall almost three times above average in November and December of 2015 over Missouri set in motion record flooding with the Cape Girardeau River gage breaking the 1993 record at 14.89 m and led to the breaching of Len Small levee on January 2, 2016. Floodwaters cut deep craters and scoured the landscape as they poured through the breach at mile marker 34 and then followed an old meander channel across the narrow neck of Dogtooth Bend peninsula to reconnect with the Middle Mississippi River at mile marker 15 (Figure 30). Levee breaches and land scouring*

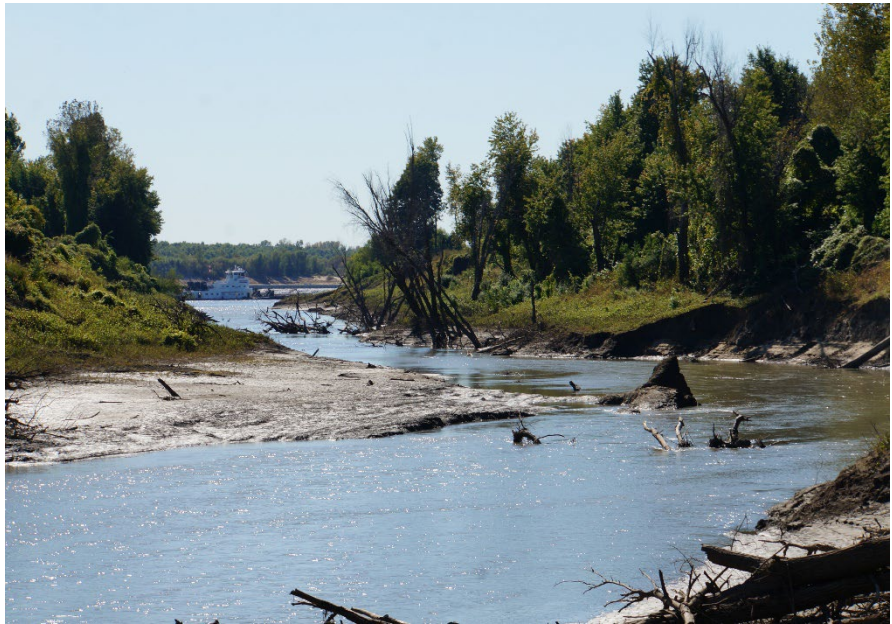
**Figure 32.** A riverboat on the Mississippi River can be seen passing the outlet of Main Ditch that drains through the 457-meter frontline levee gap at New Madrid, Missouri, to the Mississippi River. Reprinted with permission from Editor of Journal of Soil and Water Conservation.

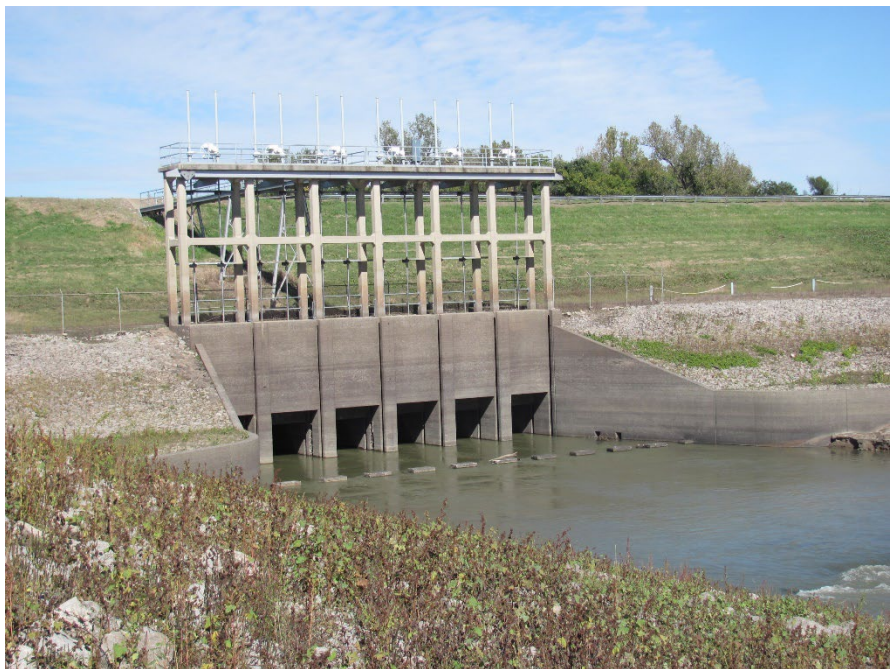
**Figure 33.** When open, the New Madrid Floodway setback levee gate drains the 80,937-hectare St. Johns Bayou basin to Main Ditch and into the Mississippi River. It is closed under flood conditions to prevent Mississippi River backup water from flowing into the basin. Reprinted with permission from Editor of Journal of Soil and Water Conservation.
