# Intelligent Monitoring of Methane at a Reclaimed Landfill Wasteland Transformed into a Valuable Public Park

Patrick K. Jjemba, Rayvonn Mercado

DE & P Technical Services LLC, Marlton, NJ, USA

**How to cite this paper:** Jjemba, P.K. and Mercado, R. (2026) Intelligent Monitoring of Methane at a Reclaimed Landfill Wasteland Transformed into a Valuable Public Park. *Open Journal of Safety Science and Technology*, 16, 35-57.  
<https://doi.org/10.4236/ojsst.2026.161003>

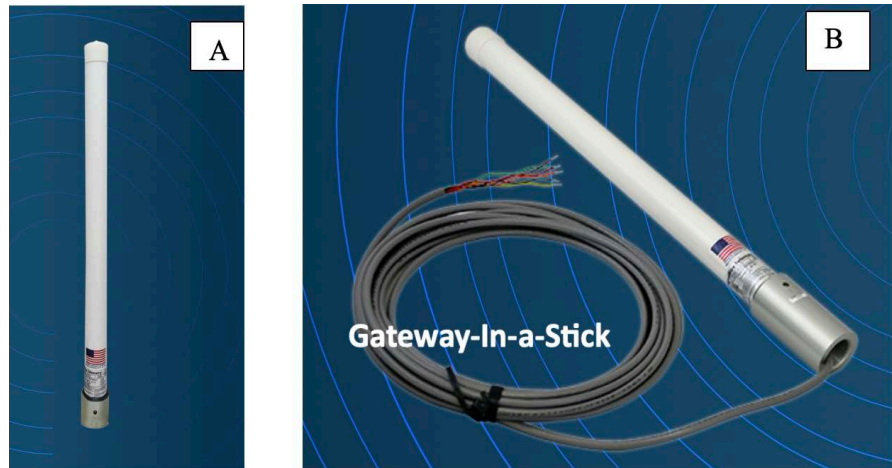
**Figure 3.** SignalFire Modbus antenna (Panel A) and Gateway stick (Panel B) used at Overpeck Park.

less Telemetry, Marlborough, MA, USA; **Figure 3(A)**) using a 3 Cond 18 Gauge shielded wire (Cat# E2203S.30.86; Carol Prysmian Group, Manchester, NH, USA). The manufacturer guidelines outlined under **Figure 2** legend notes were followed to ensure robust communication between the WBS and the Wireless Gateway Stick (WGS). For each zone, the WBS was mounted on the rooftop to facilitate wireless communication with a Macurco TXP-C64 (N4X, FIB, DUAL RS-485 PORTS, COM REL, C1D2; (Cat# 88-7000-0300-00)) controller located in Zone 1 at the southwestern end of the park. The controller was pre-configured and housed in a TXP-C64 analog (16) input board. The roof of the building in Zone 1 where the controller was located accommodated 4 wireless gateway stick (WGS; Cat# GWS-CBBL, SignalFire Wireless Telemetry, Marlborough, MA, USA; **Figure 3(B)**). On the roof, the wireless gateway sticks were installed 6 ft (1.8m) apart to facilitate communication between the 6 WBS in Zone 2 - 7 and the controller in Zone 1 (**Figure 4**). The gateway sticks were connected to the controller as presented in the wiring diagram (**Figure 5**). Likewise, the notes following **Figure 5** legend provided guidance to ensure robust communication between the WBS and WGS.

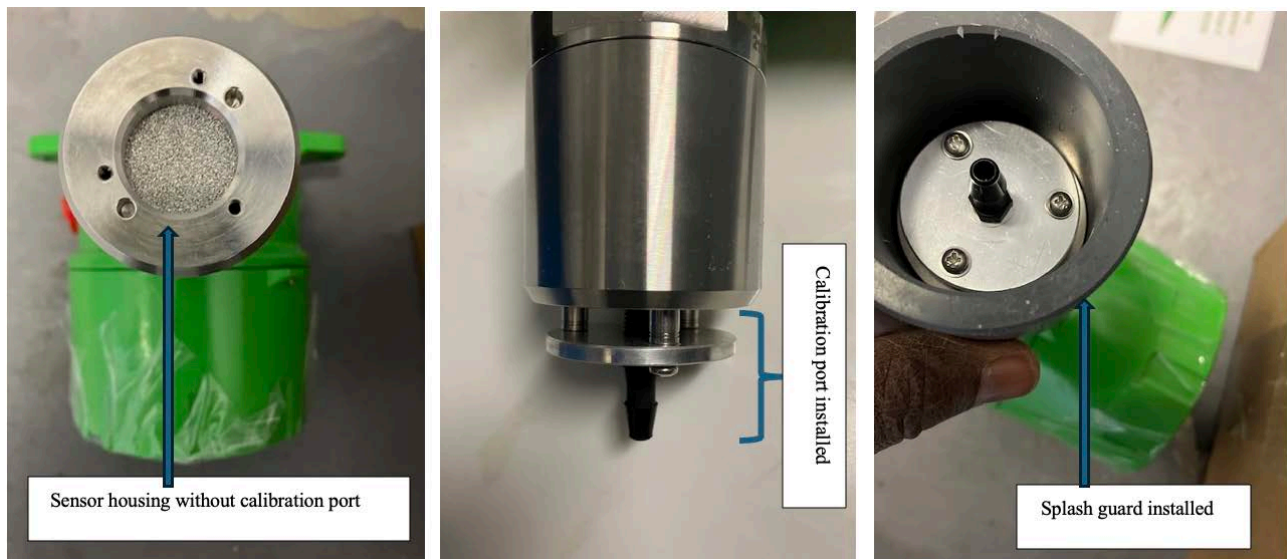
**Figure 8.** Geometry around the sensor when the splash guard is inserted.

A splash guard with a calibration port (p/n 88-C50G-0000-00) was installed on each methane detector prior to mounting the detector in place. Figure 8 displays the geometry of the detector-splash guard fitting. As is evident from the geometry, air movement around and into the sensor housing is unimpeded, even when the splash guard is fitted on the detector. Because the methane detectors

were mounted at 2.7 m (9 ft) or higher, each detector had a dedicated splash guard to make routine bump testing and calibration exercises conveniently manageable.

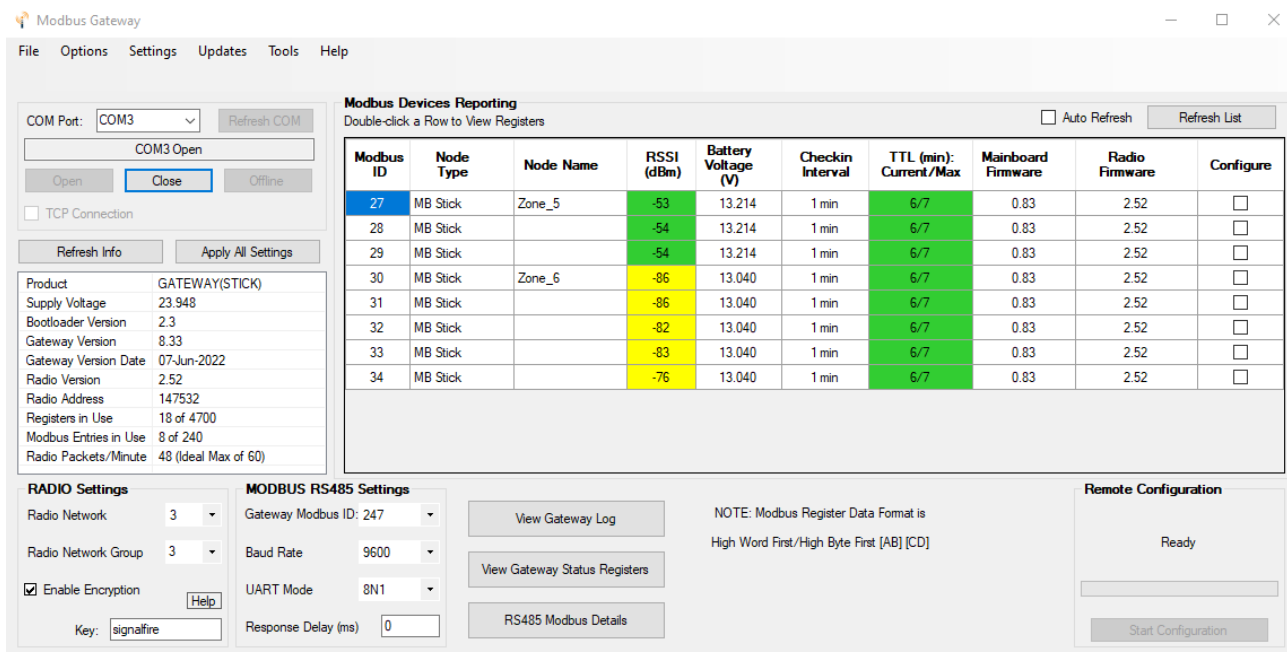
Figure 13. Received signal strength indicator (RSSI) from Zone 5 and 6.

Voltage at the antenna was 13V for Zone 5 and 6 (Table 4) where a 60Hz power supply-6 Amp (Altonix) unit was installed. The other zones (*i.e.*, 2, 3, 4, and 7) where a 60 Hz power supply-10 Amp (Altonix) unit was installed registered 26 – 28.6V. Irrespective of the voltage supply, message pulse check-in at 1-minute intervals was maintained. Transistor-transistor logic (TTL) of 6/7 or 7/7 were consistently achieved in all 6 zones communicating with Zone 1. TTL is a binary digital signal used in electronic circuits to represent an “off” or “on” state based on input and output voltages. Similar consistency of the mainboard and radio firmware were also attained. A sample RSSI output for gateway 3 (Zones 5 and 6) is presented in Figure 13.

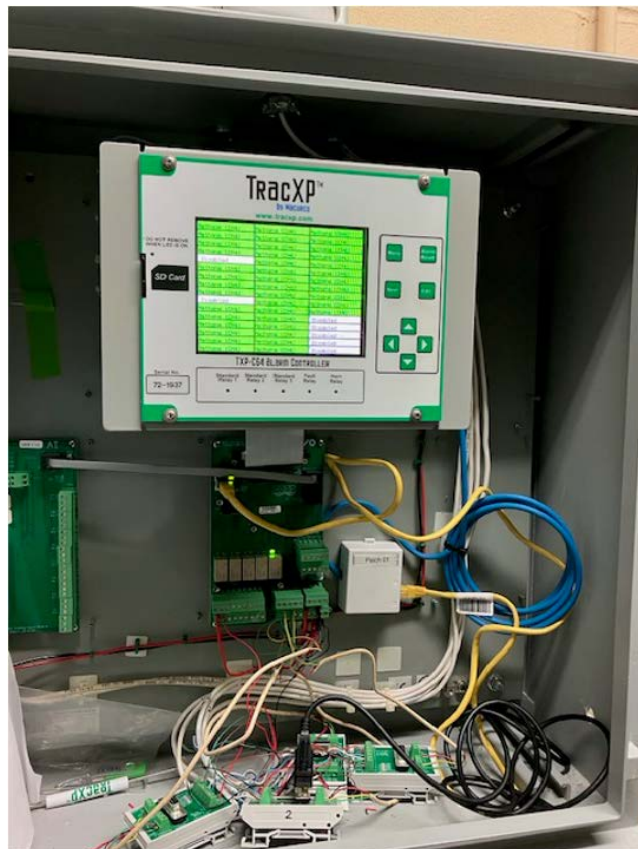
**Figure 15.** Controller system display after installation and troubleshooting were completed (Note: Grey spaces represent empty channels).
