Conservation Works on Wall Paintings of Aghtamar Church in Van

Fatma Sedes

Faculty of Architecture and Design, Istanbul Aydin University, Istanbul, Türkiye
Email: fatmasedes@aydin.edu.tr

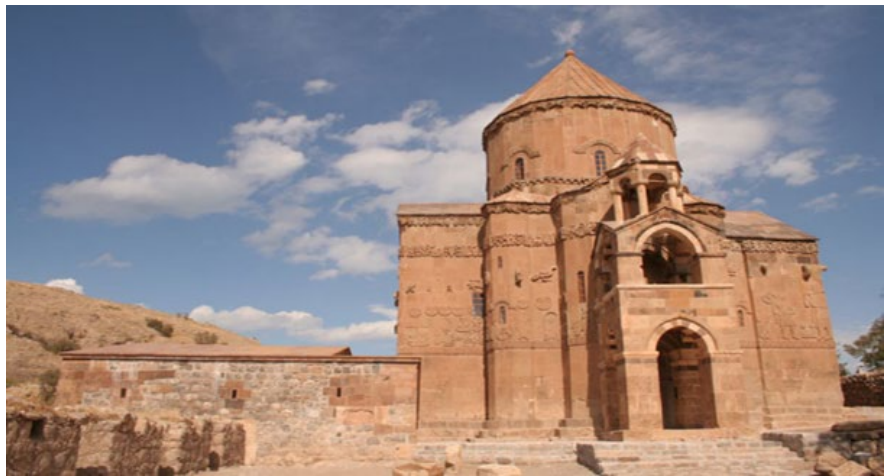
Figure 2. The church of Holy Cross Aghtamar (taken by Kartav in 2005).

These decays in the stone cause exfoliation in the stone, and in more advanced stages, the stone turns into dust. After the building was abandoned, especially due to the lack of glasses at windows to prevent the rain, the rain water flowed inside, destroyed the paints in the places where it flowed, and also created traces of streams with the dirt it carried (Figures 2-4).
