Decoding RoPax Ship Capsizes and Development of an ISO Ship Safety Standard

Soonhung Han¹, Robert Latorre²

How to cite this paper: Han, S. and Latorre, R. (2024) Decoding RoPax Ship Capsizes and Development of an ISO Ship Safety Standard. *Engineering*, 16, 225-236.
<https://doi.org/10.4236/eng.2024.169017>

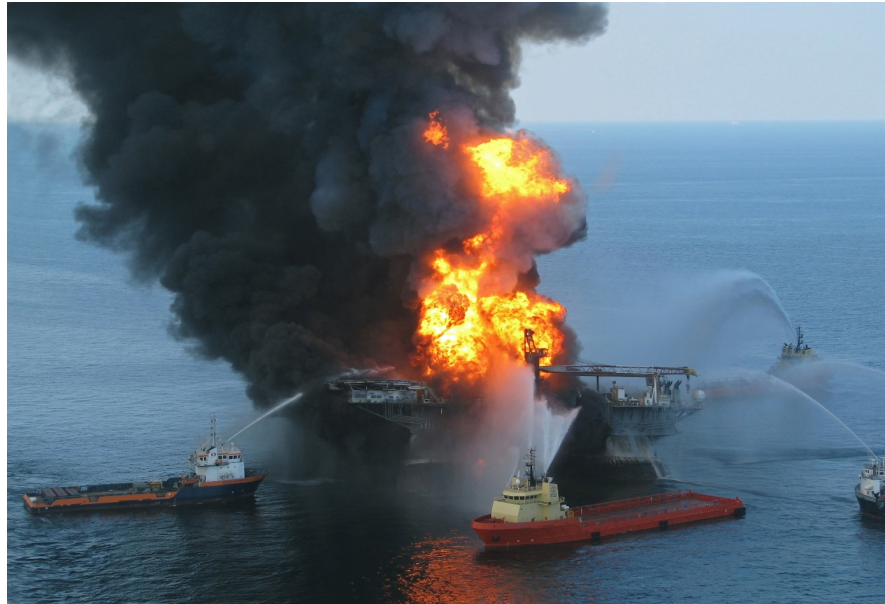
Figure 2. Explosion accident of deepwater horizon [3].

Subsequently, the Deepwater Horizon oil spill (see **Figure 2**) occurred in April 2010, when an oil drilling facility exploded in Gulf of Mexico, USA, resulting in approximately 770 million liters of crude oil leaking over the following five months. **Figure 2** shows the oil drilling facility on fire, with four firefighting ships pumping seawater to cool down the flame. This accident led to the introduction

of additional rules and regulations aimed at preventing similar offshore accidents. In 2014, the MARPOL was further expanded to address the reduction of greenhouse gas emissions from new ships by introducing the Energy Efficiency Design Index (EEDI).
