# Diagnosis of a Small Dam Using Electric and Electromagnetic Methods

## —Case of Gonsé Dam (Central Region, Burkina Faso)

Maxime Wubda, Youssouf Koussoubé, Julien Nikiema, Soumaila Paré

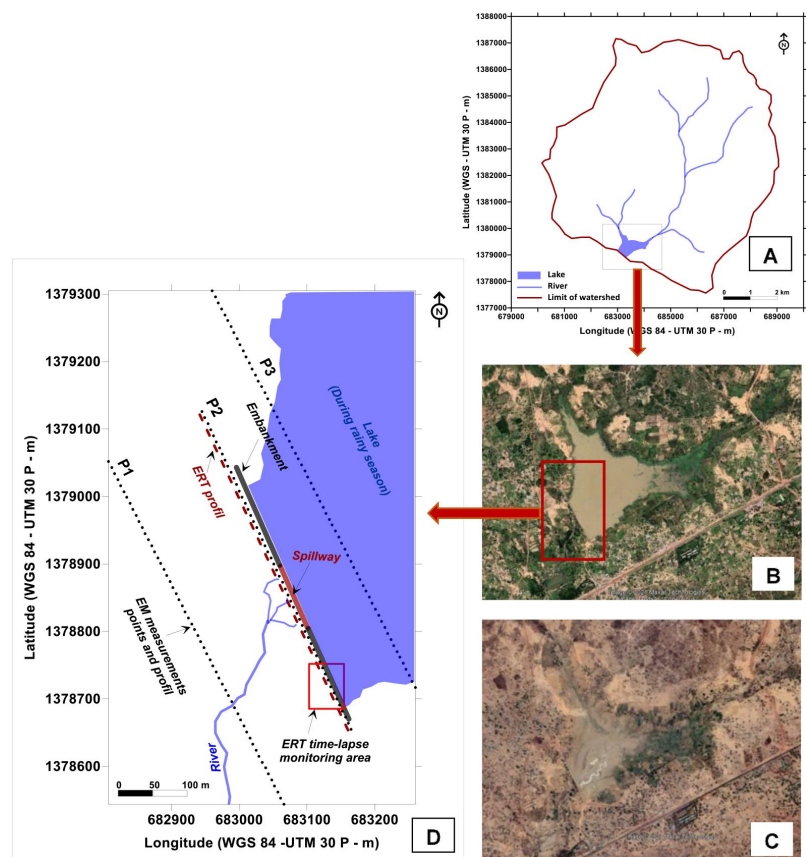
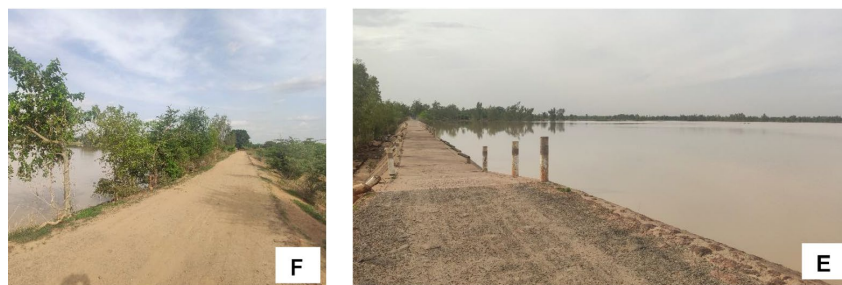
The geophysical exploration zone corresponds to the installation area of Gonsé dam (Cf; **Figure 2**). It is located in the south of the watershed (Cf; **Figure 2(A)**). The dam built there is a small water retention structure, consisting of a basin and a homogeneous compacted earth embankment (Cf; **Figure 2(F)**), 500 meters long, and oriented SSE-NNW.

The embankment obstructs a main river flowing from north to south. In its central part, it has a reinforced concrete spillway, 105 meters long (Cf; **Figure 2(E)**). The embankment also serves as a road connecting the heart of the village to the hamlets located in the southern part of the dam.

**Figure 2.** Site of Gonsé dam. (A) Location; (B) The dam site during the rainy season (Google Earth image, September 2023); (C) The site during the dry season (Google Earth image, March 2023); (D) Geophysical exploration area; (E) View of the lake and concrete spillway; (F), view of the southern section of the earthen embankment.

The dam basin upstream of the embankment covers an area of approximately 0.6 km<sup>2</sup>. It is largely filled with clay deposits whose thickness in some places reaches 60 centimeters. Due to its shallow depth (0.6 meters on average), the basin fills quite quickly at the beginning of the rainy season (June) and forms a small lake (Cf; **Figure 2(B)**) with a storage volume of approximately 376,000 m<sup>3</sup>. However, all this water is only available for a few months during the dry season (until February). By the end of March, the basin is often already dry (Cf; **Figure 2(C)**).

Geophysical studies that were carried out at the dam site, focused specifically on the neighboring parts of the embankment. This is a small area of 750 meters long (from north to south) and 400 meters wide (from east to west), in which the embankment of the dam is centred with a diagonal orientation (Cf; **Figure 2(D)**).
