# High-Temperature Stress-Strain Behavior and Fractographic Characterization of Additively Manufactured Inconel 939

Daniel Moreno<sup>ORCID</sup>, Matan Zakai, Yohanan Nahmana, Ariel Y. Cohen, Moshe Shapira

Bet Shemesh Engines Ltd., Bet Shemesh, Israel  
Email: danielm@bsel.co.il

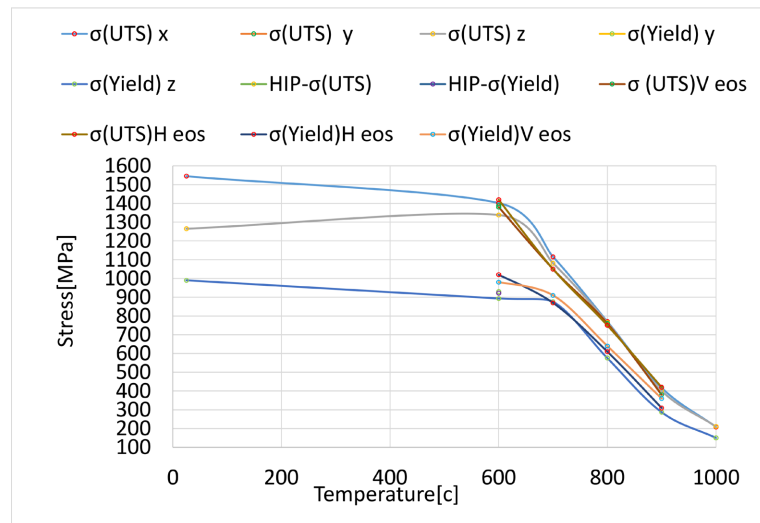
**Figure 1.**  $\sigma_{\text{uts}}$  and the  $\sigma_{\text{yield}}$  values from room temperature up to 1000 °C for different sample category. Colored lines represent best fit trend of the results.

The mechanical properties—ultimate tensile strength (UTS), yield strength, and strain ( $\epsilon$ )—measured at 25°C, 600°C, 700°C, 800°C, 900°C, and 1000°C are summarized in **Table 2**. The nomenclature used is as follows:  $\sigma$  (UTS) and  $\sigma$  (Yield) correspond to samples printed along the  $x$  direction; samples oriented perpendicular to the  $x$  direction on the build plate are designated as the  $y$  direction, while those aligned with the beam direction are designated as the  $z$  direction. “HIP” denotes samples subjected to hot isostatic pressing at 1200 atm and 1000°C to reduce porosity and microcracks. Results labeled “EOS” refer to data reported in the EOS technical brochure, where build orientations are defined as H (horizontal) and V (vertical) [11]. The values reported in **Table 2** represent the average of at least three tests, with a dispersion of less than 3%, and are plotted in **Figure 1**. **Figure 1** shows the evolution of  $\sigma$  (UTS) and  $\sigma$  (Yield) as a function of tempera-

ture, from room temperature up to 1000°C. **Figure 2** presents the corresponding strain over the same temperature range. The curves shown represent best-fit trends for each group of samples with different characteristics and are intended to highlight the overall behavior. No significant differences are observed among the HIP-ed samples, the EOS results, and the other samples. An abrupt decrease in elongation at 800°C, followed by a pronounced increase at higher temperatures, is observed in **Figure 2** and requires further discussion. Post-test SEM metallurgical characterization near the necked region adjacent to the final fracture surface of representative samples tested at different temperatures is presented in **Figure 3**. Metallographic and fractography images at 700°C and 900°C (**Figures 3-8**) are omitted, as no significant differences were observed compared with those at 600°C and 800°C, respectively. All images are presented at the same scale, allowing clear observation of grain boundaries. Cracks are evident at 800°C and 1000°C. High-magnification SEM micrographs, enabling observation of precipitates, are shown in **Figure 4**, highlighting the decrease in  $\gamma'$  precipitate density. SEM fractography of the fracture surfaces, obtained at the same magnification for comparison across different temperatures, are presented in **Figures 5-8**.

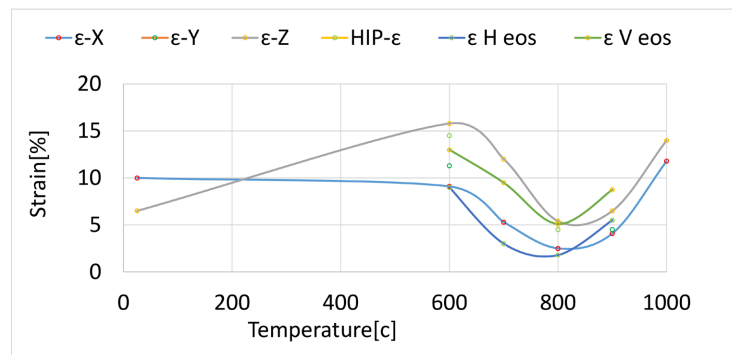
**Figure 2.** Strain values from room temperature up to 1000 °C for different sample categories. Colored lines represent best fit trend of the results. An abrupt decrease in elongation at 800 °C, followed by a pronounced increase at higher temperatures is observed.

dislocations do not penetrate the precipitates. **Figure 2** presents an increase in the stain at 1000°C. This behavior can be explained by the observation of the picture in **Figure 3** representing the sample post tested at 1000°C, that shows some cracks created along the grain boundaries but in addition, in **Figure 4**, in higher magnification at the same temperature, diluted number of precipitates in comparison with the samples at lower temperature. The dissolution of  $\gamma'$  precipitates increase significantly the flow of phase gamma that has lower number of obstacles to be crossed. Moreover, the fractography in **Figure 8** presents some incipient melting on the surface. All those factors generously donate to the weakness and the flow of the alloy at 1000°C. **Table 3** summarizes the average strain and the corresponding microscopic observations at temperatures ranging from room temperature to 1000°C.
