# Radon Levels with and without Remediation at McNenny State Fish Hatchery, Spearfish, South Dakota, USA

**How to cite this paper:** Gerber, A.L., Voorhees, J.M. and Barnes, M.E. (2026) Radon Levels with and without Remediation at McNenny State Fish Hatchery, Spearfish, South Dakota, USA. *Occupational Diseases and Environmental Medicine*, 14, 18-30. <https://doi.org/10.4236/odem.2026.141003>

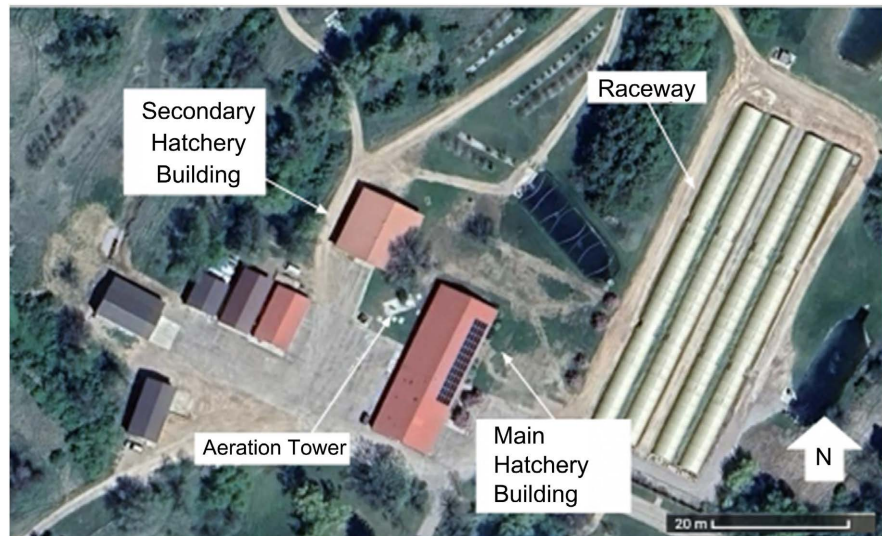
**Figure 1.** Aerial view of McNenny State Fish Hatchery with the location of the main hatchery building and aeration tower noted.

This study was conducted at McNenny State Fish Hatchery, Lawrence County, South Dakota, USA (Figure 1). Production water for the hatchery building comes

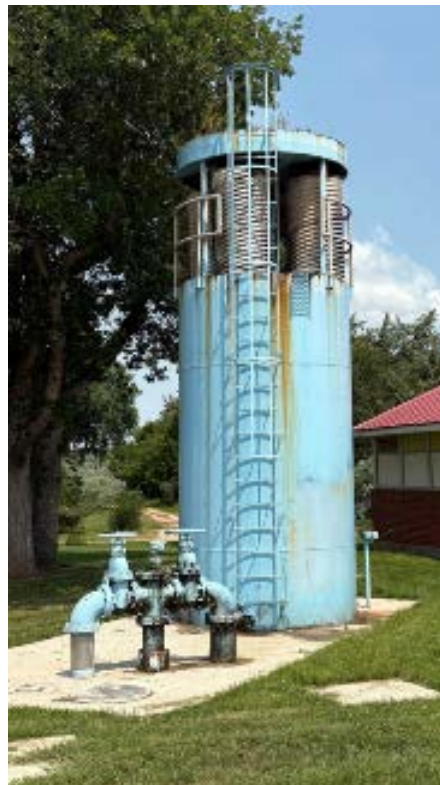
**Figure 2.** Aeration/degassing tower at McNenny State Fish Hatchery.

from three open-bore artesian wells approximately 90-m deep. To remove super-saturated nitrogen gas and increase dissolved oxygen levels, the water, under its own pressure, is directed to the top of an open-air degassing/aeration tower outside of the hatchery tankroom (**Figure 2**). This tower also acts as a water tower providing gravity-flow water to the hatchery tankroom.

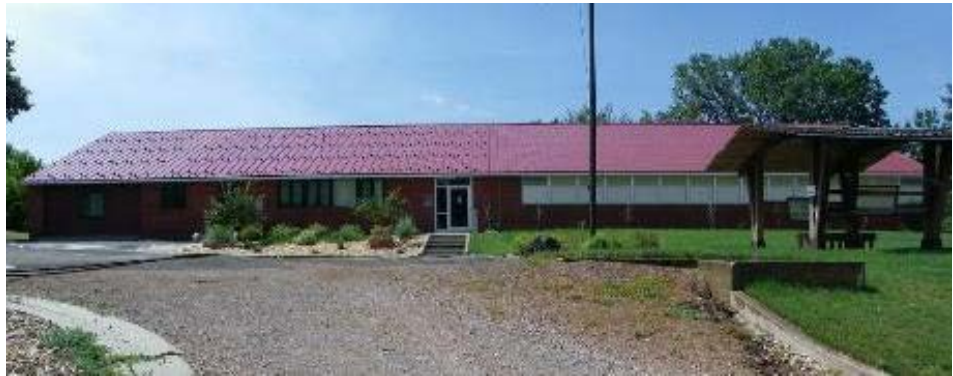
**Figure 3.** Photograph of the main hatchery building at McNenny State Fish Hatchery.

The hatchery tankroom contains 35, 1.8-m diameter circular tanks and occupies approximately one-half of the floor space of the main hatchery building (**Figure 3**). The remainder of the building houses offices, a conference area, mechanical rooms, and storage areas (**Figure 4**). The side of the building containing fish rearing has four small, screened vents and an exhaust fan for ventilation. The tankroom is typically only passively heated via the 11°C fish production water flowing through the hatchery tanks. Doors from the tankroom to the rest of the hatchery are closed when not in use. The remainder of the building is heated and cooled by forced air from a water-based heat pump. Most of the doors within this remainder of the building typically remain open.

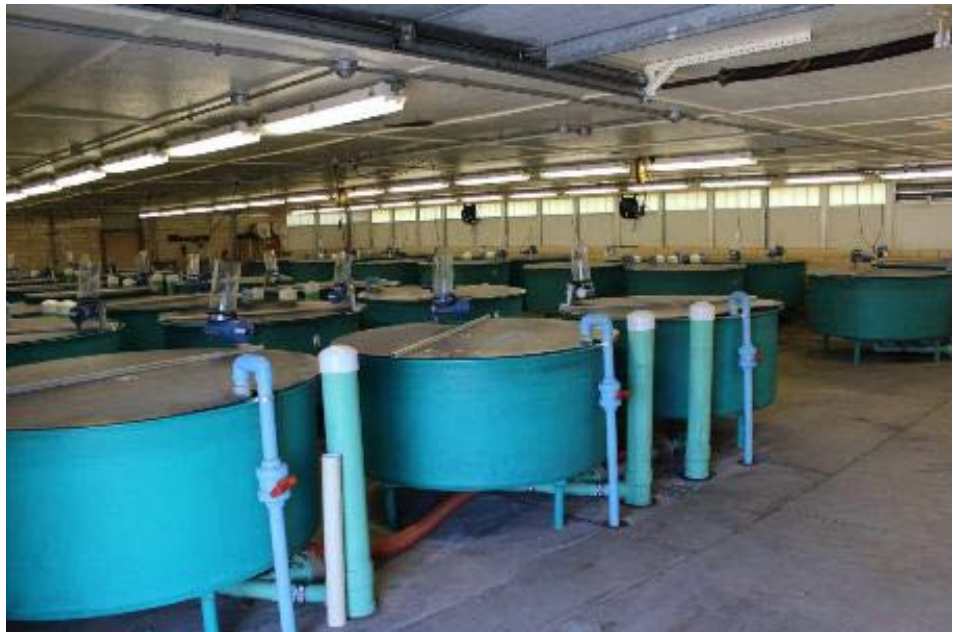
**Figure 4.** Photograph of inside the tankroom in the main hatchery building at McNenny State Fish Hatchery.

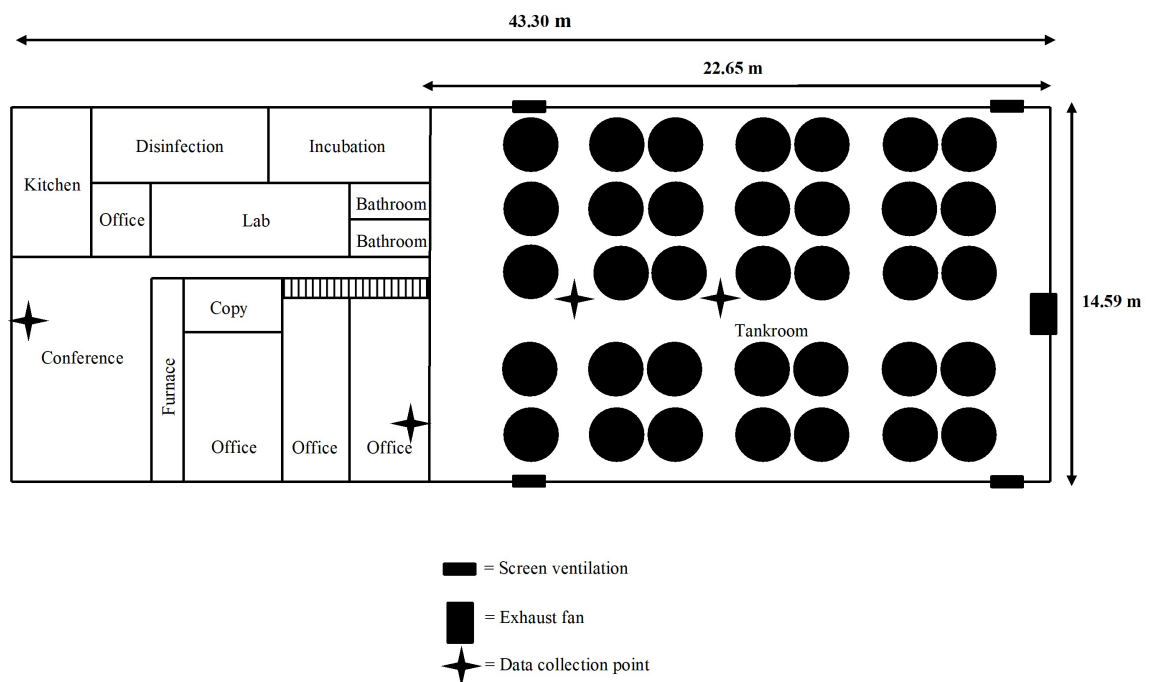
**Figure 5.** Schematic of the main hatchery building at McNenny State Fish Hatchery, Spearfish, South Dakota, USA. Screen ventilation is marked by horizontal rectangles, the exhaust fan is marked by a vertical rectangle, and radon meters are marked by four-point stars.

daily. Meters were placed in the tankroom, conference room, and one office (**Figure 5**). Radon levels were recorded daily from 8 August 2020 to 20 September 2021. In addition to recording daily radon levels, the number of fish rearing tanks in use (receiving water) was also recorded. Because this study was done while actual fish production was occurring and production loadings changed throughout the year, the number of tanks being used changed as well. To determine the impacts of exhaust fan use on radon levels in the hatchery building, it was turned on approximately one-half of the days of the study, with the timing of use ensuring it was both on and off an adequate number of days in relation to different tank numbers in use.

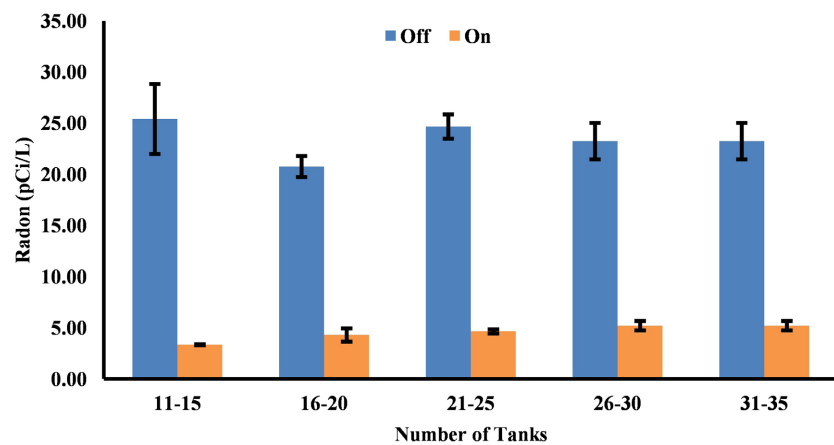
**Figure 6.** Mean radon readings (pCi/L) with the exhaust fan off and on in relation to the number of tanks in use (with flowing water) in the tankroom at McNenny State Fish Hatchery.

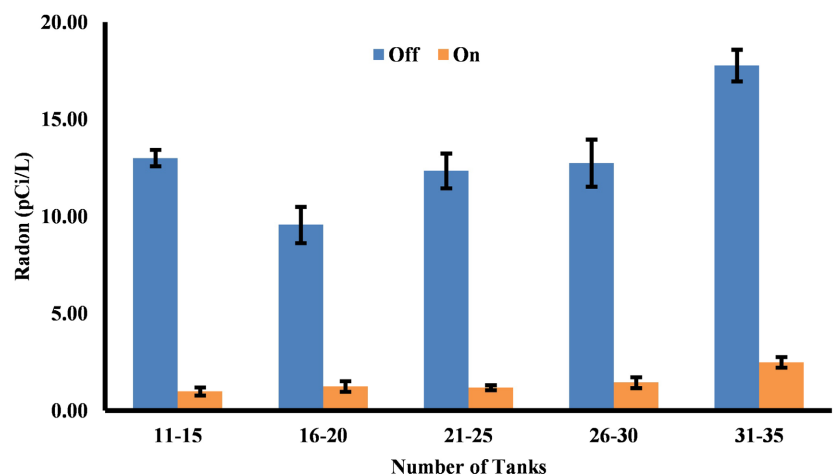
**Figure 7.** Mean radon readings (pCi/L) with the exhaust fan off and on in relation to the number of tanks in use (with flowing water) in the conference room at McNenny State Fish Hatchery.

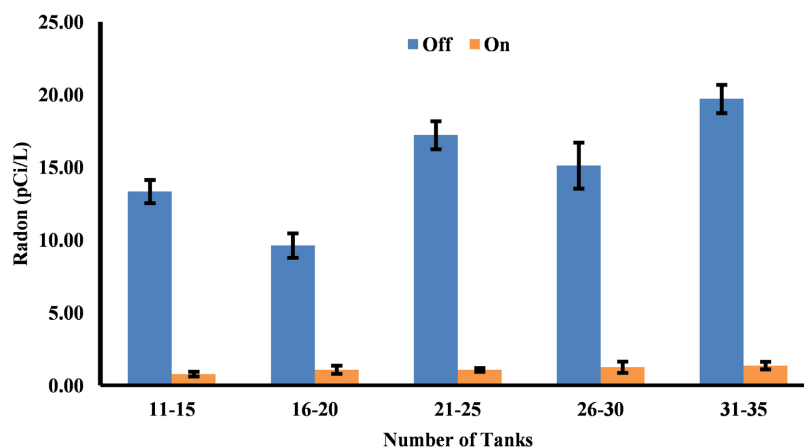
**Figure 8.** Mean radon readings (pCi/L) with the exhaust fan off and on in relation to the number of tanks in use (with flowing water) in the office at McNenny State Fish Hatchery.

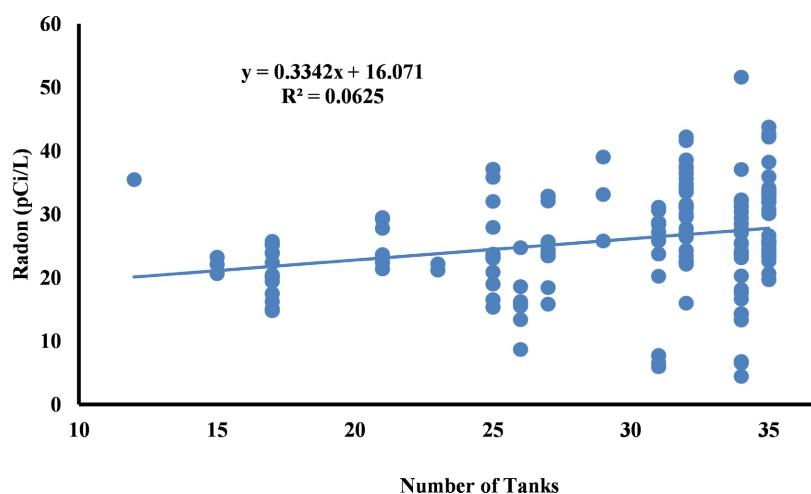
**Figure 9.** Radon readings (pCi/L) in relation to the number of tanks in use (with flowing water) in the tankroom at McNenny State Fish Hatchery.

Radon levels were significantly correlated to the number of tanks in use (with water running) in all three locations: the tankroom ( $R^2 = 0.063$ ,  $p = 0.002$ ; **Figure 9**), conference room ( $R^2 = 0.129$ ,  $p = 0.001$ ; **Figure 10**), and office ( $R^2 = 0.136$ ,  $p = 0.001$ ; **Figure 11**).

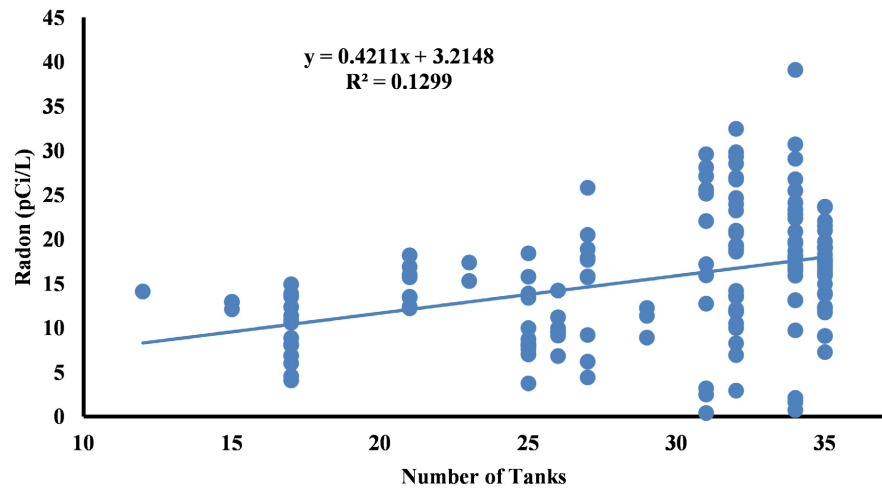
**Figure 10.** Radon readings (pCi/L) in relation to the number of tanks in use (with flowing water) in the conference room at McNenny State Fish Hatchery.

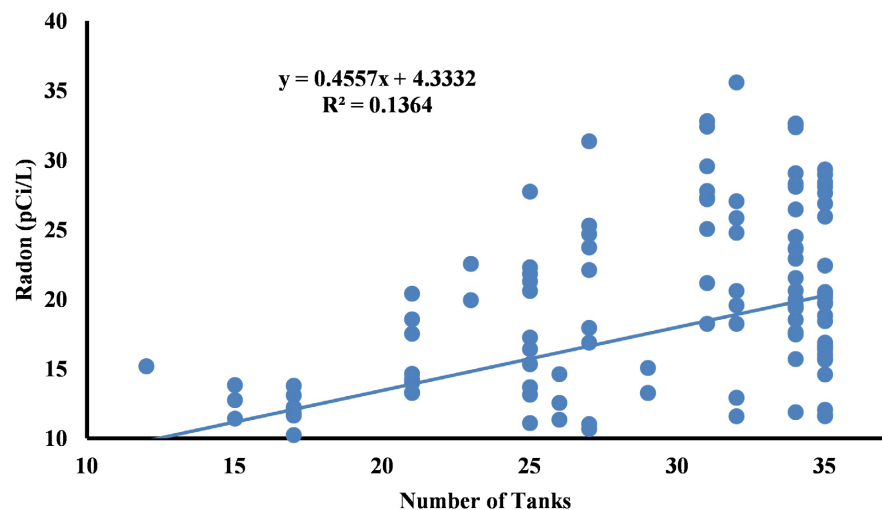
**Figure 11.** Radon readings (pCi/L) in relation to the number of tanks in use (with flowing water) in the office at McNenny State Fish Hatchery.
