Reactor Pressure Vessel Internals: Research on the Effects of Aging Caused by Operating Conditions

Galya Dimova

Department of Energy and Mechanical Engineering, Technical College-Sofia, Technical University of Sofia, Sofia, Bulgaria
Email: gtdimova@abv.bg, dimova@tu-sofia.bg

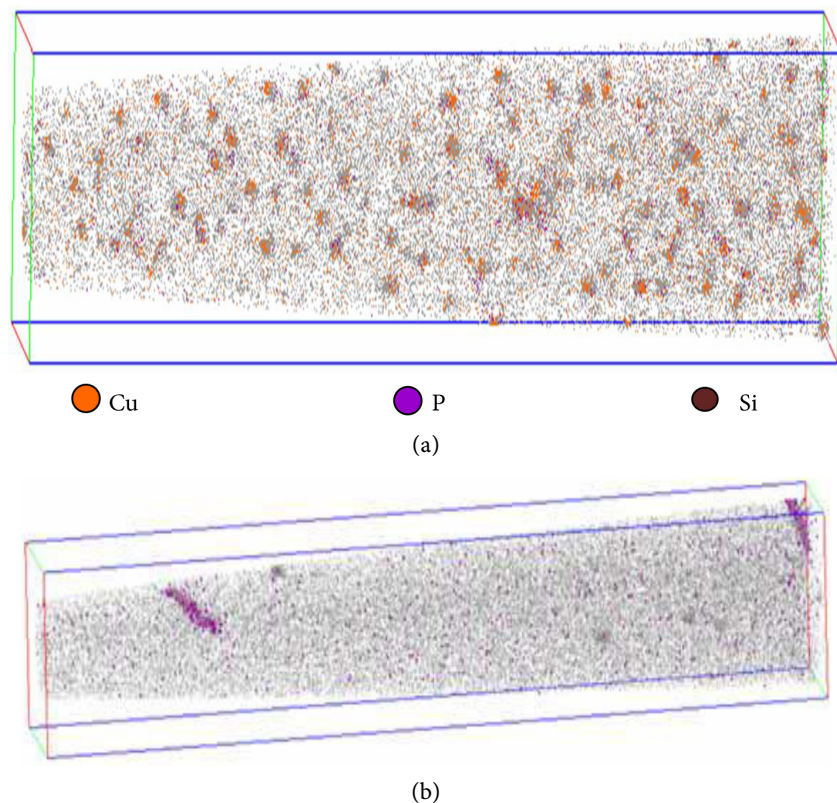
Figure 1. (a) Welded joint EW-P2 R7-00561 with a high content of Cu, irradiated with high fluence, sample sizes $30 \times 29 \times 232 \text{ nm}^3$. (b) Low Carbon Steel Cu: 0.03 Cu, $6 \times 10^{19} \text{ n/cm}^2$.

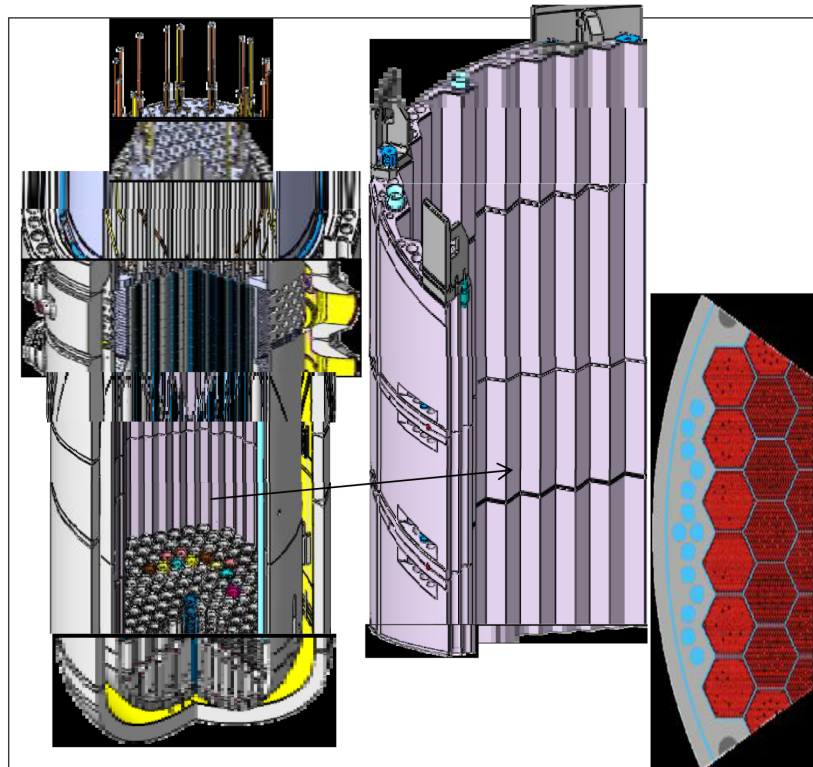
The uneven metal structure is the root cause of the brittleness of RPV Internals metals. (In the state of brittle fracture, metal fracture can occur suddenly and unpredictably, with a small influx of external energy). The neutron flux produced by the chain reaction of the decay of uranium fuel in the core causes the neutron and thermal brittleness of the metal [4]. The essence of the problem is: 1) Swelling is an increase in the external dimension of solid materials after irradiation. 2) Vacancies created by the materials that make up the inside of the reactor as a result of irradiation can accumulate in cavities, which can lead to changes in the dimensions of the material. 3) A change in the dimensions of the Internals leads to a decrease in the distance, a violation of the movement of the coolant and the heat balance, and may lead to jamming and blocking of control and protection system units. Swelling is an increase in the external dimension of solid materials after irradiation and is an extremely dangerous condition of the metal structure, because it reduces the bearing capacity of structures. **Figure 2** shows diagrams of Reactor Pressure Vessel Internals and Core Barrel.

Figure 2. Reactor pressure vessel internals (Left) and Core Barrel (Right).

The Core Baffle is important for safety because it provides a high concentration of the reactor coolant flow in the core region. The Core Baffle is made up of vertical plates called baffles and horizontal support plates called formers. The baffle plates are bolted to the formers by the baffle/former bolts, and the formers are attached to the core barrel by the barrel/former bolts. The Baffles provide a barrier between the core and the former region so that a high concentration of flow in the

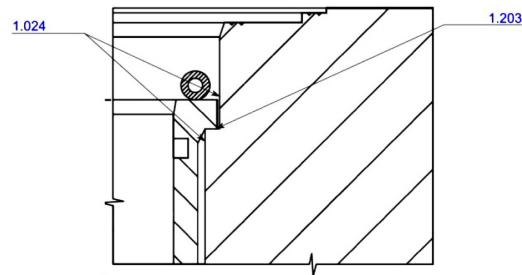
Figure 3. Core barrel flange.

Equipment	Critical component	
	Exterior surface	Inner surface
Reactor Pressure Vessel	-	Overlay-base metal and welded joints
Core Barrel	Core barrel flange, Figure 3 Flange pipe attachment nodes	Keyways on the top attachment of the Block Protective Pipes (BPP), Figure 4
	Surface of keyways for top/bottom fastening of Core Barrel	Welded key joints of the bottom/top attachment of BPP
	Base metal and welded joints, from the flow divider to its elliptical part	Base metal of the keys of the bottom attachment of BPP
	Bottom	Welded joints of the keys on the upper attachment of the Core Barrel Support pipes of the Core Barrel Perforated part and bottom of the support tube

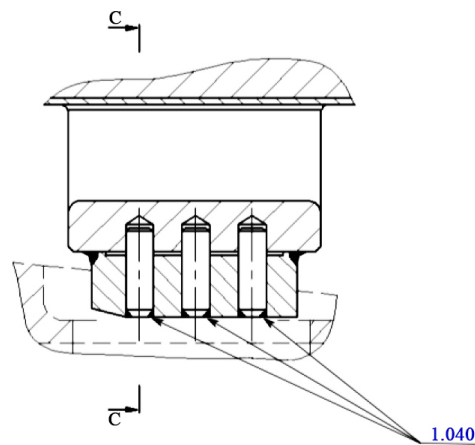
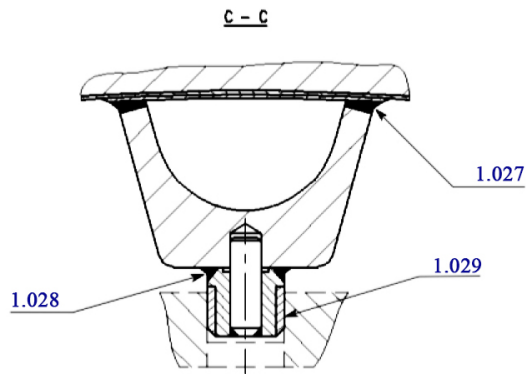
Figure 4. Core barrel fixation in RPV (key—groove and tongue).

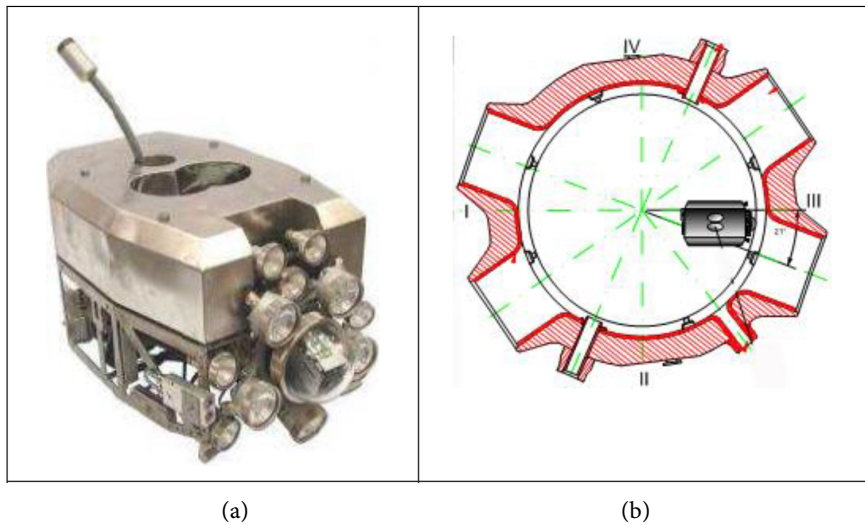
The equipment and the visual inspection scheme are presented at **Figure 5**.

Figure 5. (a) Underwater system SIMENS SUSI 420. (b) Scheme of visual inspection of the Core Barrel.

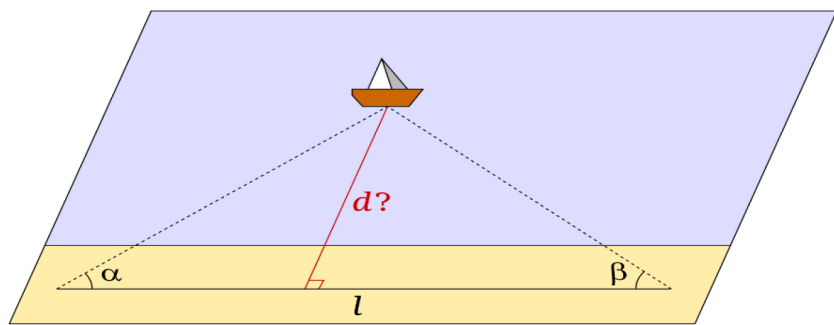
The measurement of geometric dimensions of the Core Barrel is carried out on the basis of the triangulation method, **Figure 6** [9].

Figure 6. To find the distance from the shore to the ship, the triangulation method is used. Observers in points α and β measure the distance between them and the corners α and β . To calculate the distance d the length l is used and the corners α and β .

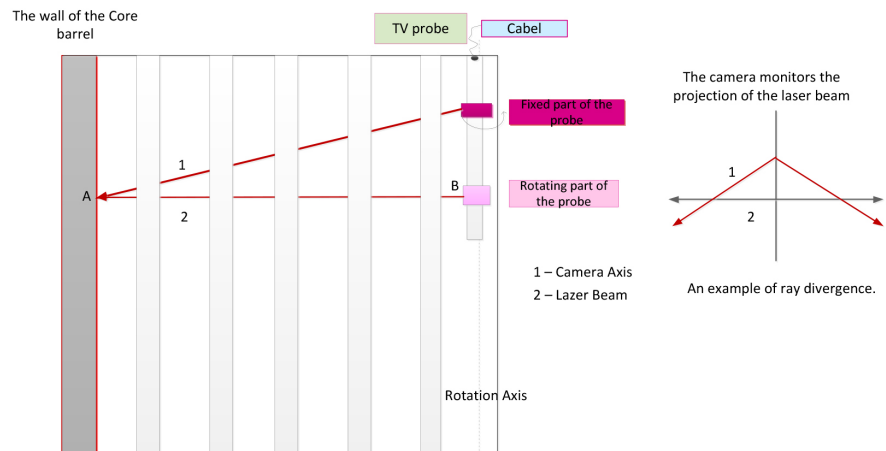
The known dependencies of such triangles are used. In this method, a television probe (camera) is used, which has a fixed part and a rotating part. A light source (laser) is attached to the rotating part, **Figure 7**. The laser beam scans the wall of the Core barrel step by step. Through the camera, the image of the metal is monitored and recorded. The distance from the probe to the Core Barrel wall (AB) is measured. Any deviation from the initially set value of this distance (reference value) is registered.

Figure 7. Scheme for measuring geometric dimensions of the Core Barrel.

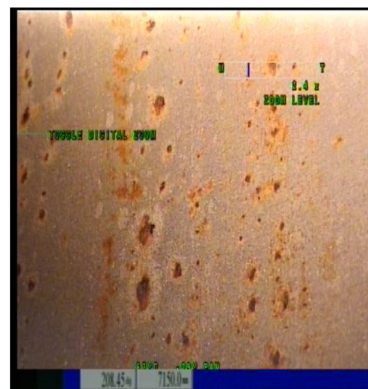
The results of a visual examination of the Core Barrel metal of three WWER blocks show that no corrosion spots are observed on the surface of the objects. Corrosion ulcers are noticeable only on the inner surface of the reactor vessel in the places of upper attachment of the elements of the Core baffle, **Figure 8**.

Figure 8. Corrosion and erosion foci concentrated in the zone of bulging by the reinforcing units of the internal housing devices.

Individual surface inconsistencies (defects) in the shell surfacing are observed and their parameters are determined. An analysis is being carried out whether the defects are permissible according to the regulatory requirements.

The assessment of resistance to corrosion and erosion wear (general corrosion) is made by the aging index—the type, size and location of surface defects of the metal from the inner surface of the reactor vessel. The defects found are admissible according to the regulatory documents, therefore, the requirement for resistance of the metal to corrosion and erosion wear is met.

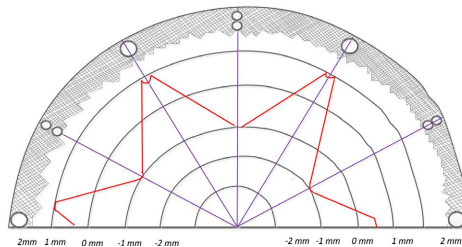
The measurement results obtained are given in **Figure 9**.

Figure 9. Results obtained from the measurement of the Core Barrel (red line).

- 1) Coverage of the measured distance, 1450 ÷ 1650 mm; Discrete distance value, 0.1 mm; absolute distance measurement error, ±0.5 mm;
- 2) Rotation Angle Measurement Range, 0 ÷ 360°; Discrete Angle Value, 0.0001°; Absolute Rotation Angle Measurement Error, ± 0.5°.

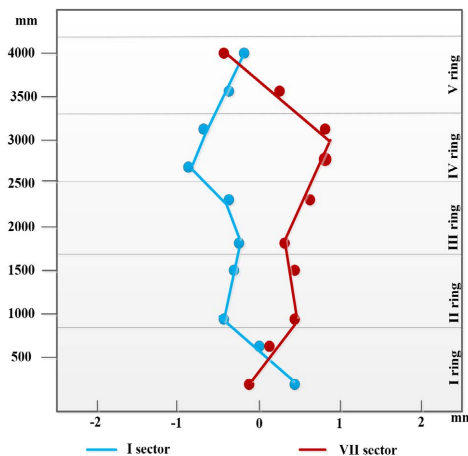
Measured results by height of the Core barrel are presented in **Figure 11**.

Figure 11. The sectors with maximum displacement are I and VII; the displacement dimensions are less than 1 mm.

The assessment of swelling resistance is carried out by the indicator change in dimensions. The results obtained show that there is no significant change in the geometric distances of the Core Barrel, compared to the passport data. The displacement dimensions are less than 1 mm. The metal is resistant to swelling. It is assumed that until the next such measurement (after 4 years) there will be no (significant) change in the geometric distances.
