# Mechanical Complications of Osteosynthesis: Frequency and Management at the Orthopedics-Traumatology Department of CHU Ignace DEEN

**How to cite this paper:** Camara, T., Aboud, A., Bangoura, I.S., Hippolyte, M.N., Youla, M., Kouassi, U.J.A., Bah, M. and Lamah, L. (2024) Mechanical Complications of Osteosynthesis: Frequency and Management at the Orthopedics-Traumatology Department of CHU Ignace DEEN. *Open Journal of Orthopedics*, 14, 404-410.

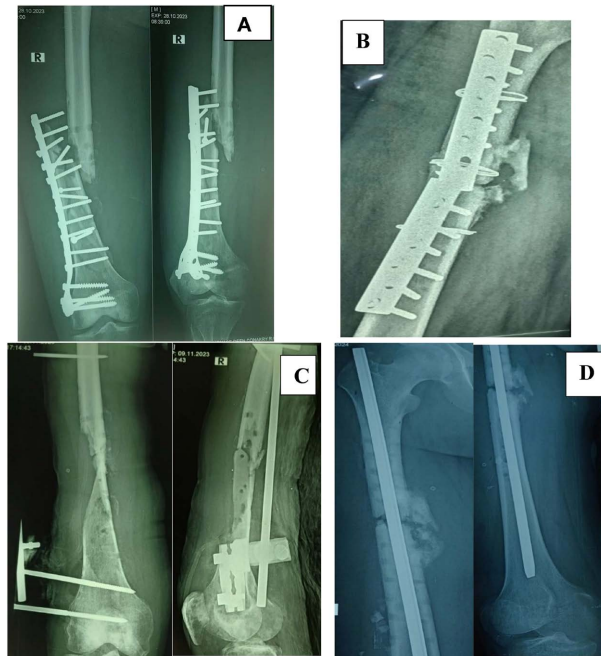
**Figure 1.** (A): Fracture line persistence and Chiron plate disassembly; (B): Fracture line persistence and screw-plate rupture. (C): Control radiograph after revision osteosynthesis using external fixators; (D): Control radiograph after revision osteosynthesis using a centromedullary nail.

X-rays of the involved limb (face/profile) (**Table 1** and **Figure 1**) were systematically performed on all patients. This revealed the type of implant, the condition of the bone, and the type of mechanical complications (implant rupture, disassembly of the material and torsion of the osteosynthesis material, etc.).

After surgery, a control radiograph (**Table 3** and **Figure 1**) was taken. Patients received antibiotics, analgesics, anticoagulants (except in cases of lesions localized to the thoracic limbs and in children) and biphosphonate for the treatment of osteoporosis.
